TRANSACTIONS OF THE ESSEX SOCIETY
FOR ARCHAEOLOGY AND HISTORY

Volume 25

1994

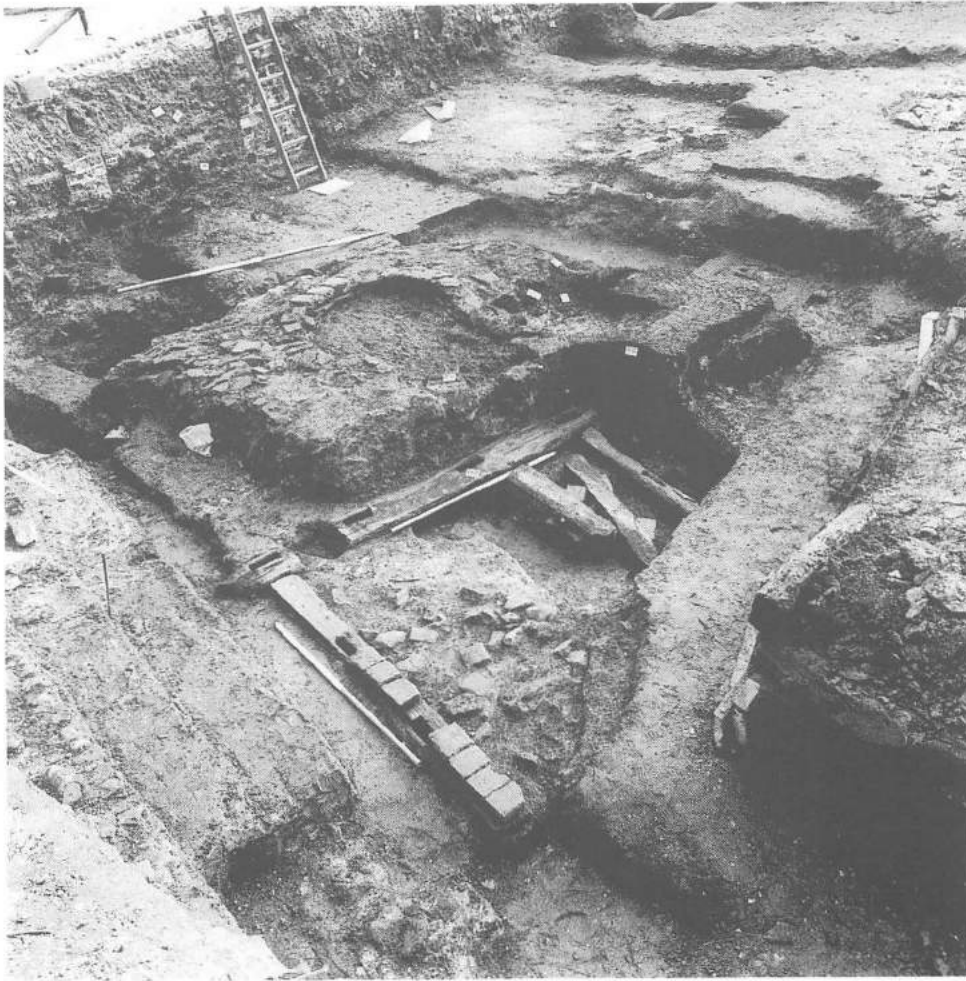
Fig. 8 Site A. Building 179, timber-framed structure, AF60, viewed from the west.

The ground-plates of a small timber-framed structure (AF60) were set in a shallow pit (AF54; Figs 7 and 8), 0.4 m deep, immediately west of AF37.

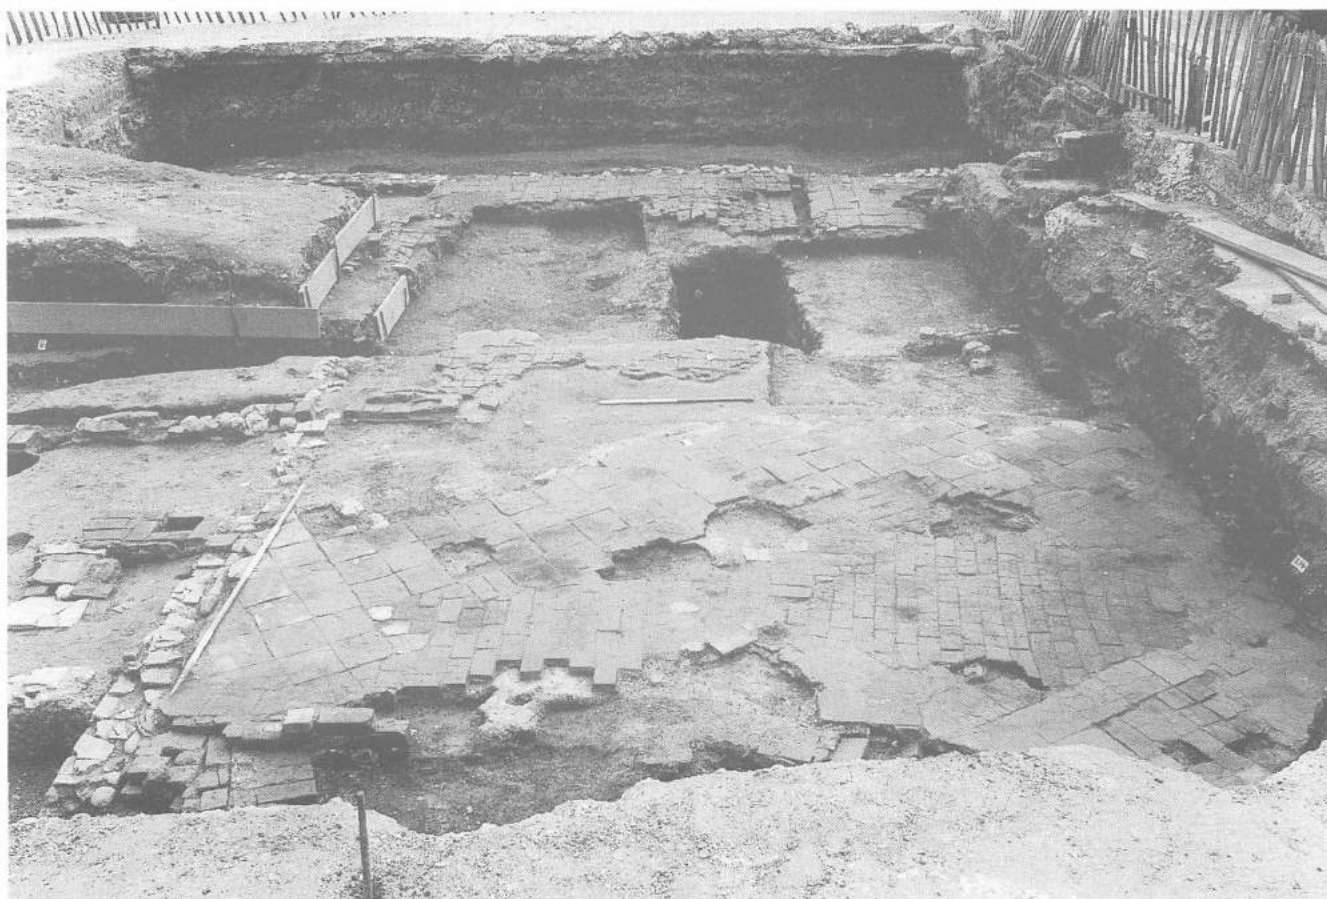
Fig. 12 Site C. Building 180, Period 3b, viewed from the north.

ground-plates in CF4 and CF8, while the foundations and floors were sealed by a layer of destruction debris (CL14, CL17 and CL19) 0.5 m thick, consisting of fragments of burnt daub, charcoal, brick and tile. The dating evidence strongly suggests a mid-17th century date for this horizon and it seems likely that Building 180 was burnt down during the Siege of Colchester, probably following the attack on the nearby St John's Abbey gatehouse on 14 July, 1648.

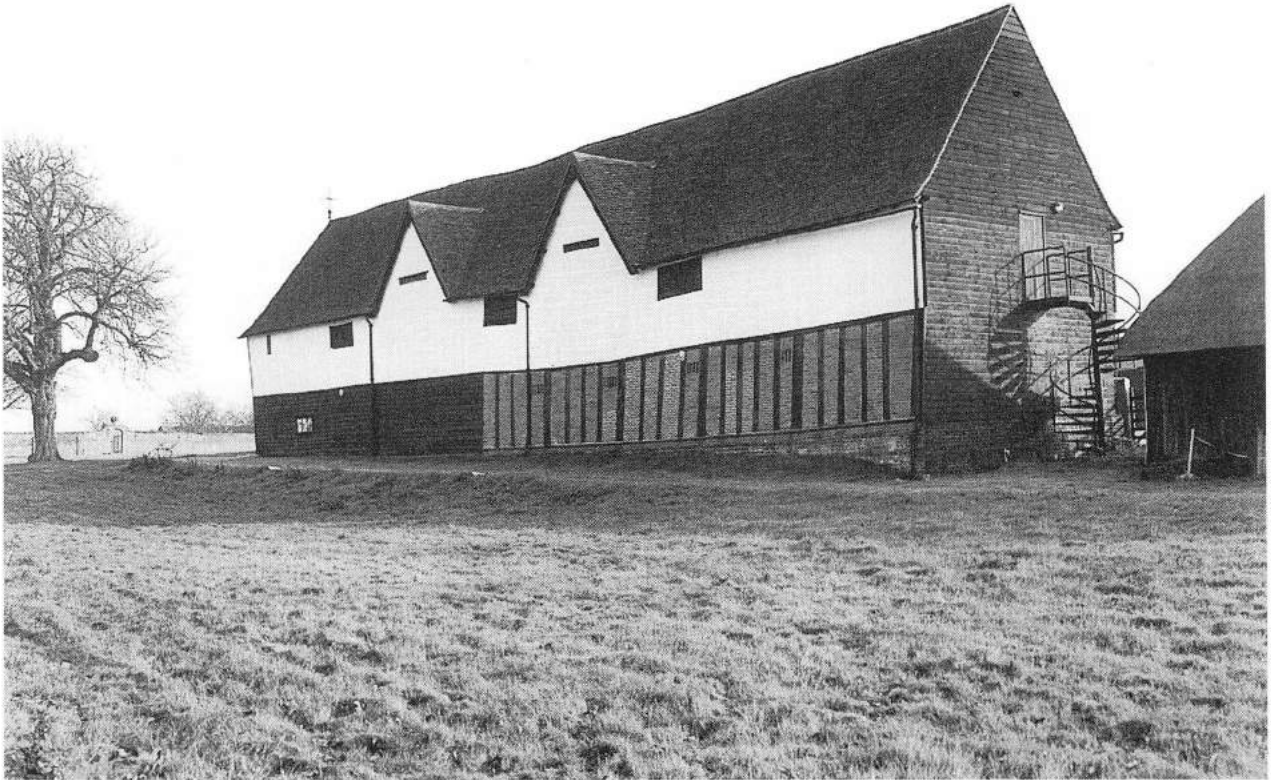
Plate 1 The west side of the Granary.

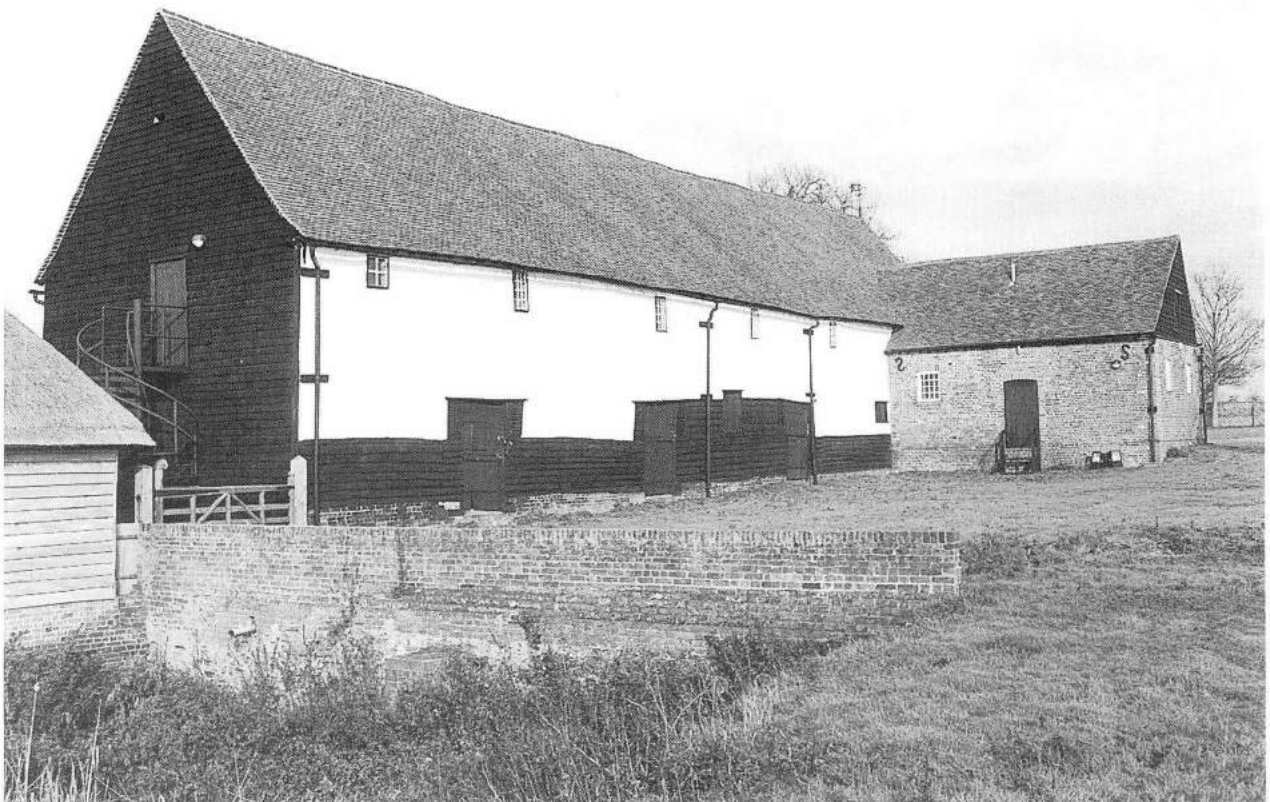
Plate 2 The east side of the Granary, with the former kiln, now the toilet block.

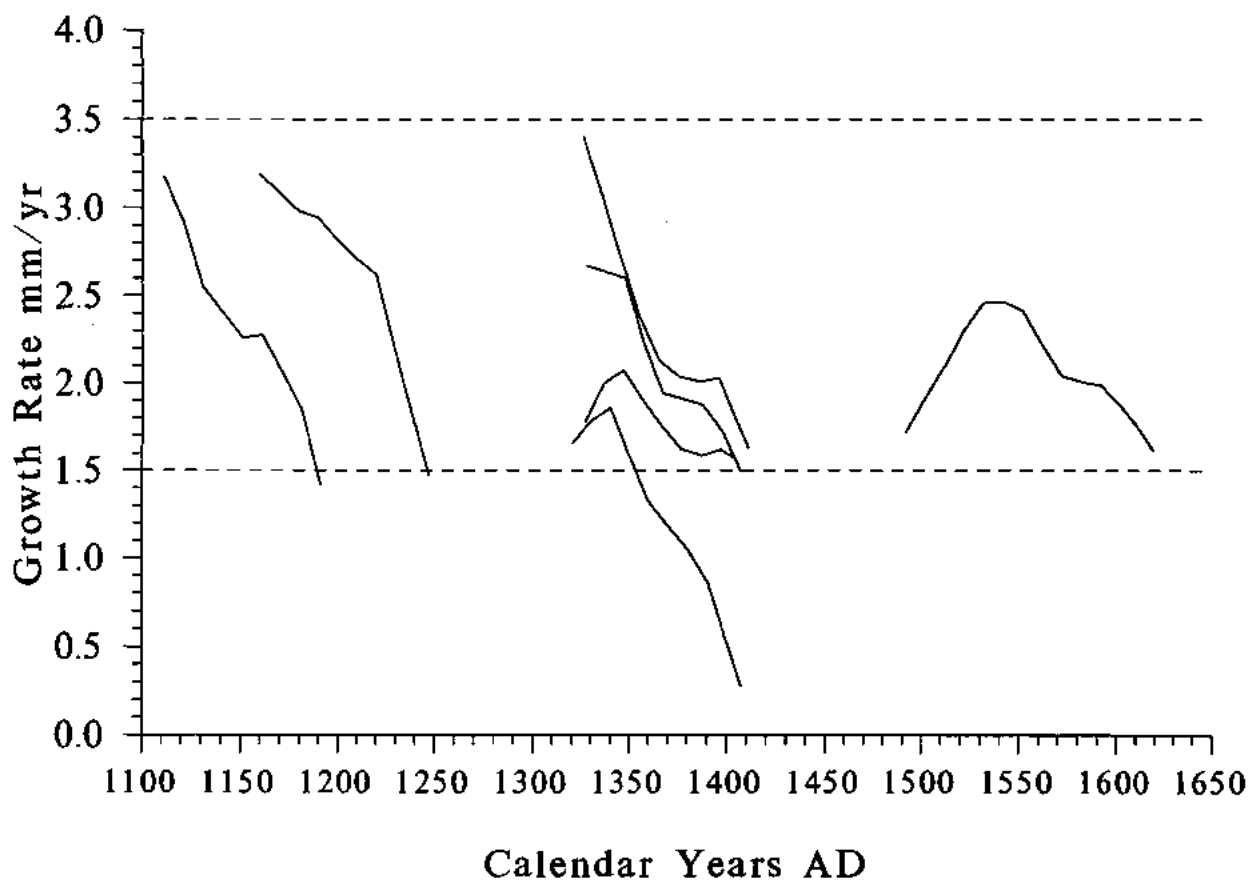
Fig. 9 Average smoothed growth rates of dated material from Cressing. Note the apparently aberrant nature of the Granary rafters.

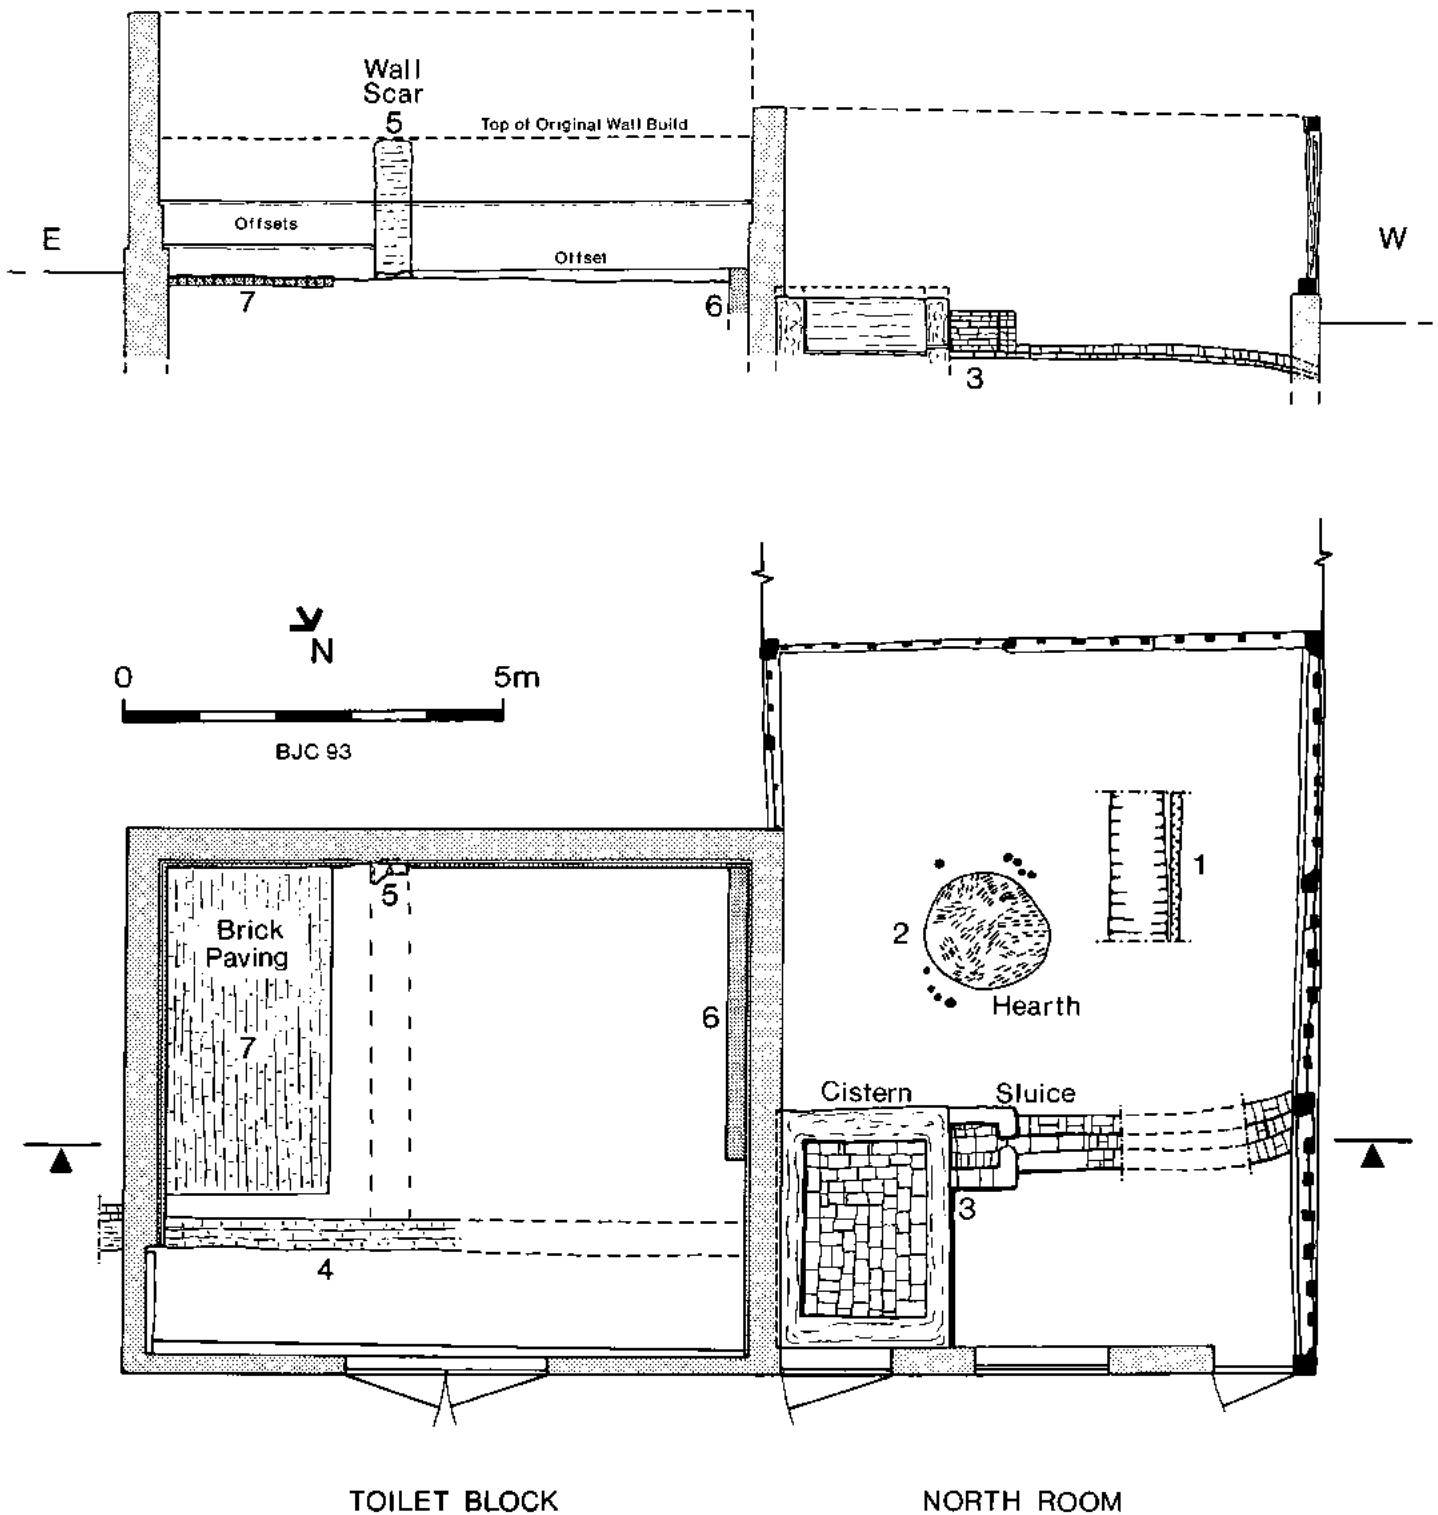
Fig. 11 Plan of the excavations in the north room of the Granary and the adjacent building, with a section and elevation (above) facing south.

Whether or not this was so, the existence of a building which clearly pre-dated the Granary was indicated by patches of a clay floor and a circular hearth built of broken roof-tiles set on edge in a bed of clay (2, Fig. 11). Associated with the hearth were eight or nine shallow postholes, circular scoops in the floor

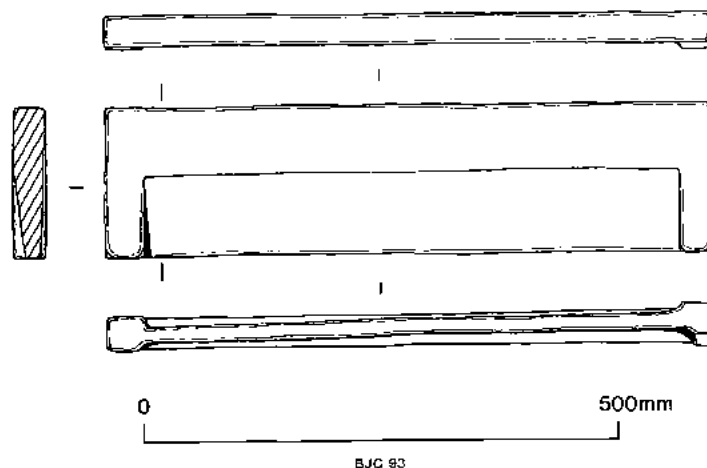
Fig. 12 A malting kiln floor support tile found in the walled garden at Cressing Temple.

Similar tiles been found at Hopwells Farm in Great Maplestead where the kiln was dismantled at the beginning of this century. In no instance has it been possible to identify a date for their initial use. It is known that timber joists were used in Kentish oast houses which are similar to malt kilns and were sometimes used as dual-purpose buildings.

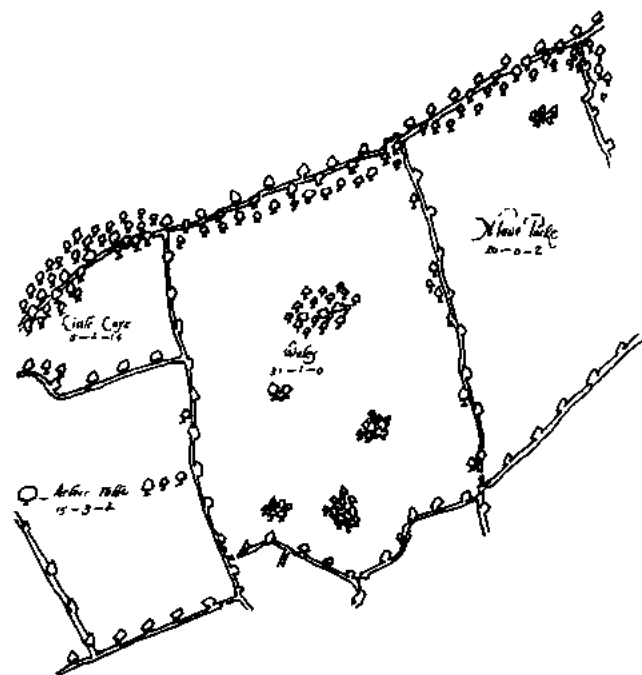
The map is interesting in other respects (Fig. 4). It shows trees growing freely in clumps — a feature one associates with planting styles of a much later date; they are not formal roundels. Also there is a spring or

Fig. 4 A transcription of the area of the former park, showing spring and clumps. From "A trewe platt of the Mannor of Little Leighs Haule within the Countie of Essex" — John Walker, 1609 (ERO T/M 320).

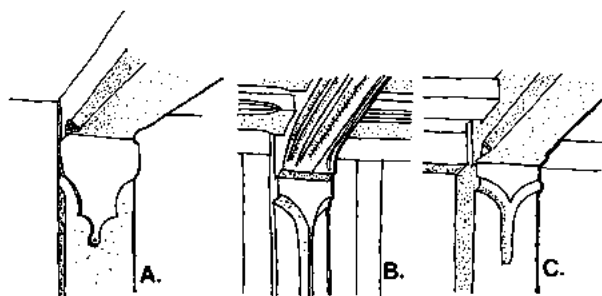
Fig. 9 Examples of bifurcated arcades.
A. Reused post, farmhouse, Little Waltham
B. The Red Lion
C. High Street, Brightlingsea.

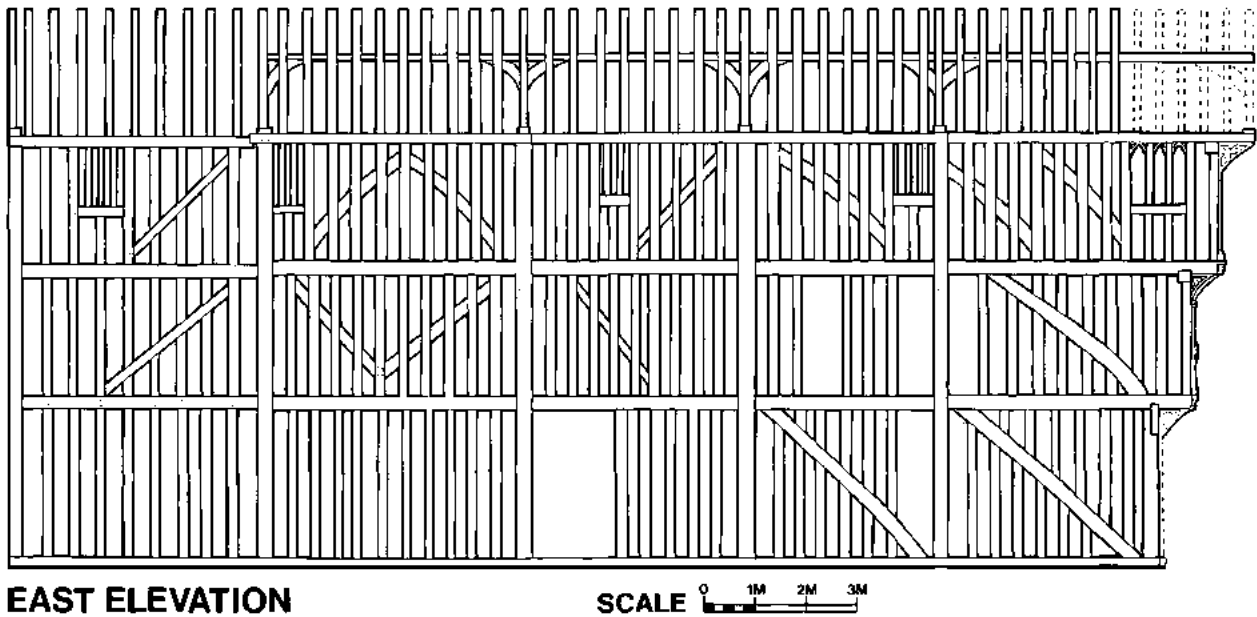
Fig. 10 The Red Lion, Colchester. East elevation of the timber frame.

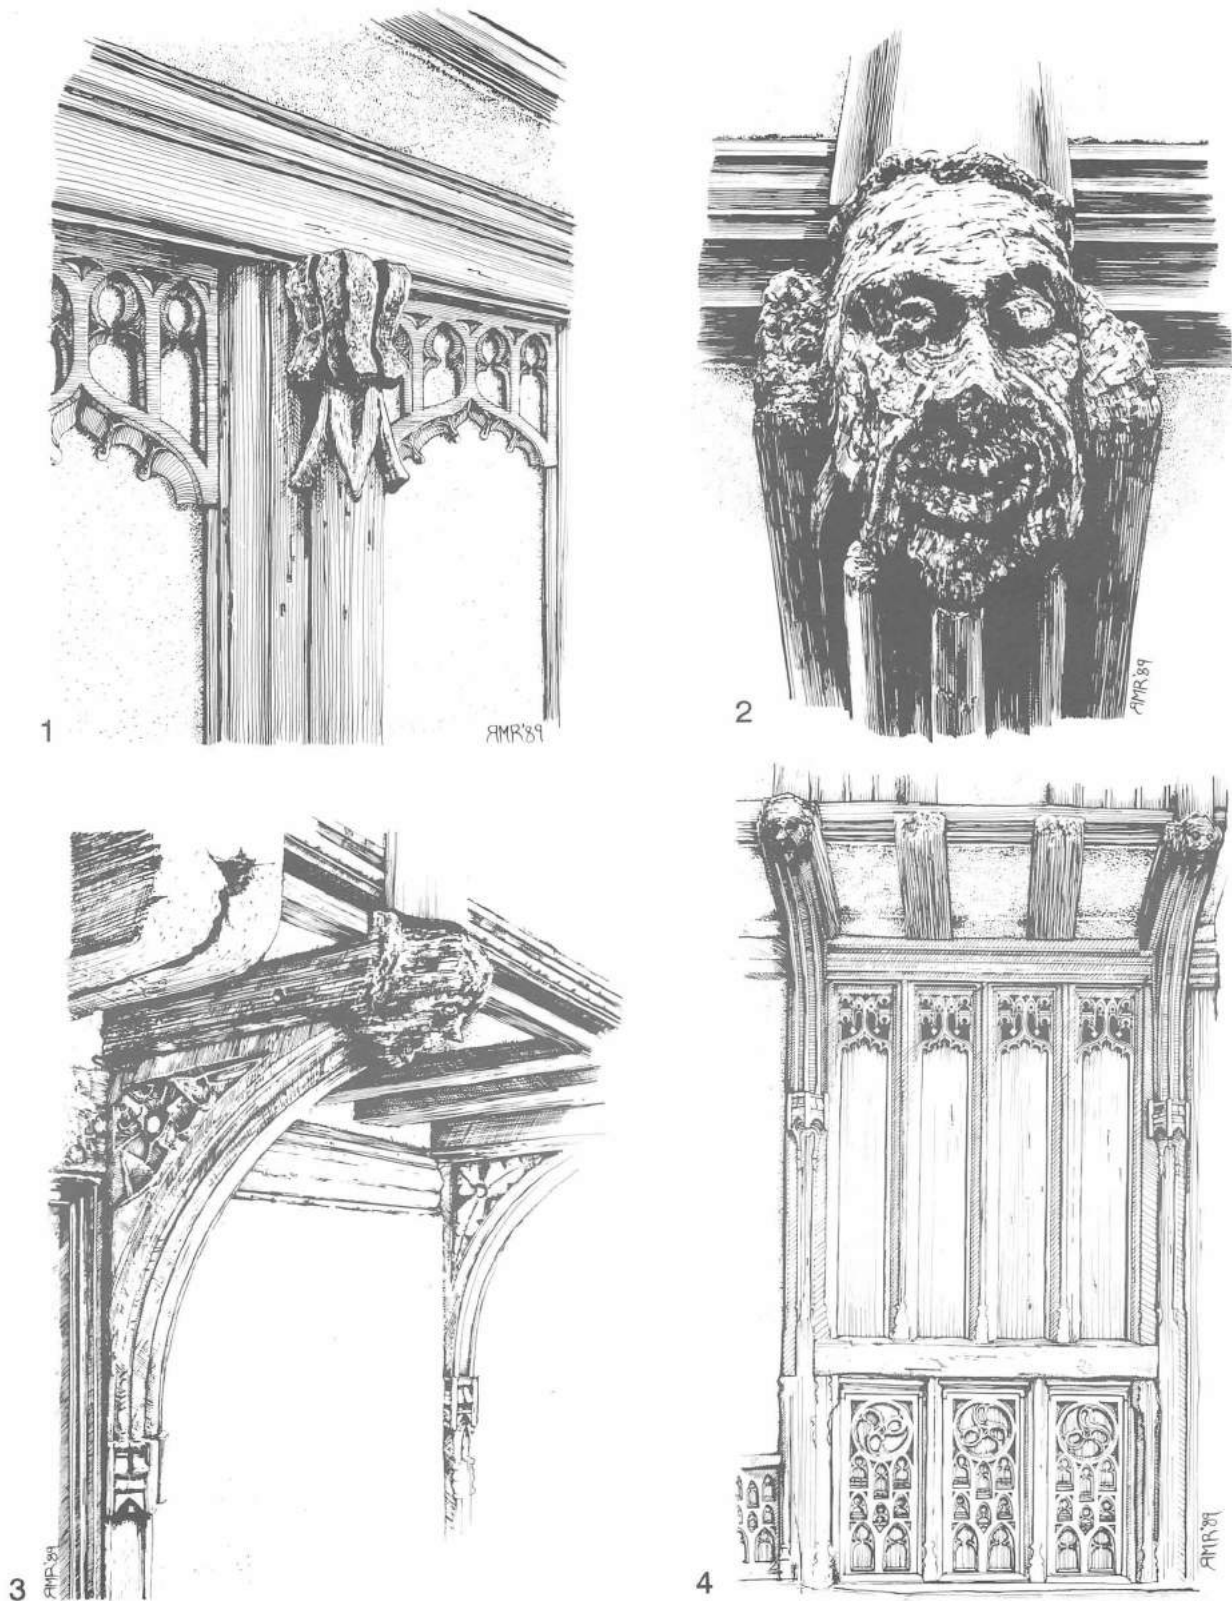
Fig. 15 The Red Lion, Colchester. Details of High Street elevation:
 1. Second floor, attached shaft and window tracery
 2. Grotesque head, end of bridging joist
 3. First-floor jetty detail with carved blocked spandrels
 4. One bay of first-floor elevation with blind tracery panels.

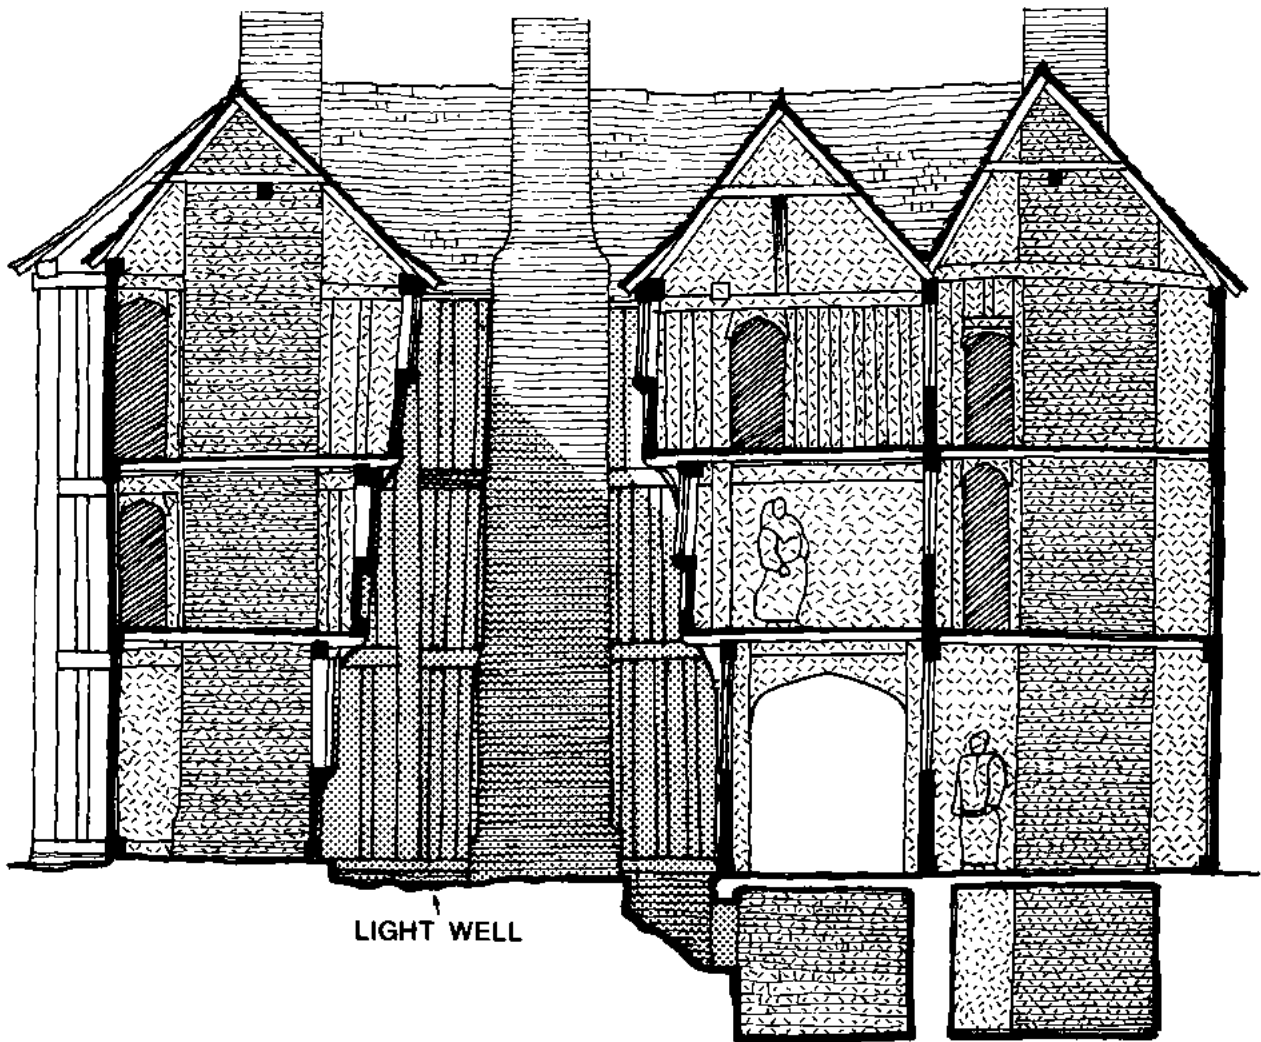
Fig. 17 The Red Lion, Colchester. Section through the centre of the building from west (left) to east (right). Refer to Fig. 3 for position of this section.

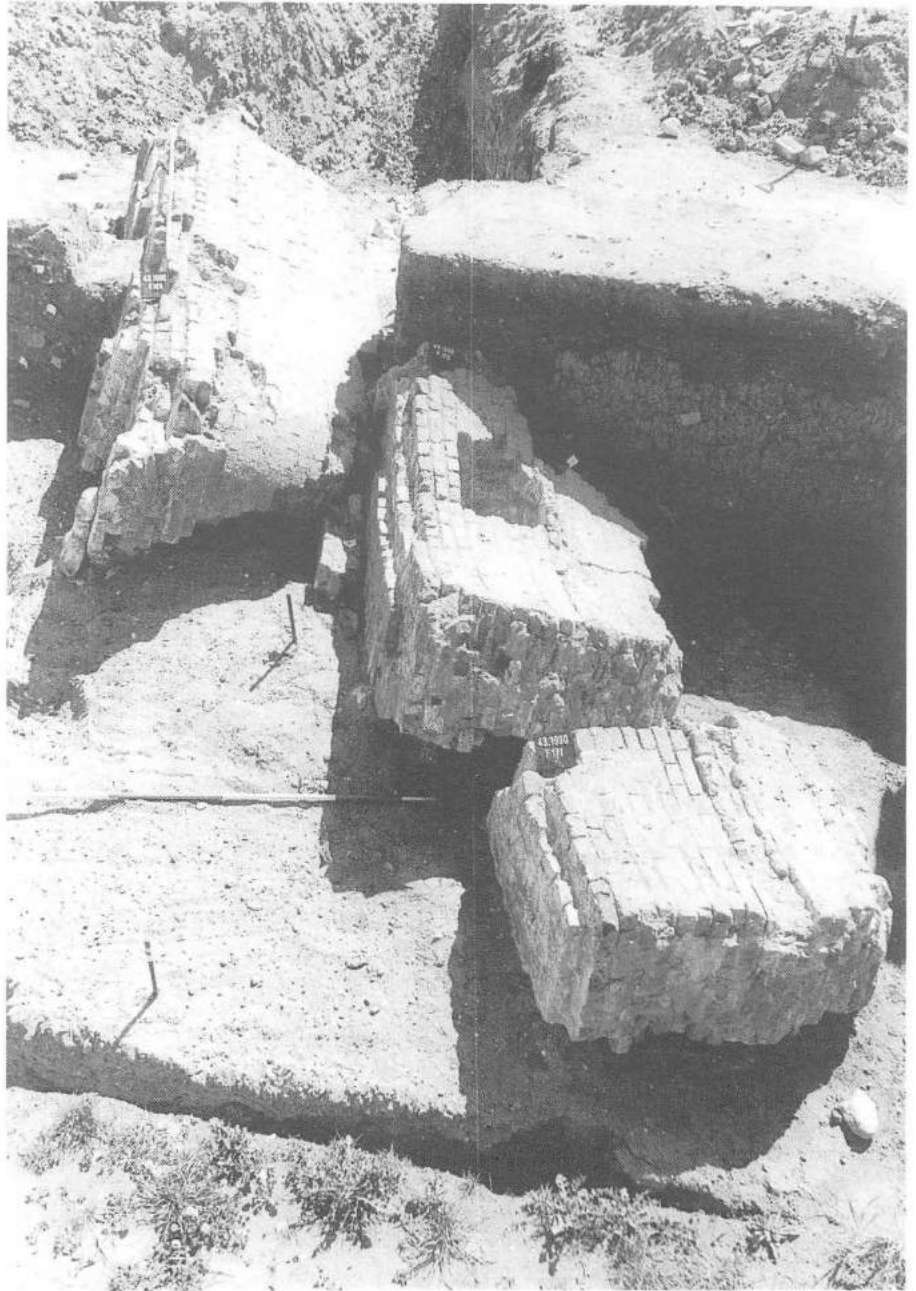
Fig. 6 Fallen wall sections in trench A, showing rampart wall 169 in background, and emplacement wall sections 170 and 171 in centre and foreground.

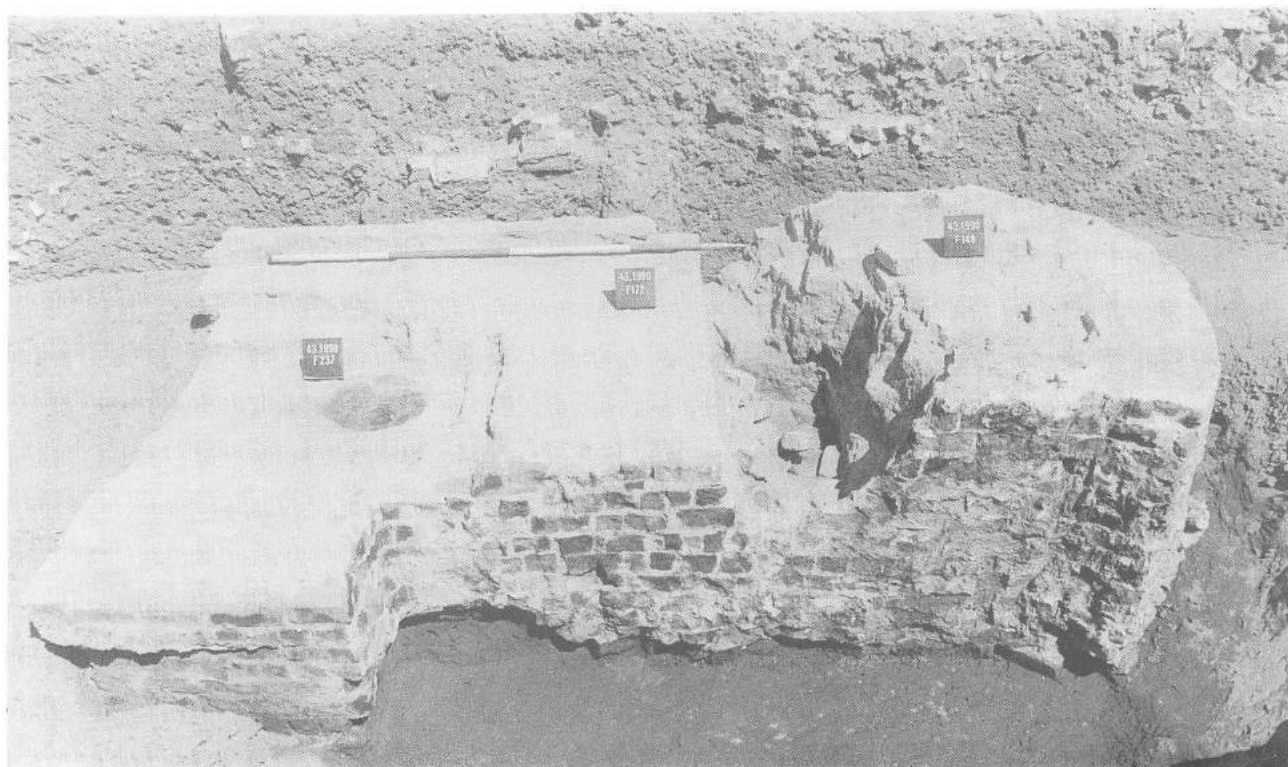
Fig. 9 Gun emplacements 172 and 148 showing damage in 148 caused by removal of 1st-phase pivot (on right), and the cascabel of 2nd-phase pivot 237 (on left). Damage in the foreground was caused by a Victorian storage tank.

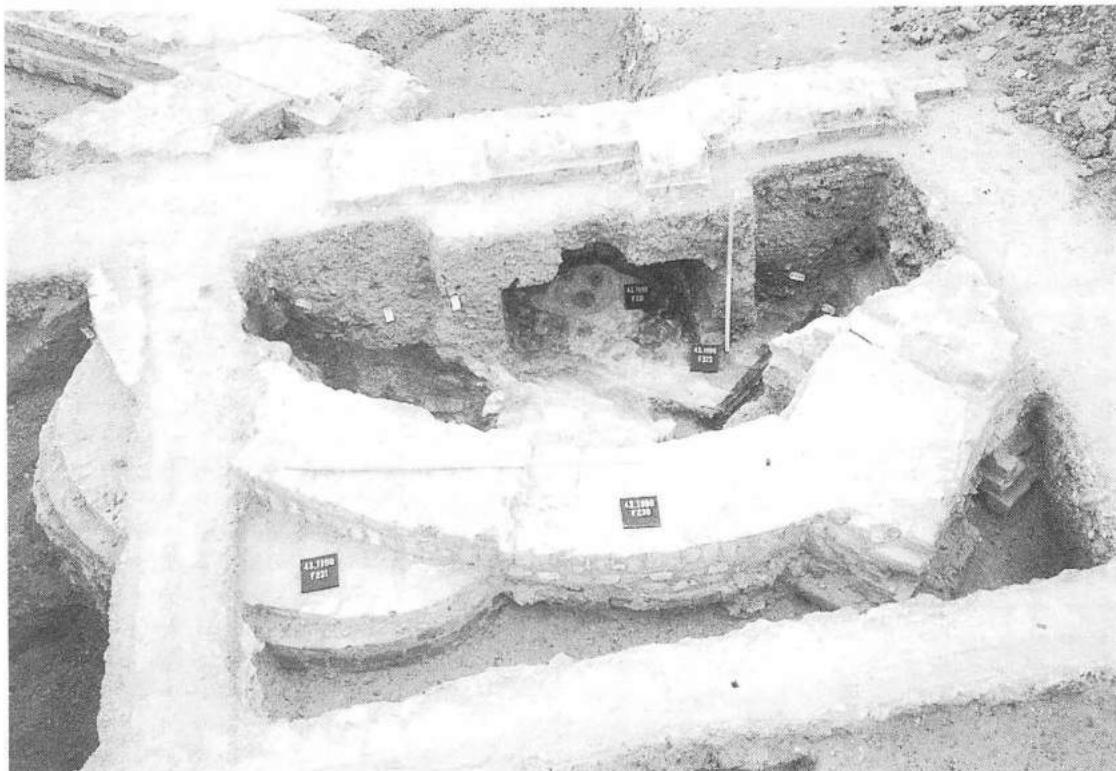
Fig. 12 Southern gun position in trench B, cut by Victorian house foundations. Showing 1st-phase emplacement 231, and 2nd-phase emplacement 323 (with pivot cannon cascabel 331); and 2nd-phase racer 230 joined either end to remains of 1st-phase racer.

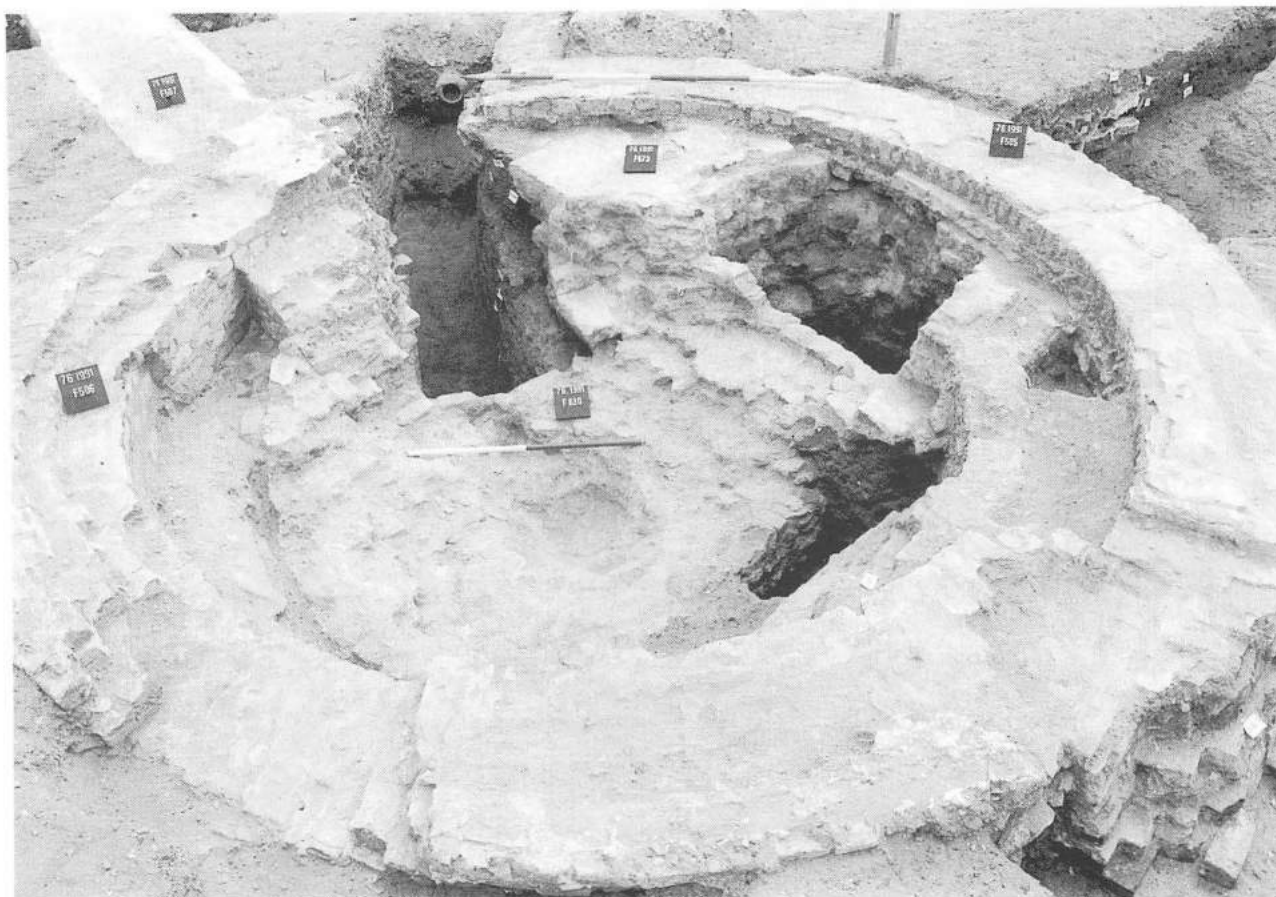
Fig. 14 Northern gun position, showing rampart wall sections 507 (top left), 650 (bottom right); 1st-phase emplacement 573; 2nd-phase emplacement 630 and racer 505; and emplacement wall 506.

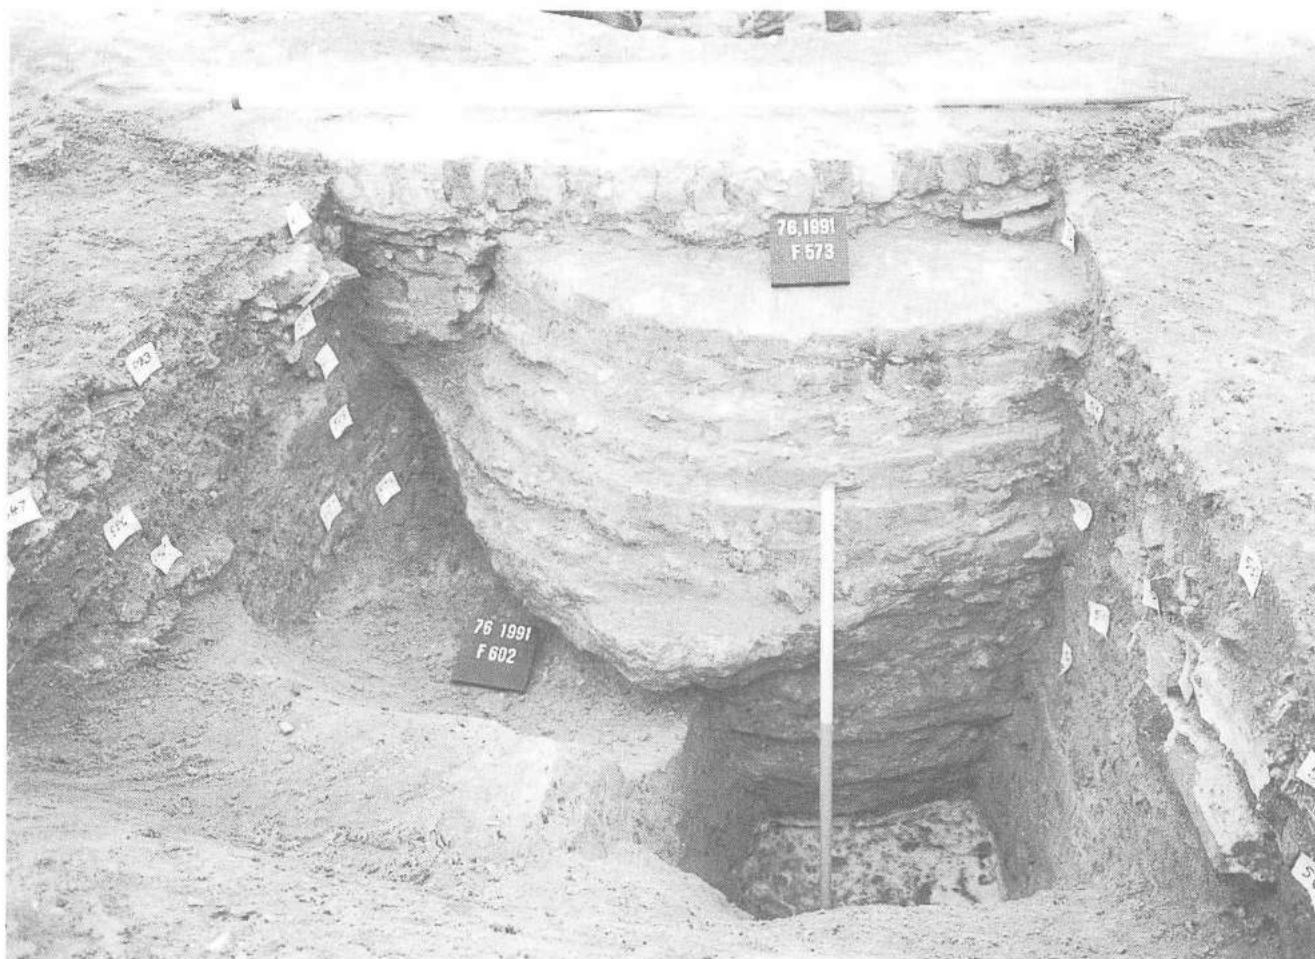
Fig. 15 South side (rear) of 1st-phase emplacement 573; 2nd-phase racer is seen above. Remains of 1st-phase racer is seen in section (bottom right).

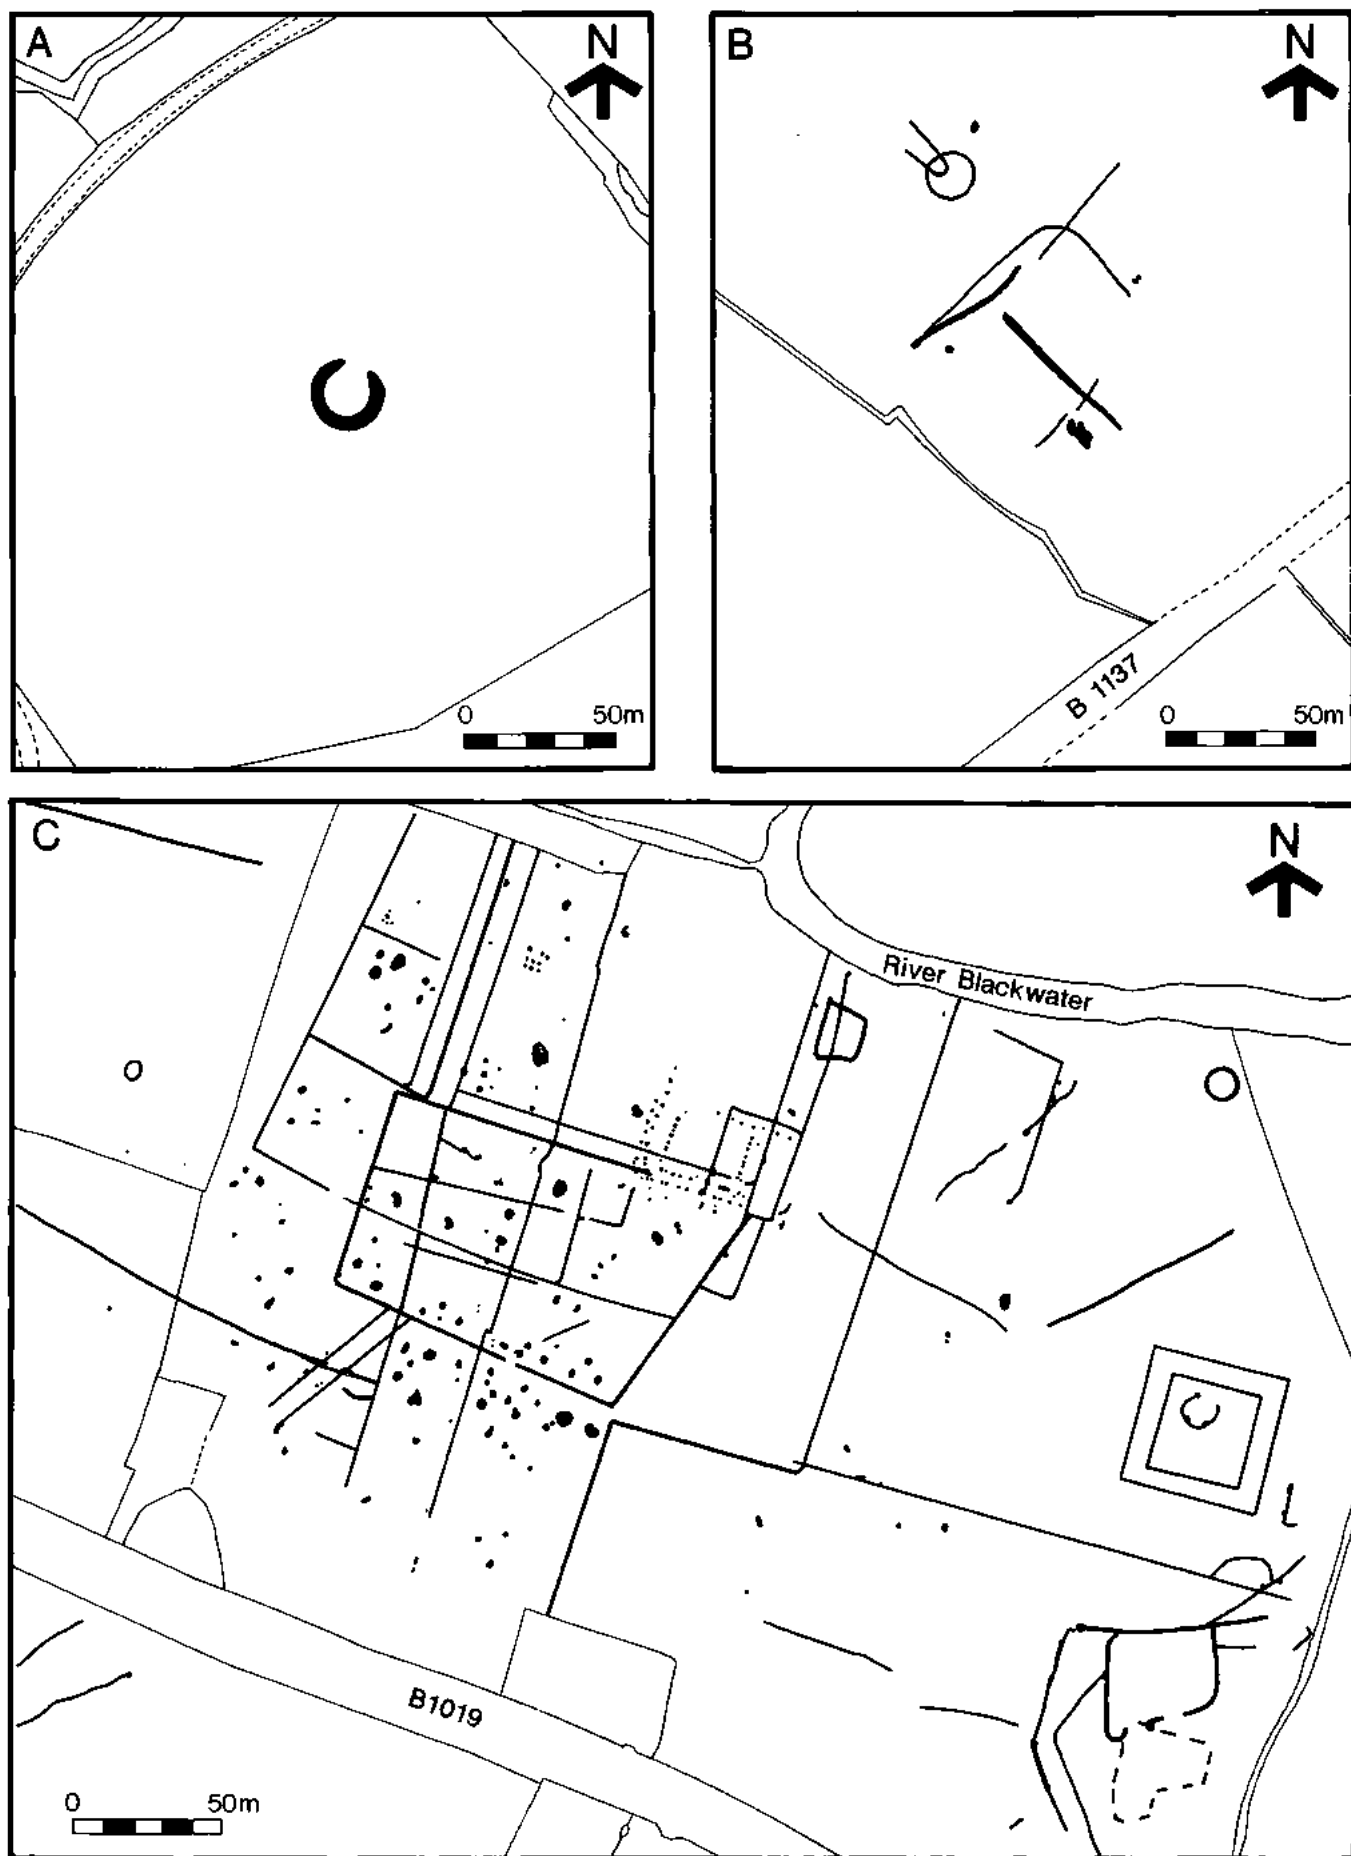
Fig. 6 A - A possible windmill site at Terling; B - A ring ditch and other features at Springfield; C - Cropmark complex at Langford.

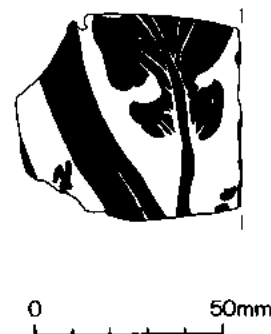
About 60 unstratified fragments of window glass were recovered from the excavation of a contractors trench in 1990, all presumably derived from the south window of the transept, which is now blocked in 18th-19th century brick. About 16 fragments about 1mm thick and slightly greenish in colour, were probably post-medieval, but the rest were probably late medieval. Most were badly devitrified and fairly thick, but they included six painted fragments, of which two joining fragments are illustrated here (Fig. 13). They are 3-4 mm thick and devitrified, but not laminated or iridescent. The right-hand edge is grozed. The painting is a dull purplish red and represents a leaf and a curvilinear stem or border. It seems to be a fragment of grisaille or monochrome foliate pattern, and may be dated to the 13th-14th centuries.

Fig. 13 St. Michael's, Great Sampford: glass.

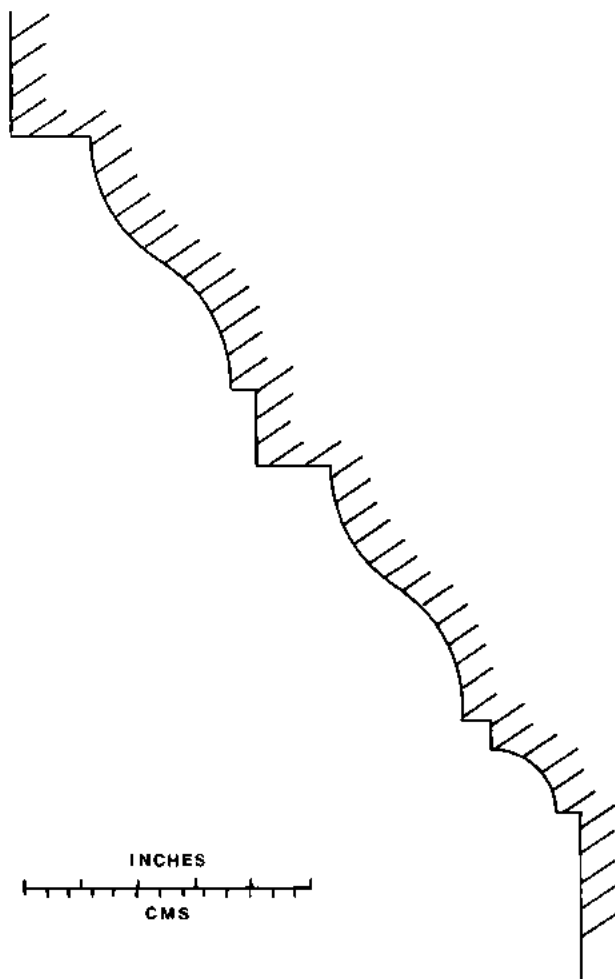
Fig. 21 Berechurch Hall dovecote. Profile of original cornice.
