# **THE RAILWAYS OF THE BLACKWATER AND CROUCH ESTUARIES**

**The Shenfield to Southminster branch.**

**A History and Field Survey of the Extant Structures**

**Essex County Council, 2011.**

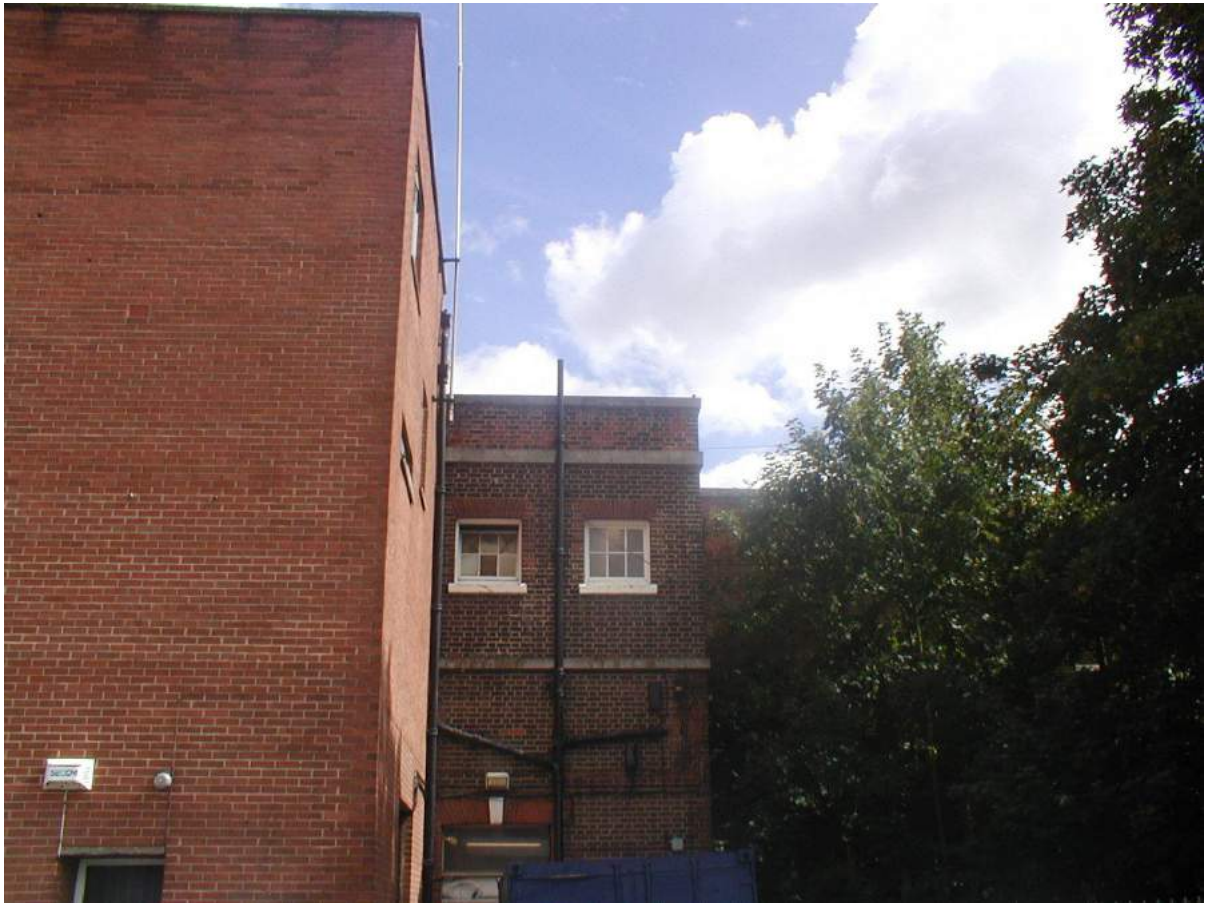
Southern section of the older part (?1933, darker brick) of the station, Shenfield.

**SITE DESCRIPTION.** The west-facing station **booking hall facade** with offices above (Photo Film E24/P101024 from west) of brick red brick in regular bond mostly conceals the **older building** of darker red brick in irregular Flemish bond which is exposed at the extreme right (south), (Photo Film E29/P101029) and left of the facade. Below the left wing forming part of the embankment are **3 blind niches** in blue engineering brick (Film E25/ P101025) with, above, a blue brick double-diamond motif imposed in the red brick.

The five platforms, one single to the west and two double, with metal posts and brackets supporting the canopies, are accessed from street level by stairs or lift. Sidings to the southwest.

**RECOMMENDED ACTION** Record and monitor any proposed development.

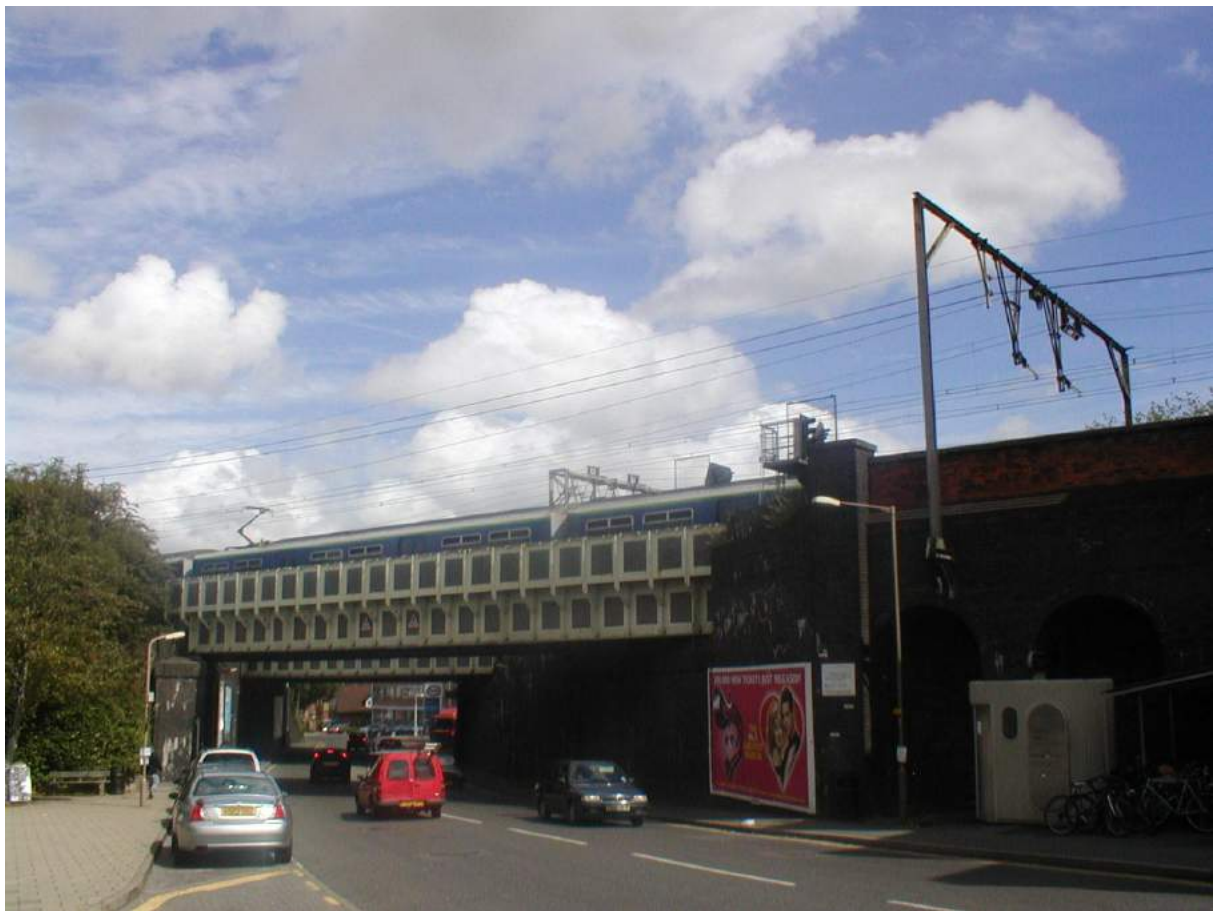
Southern Hutton Road bridge (northern just visible behind), Shenfield.

**RECOMMENDED ACTION** Record and monitor any proposed development.

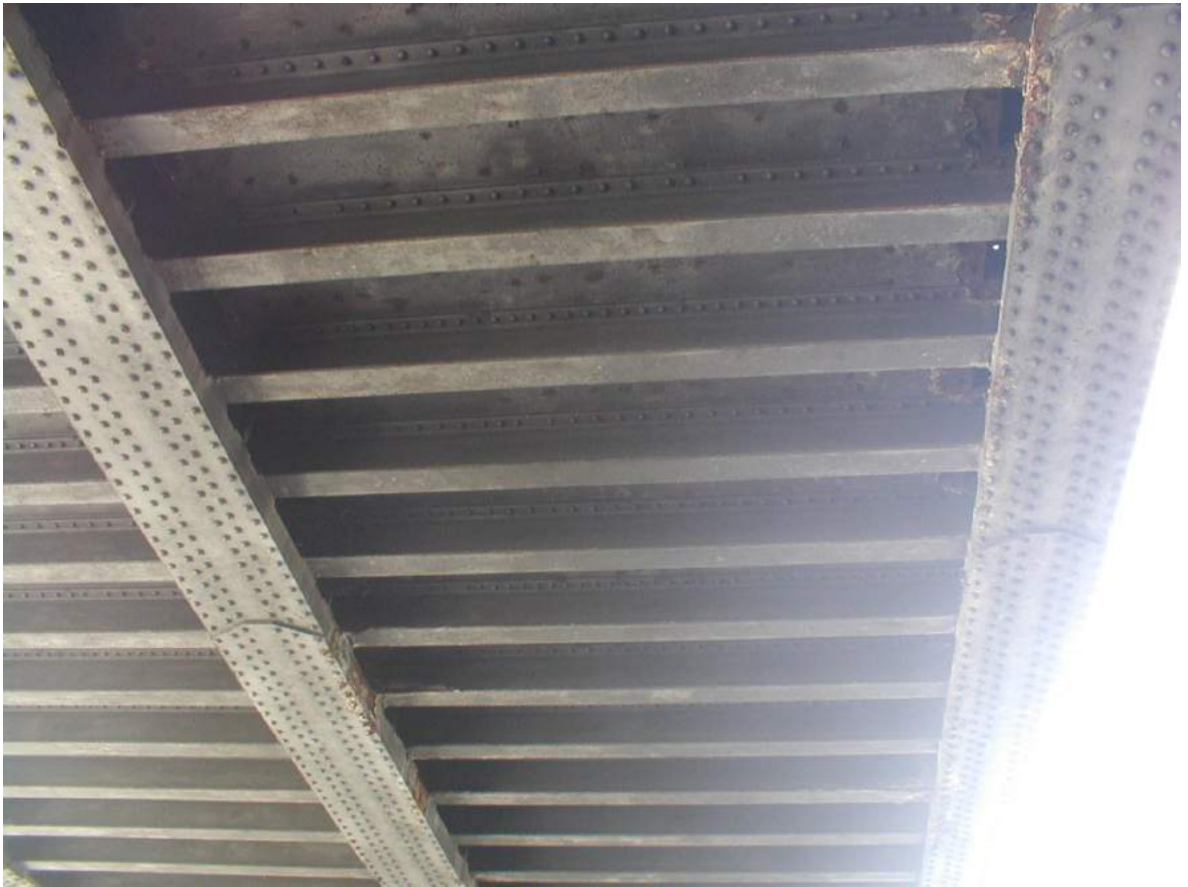
Under-structure of Hutton Road bridge, Shenfield.

**RECOMMENDED ACTION** Record and monitor any proposed development.

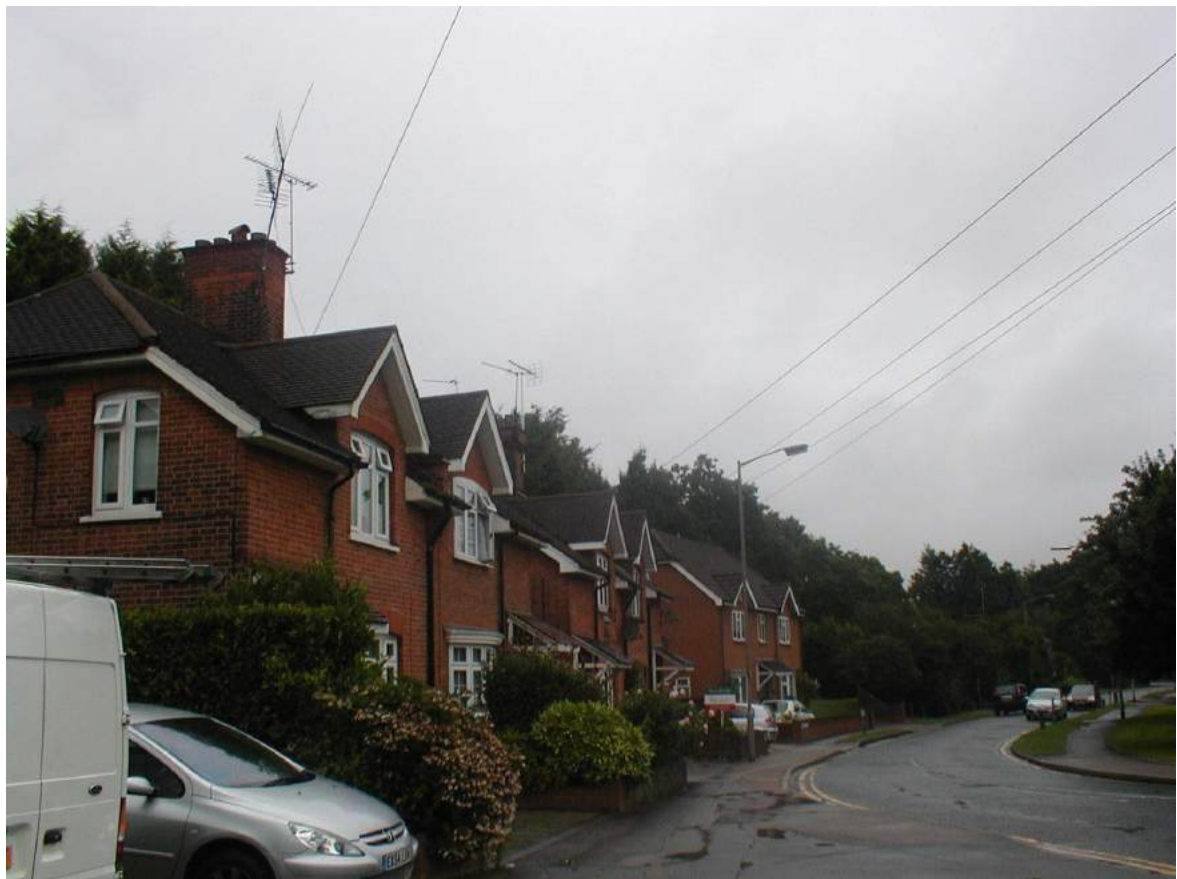
Railway cottages, Alexander Lane, Shenfield.

**RECOMMENDED ACTION** Record and monitor any proposed development. ?List Nos 2/4, 6/8.

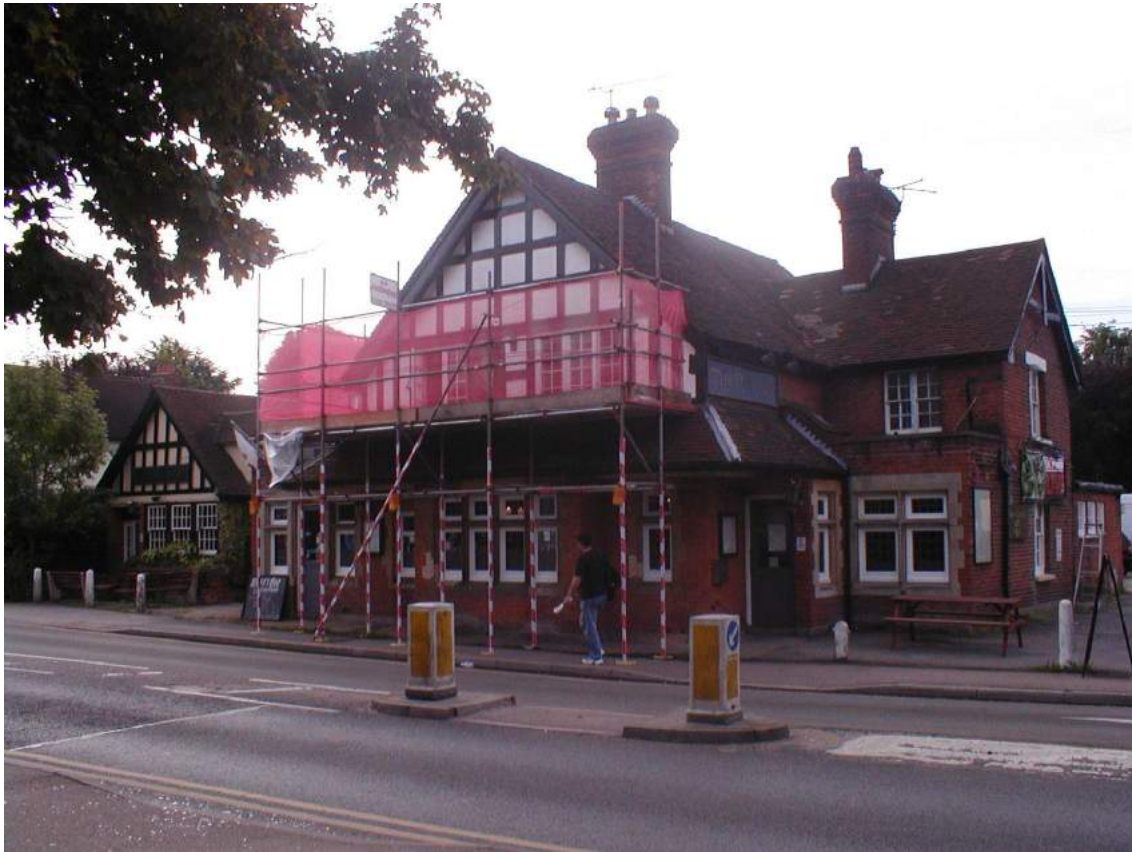
“Hutton Junction Hotel” (The Hutton), Rayleigh Road, Shenfield

**SITE NAME** “The Hutton” public house, Rayleigh Road, Shenfield, formerly “Hutton Junction Hotel”.

**RECOMMENDED ACTION** Record and monitor any proposed development.

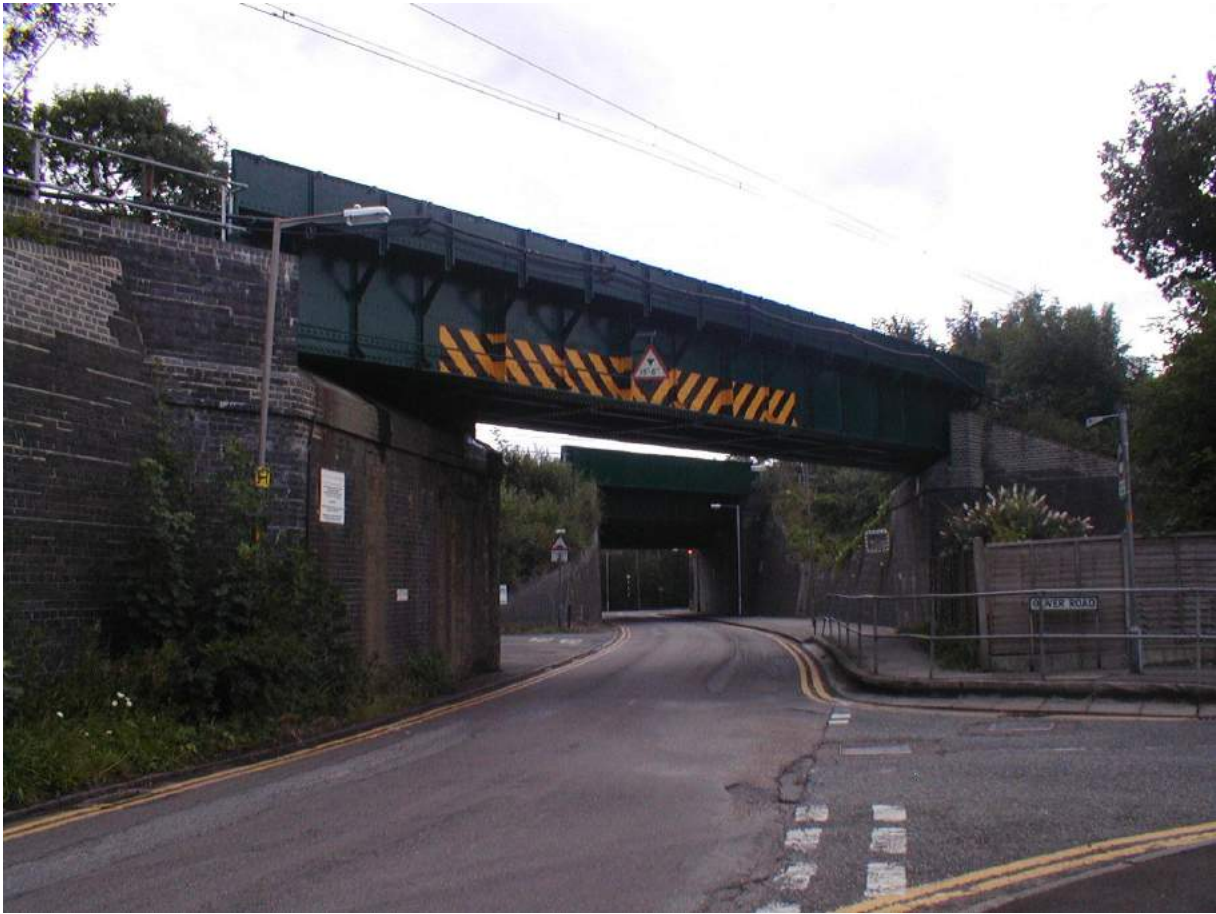
Alexander Lane bridges from north, Shenfield.

**RECOMMENDED ACTION** Record and monitor any proposed development.

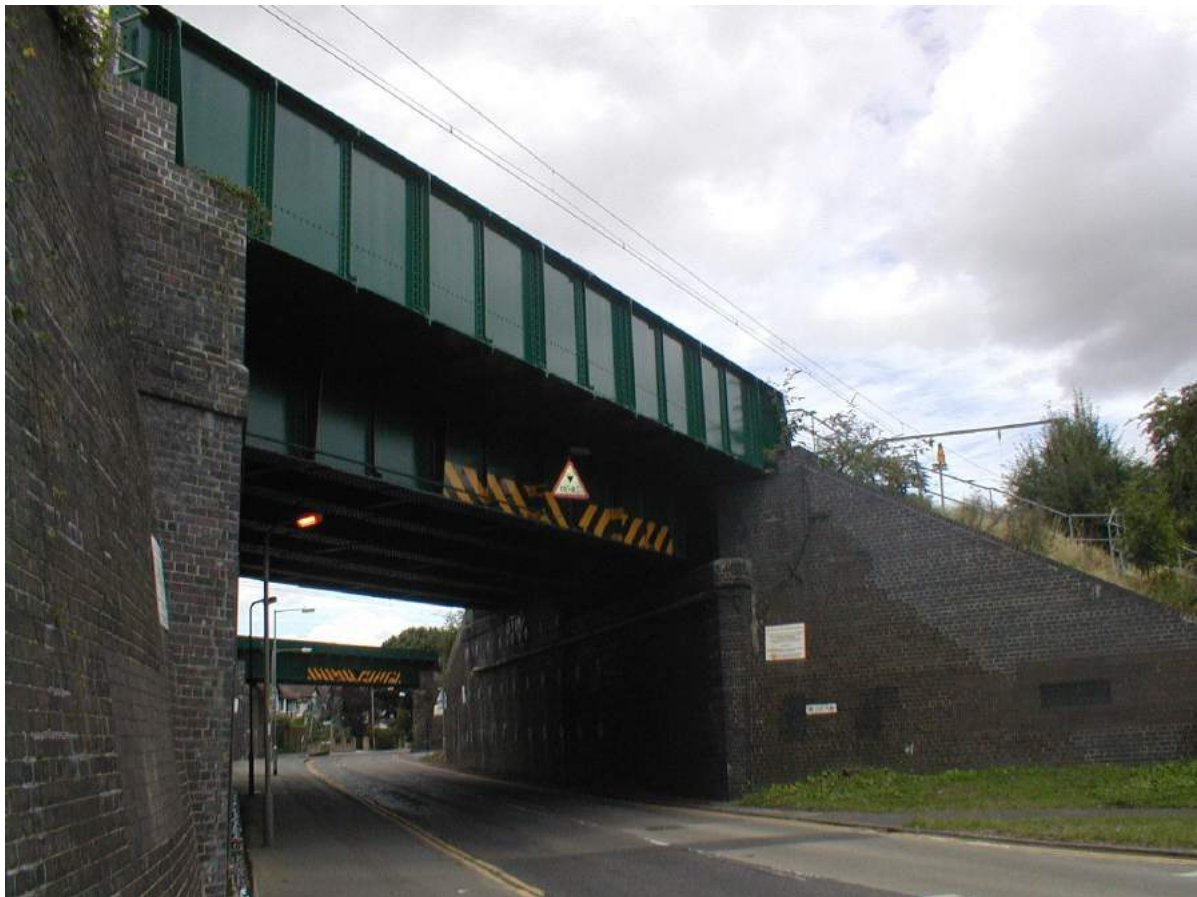
Alexander Lane bridge from south, Shenfield.

**RECOMMENDED ACTION** Record and monitor any proposed development.

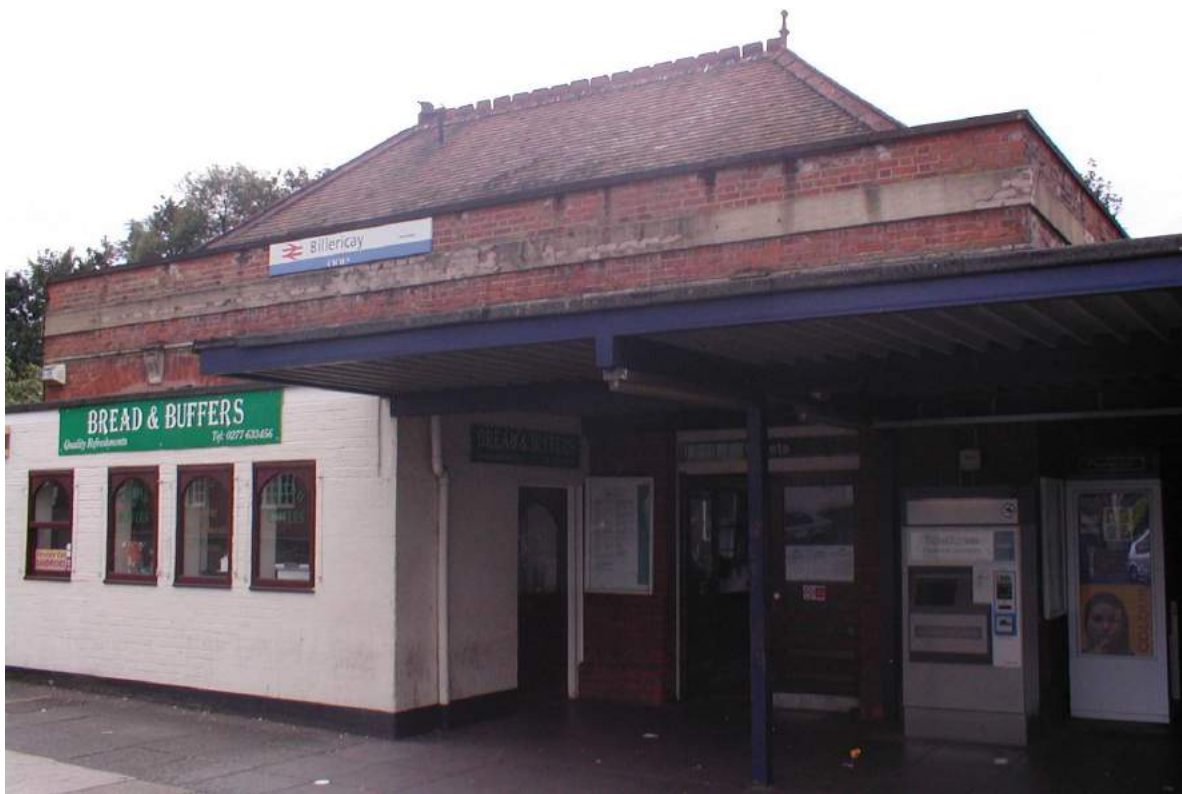
Booking Hall entrance from north (Radford Way), Billericay.

**RECOMMENDED ACTION** Record and monitor any proposed development.

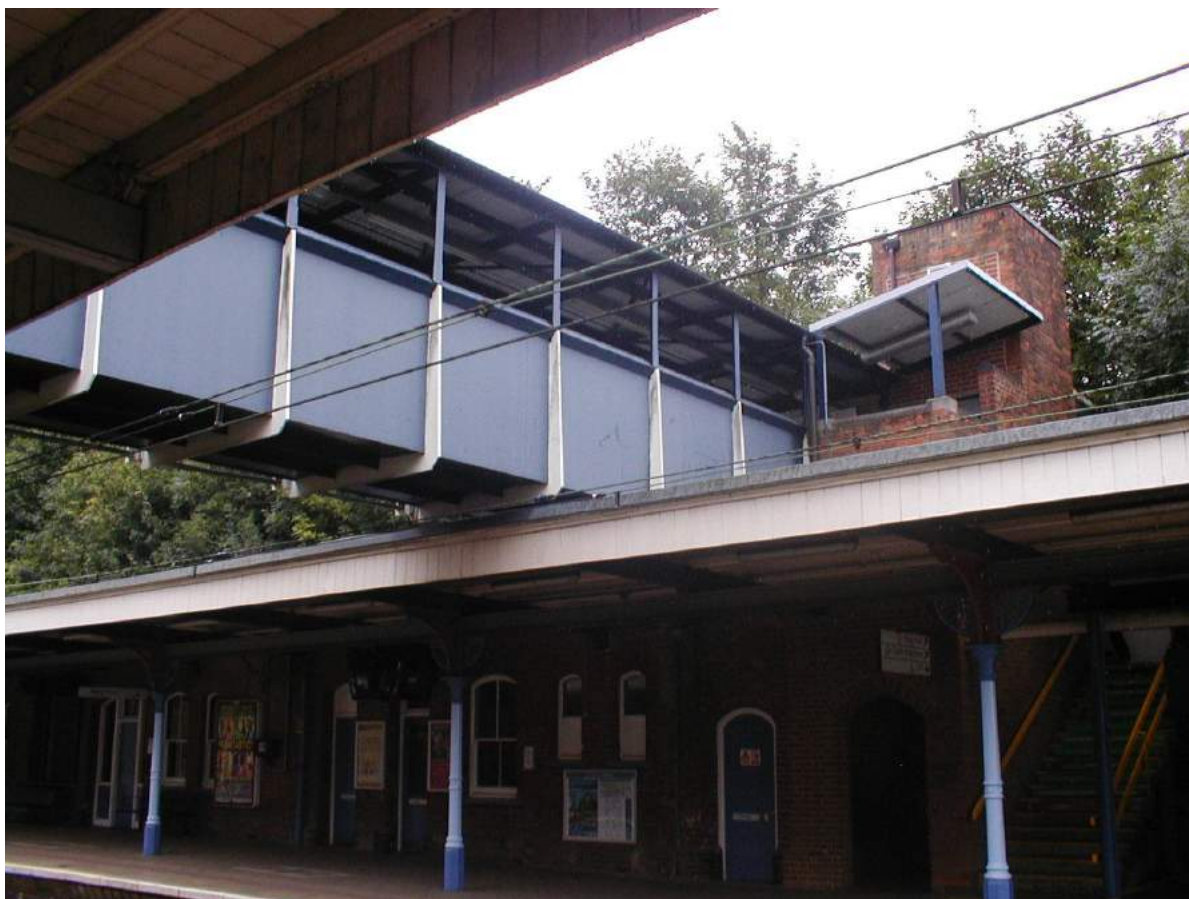
The up-line (south) platform, Billericay.

**RECOMMENDED ACTION** Record and monitor any proposed development.

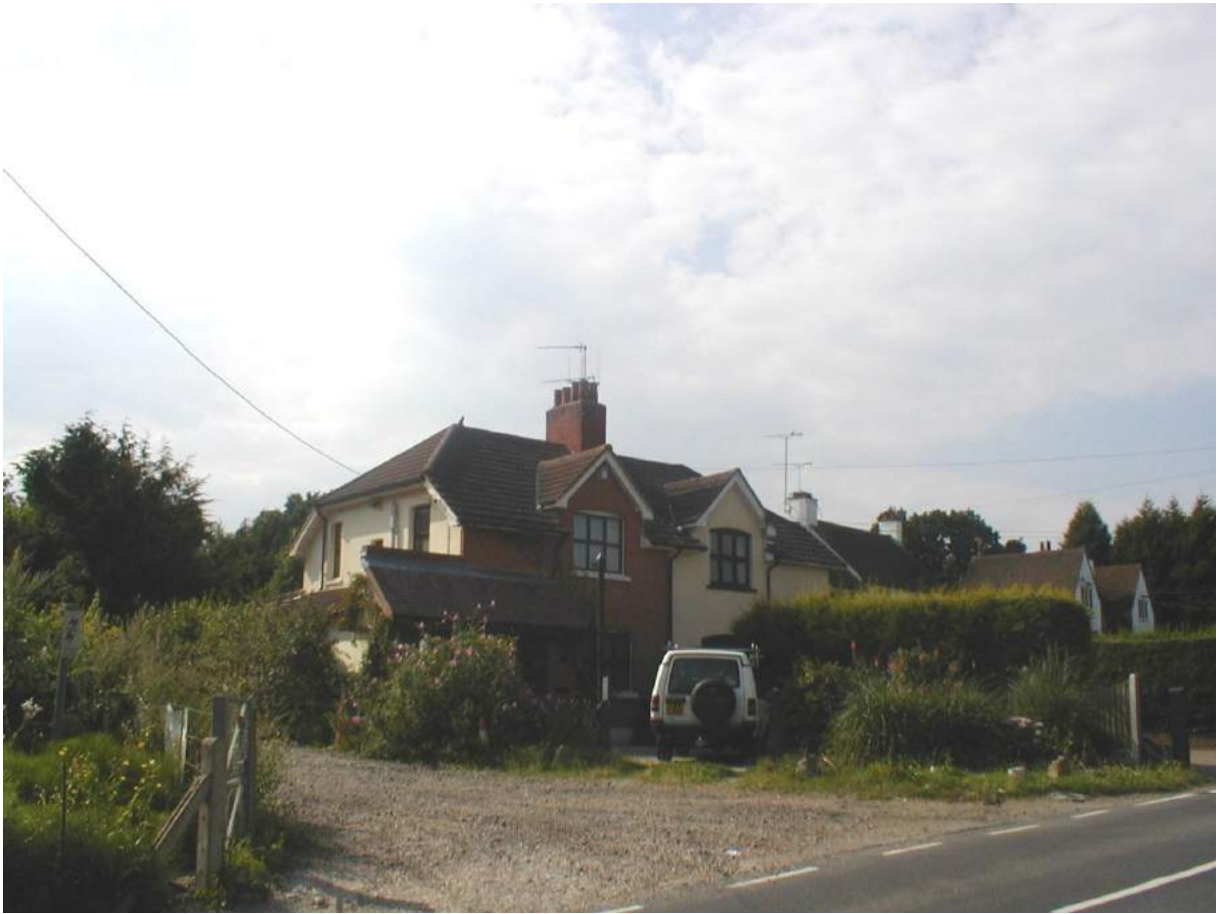
Railway cottages, Church Road, Ramsden Bellhouse.

**SITE NAME** Railway cottages, Church Road, Ramsden Bellhouse

**RECOMMENDED ACTION** Record and monitor any proposed development.

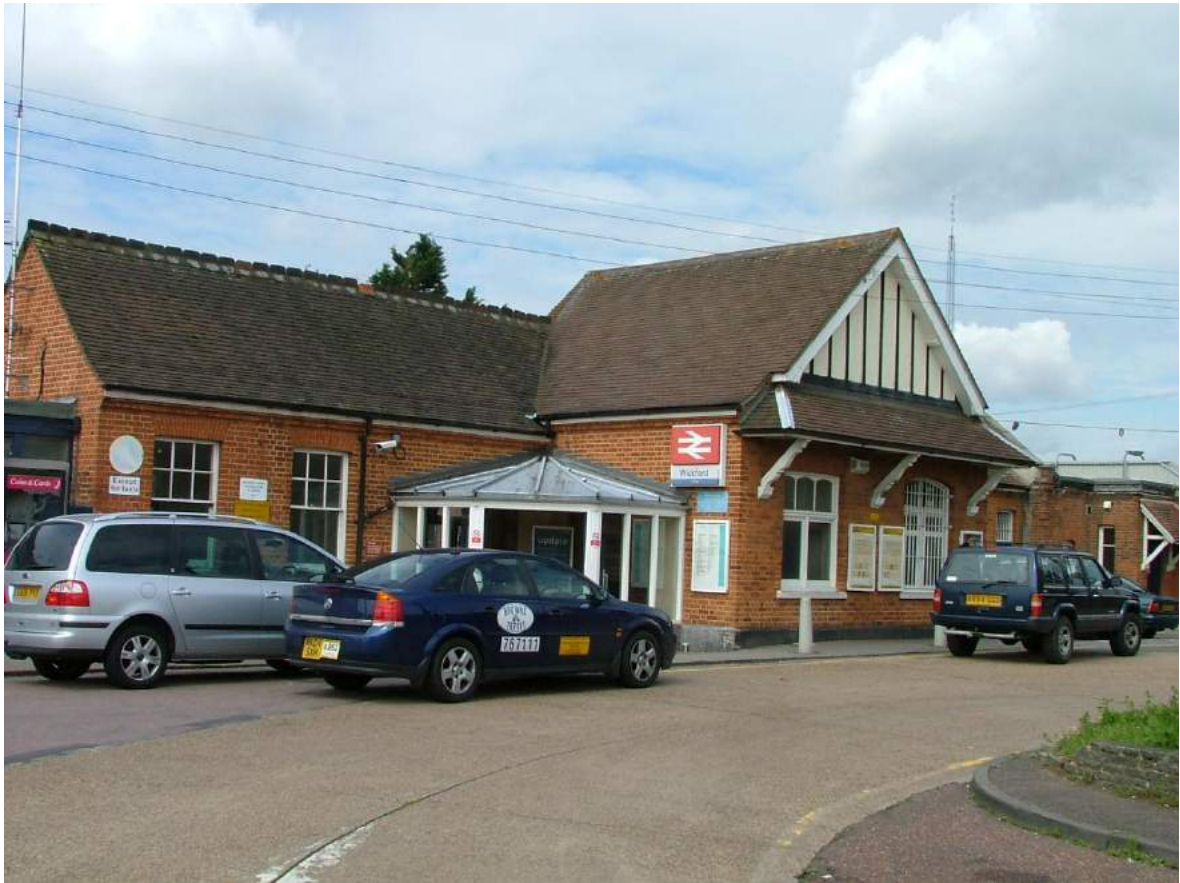
Booking pavilion, Wickford Station, from east.

Ground-floor remnant to its N of **Station Master's House** (upper floor burned down c.1998) lie E of the platforms (Photos Film C6/DSCF2695 from southeast, C7/DSCF2676 from southeast, C10/DSCF2699 from east). Lattice-sided **footbridge**, c.1888, altered, gives access to W platform at N end (Photo Film C9/DSCF2698 looking north). Iron columns and brackets supporting not-original platform roofs (Photo Film C8/DSCF2697 looking north). Down platform canopy c.1888.

**SITE SIGNIFICANCE** Station contains significant elements dating from build of c.1888. The western platform buildings were replaced in 1978.

**RECOMMENDED ACTION** Record and monitor any proposed development.

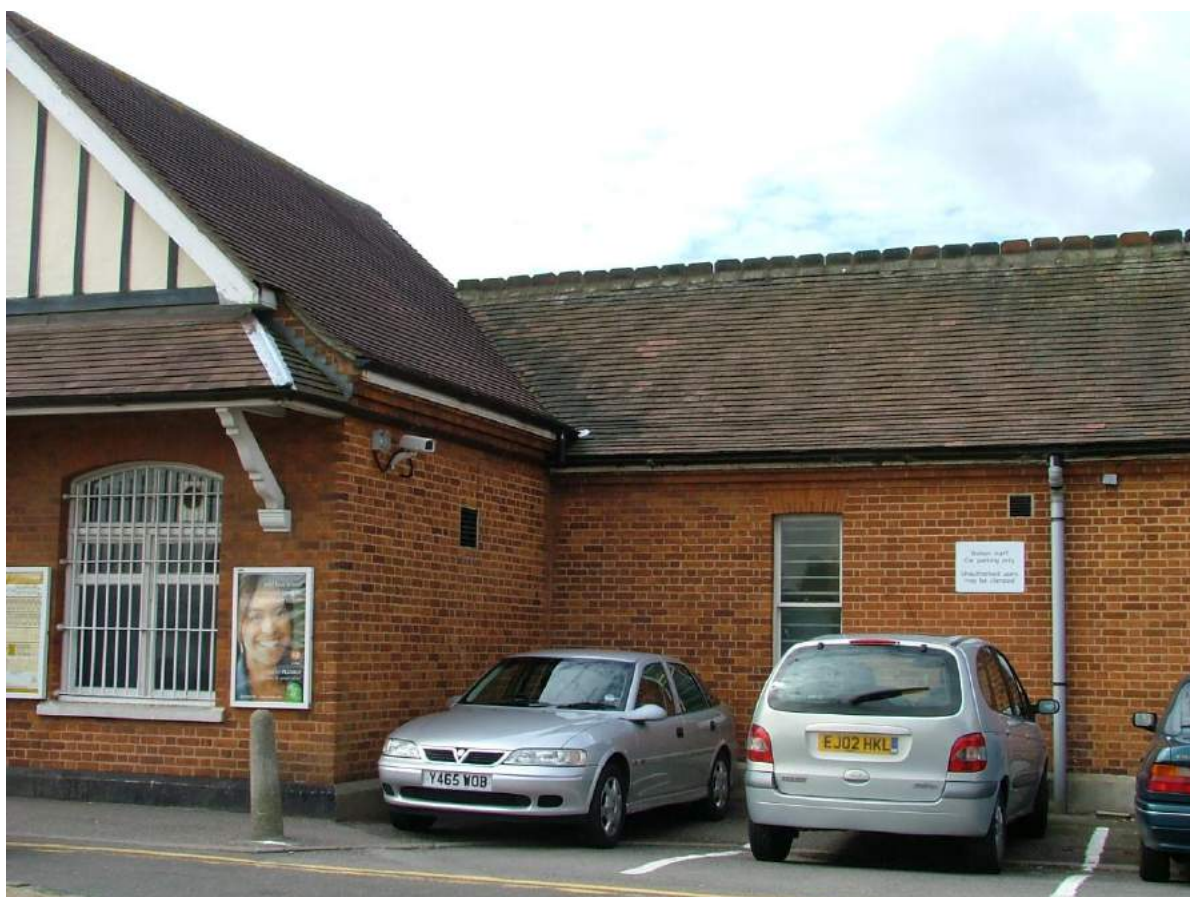
Remnant of Station Master's house, Wickford.

**RECOMMENDED ACTION** Record and monitor any proposed development.

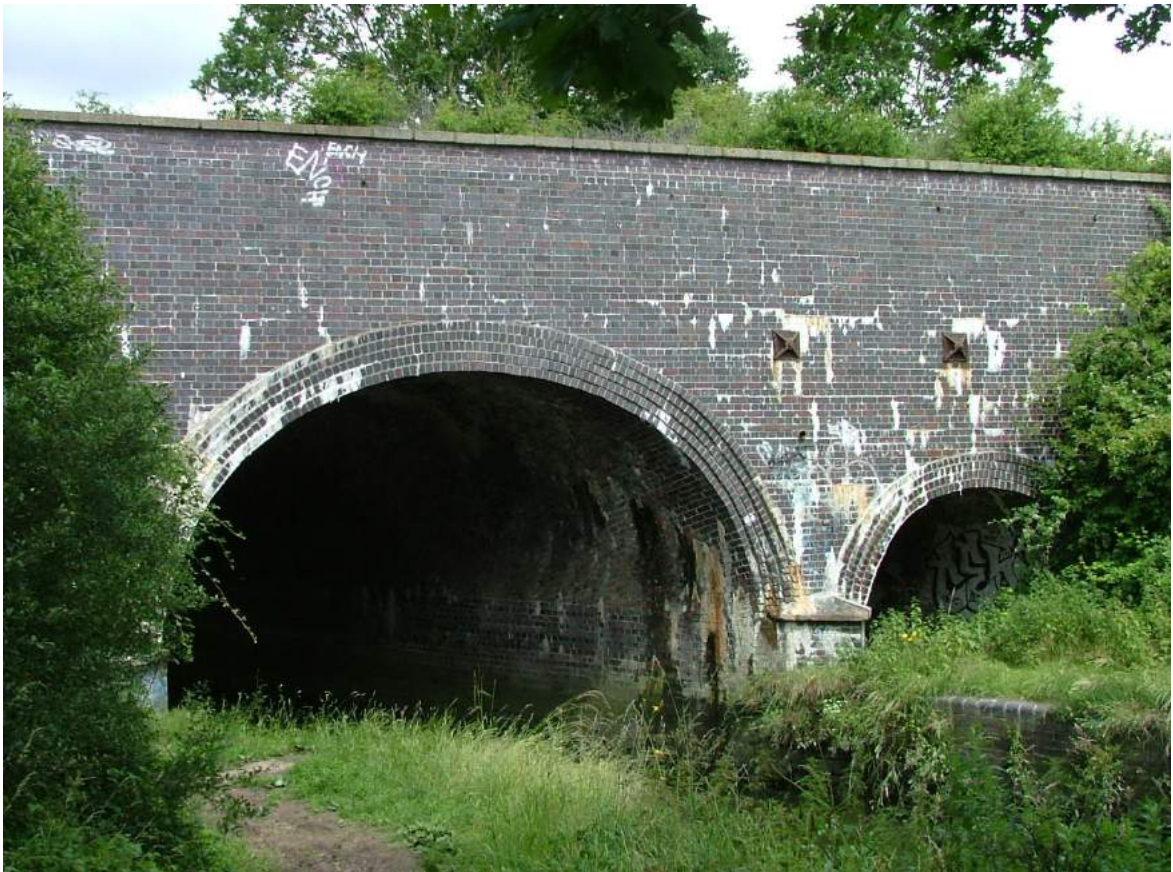
River Crouch bridge, Southlands Farm, Wickford, from south.

**SITE SIGNIFICANCE** Probably the bridge essentially as built c.1888. Repaired 1963.

**RECOMMENDED ACTION** Monitor and record any development.

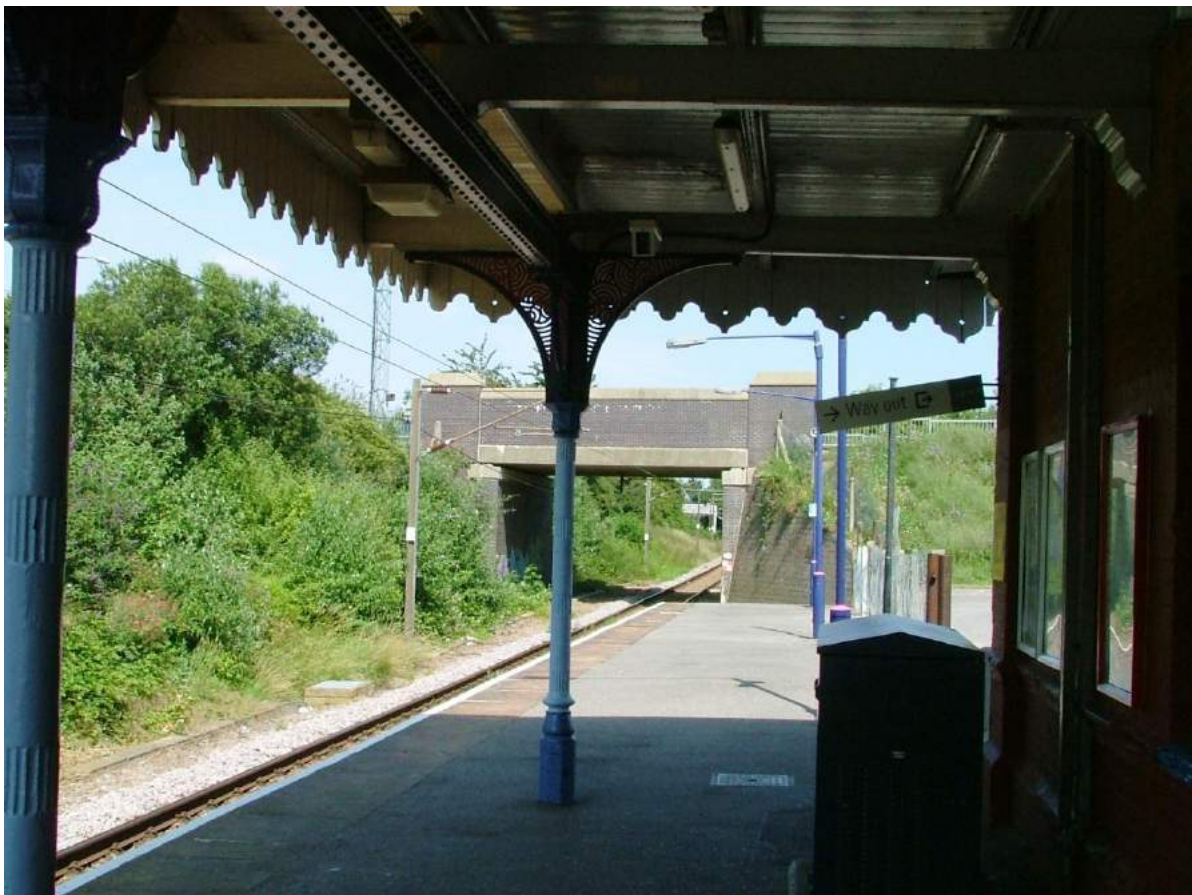
Church Road bridge from Burnham station

**SITE NAME** Church Road bridge, Burnham

**RECOMMENDED ACTION** Monitor and record any development.

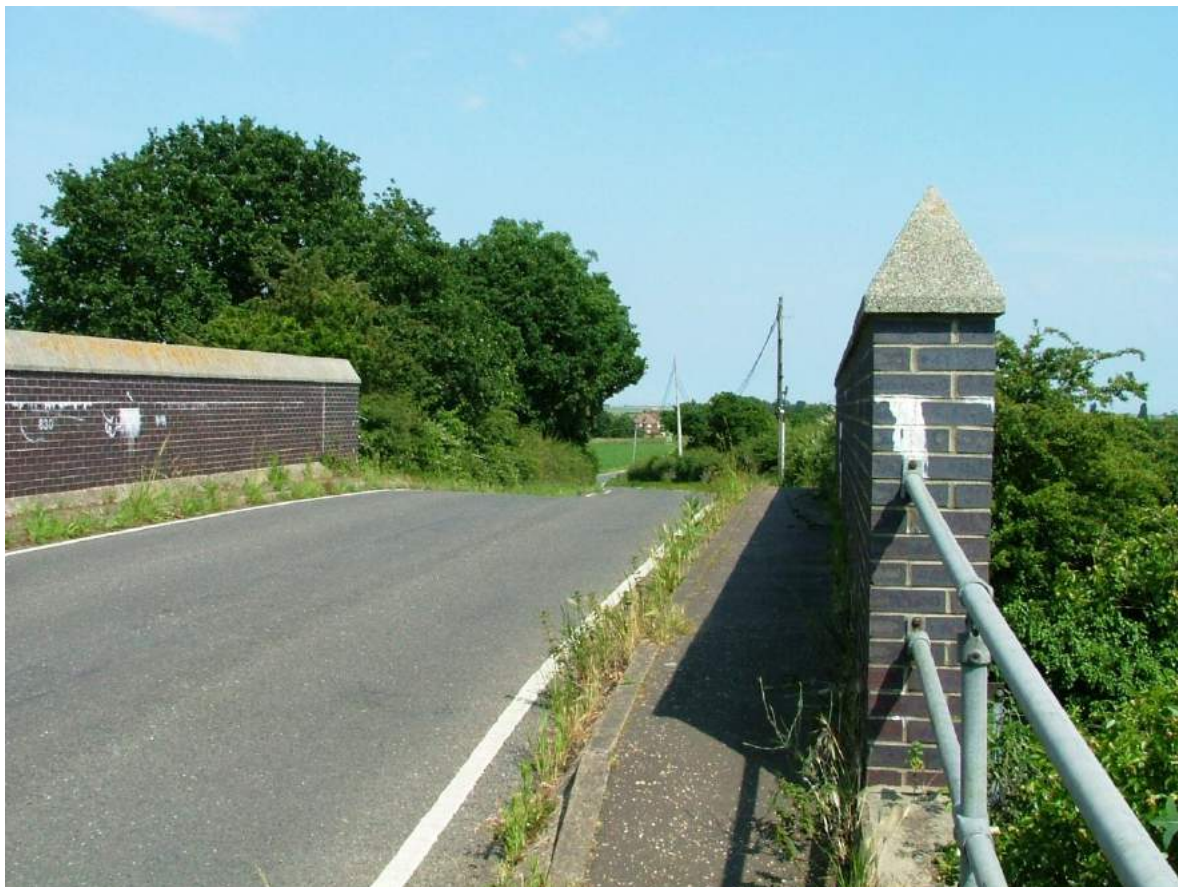
Marsh Road bridge, Burnham, from west

**SITE NAME** Marsh Road bridge, Burnham

**RECOMMENDED ACTION** Monitor and record any development.
