WATER & STEAM MILLS IN ESSEX

*An archaeological, architectural and historical appraisal of
post-medieval and industrial age water powered and
steam powered mills*

COMPARATIVE SURVEY OF MODERN / INDUSTRIAL SITES AND MONUMENTS No. 18

August 2008

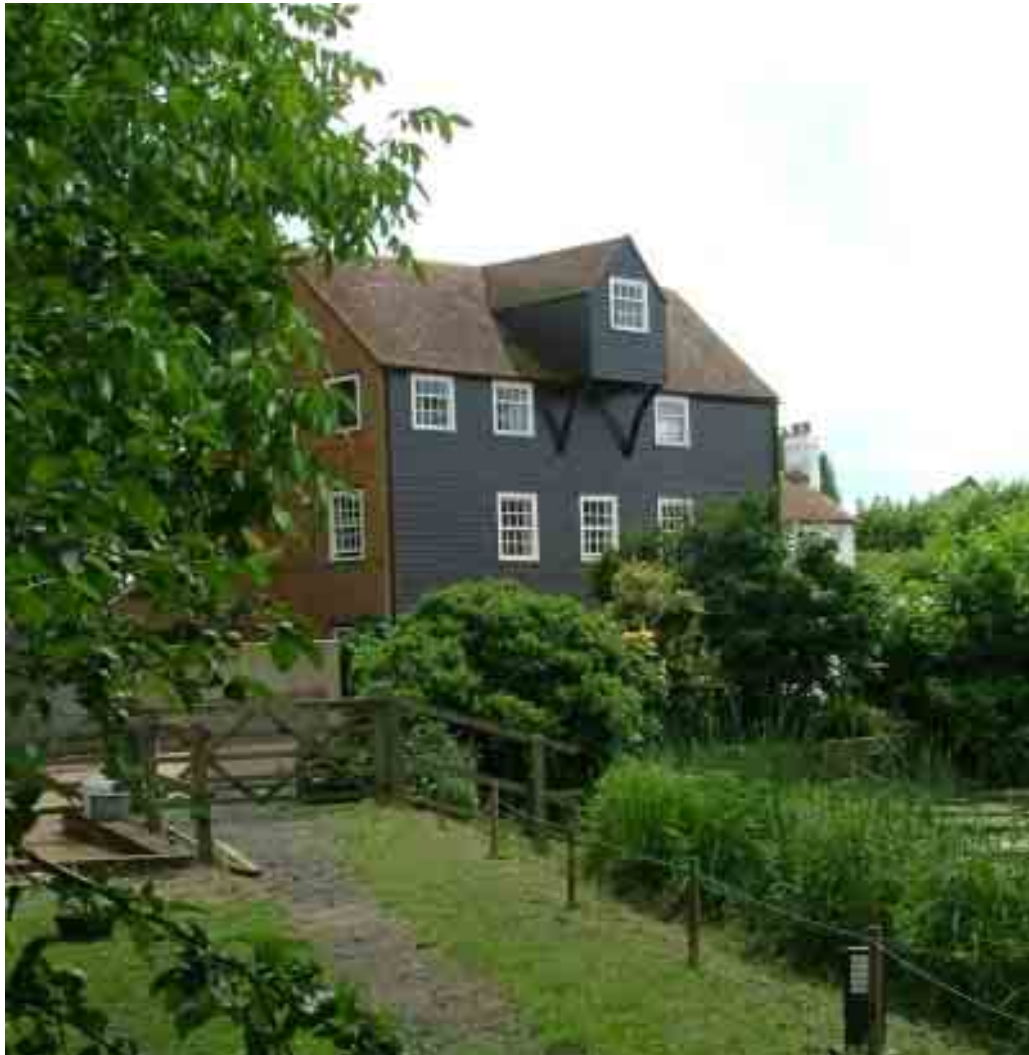
Borley mill and adjacent buildings are presently in use as a private residence and as commercial premises and as such are well maintained. Should the opportunity present itself an internal inspection is recommended and/or an historic building survey at RCHME level 3 should be recommended if the mill becomes threatened by significant alteration or demolition.

Borley Mill looking south-east

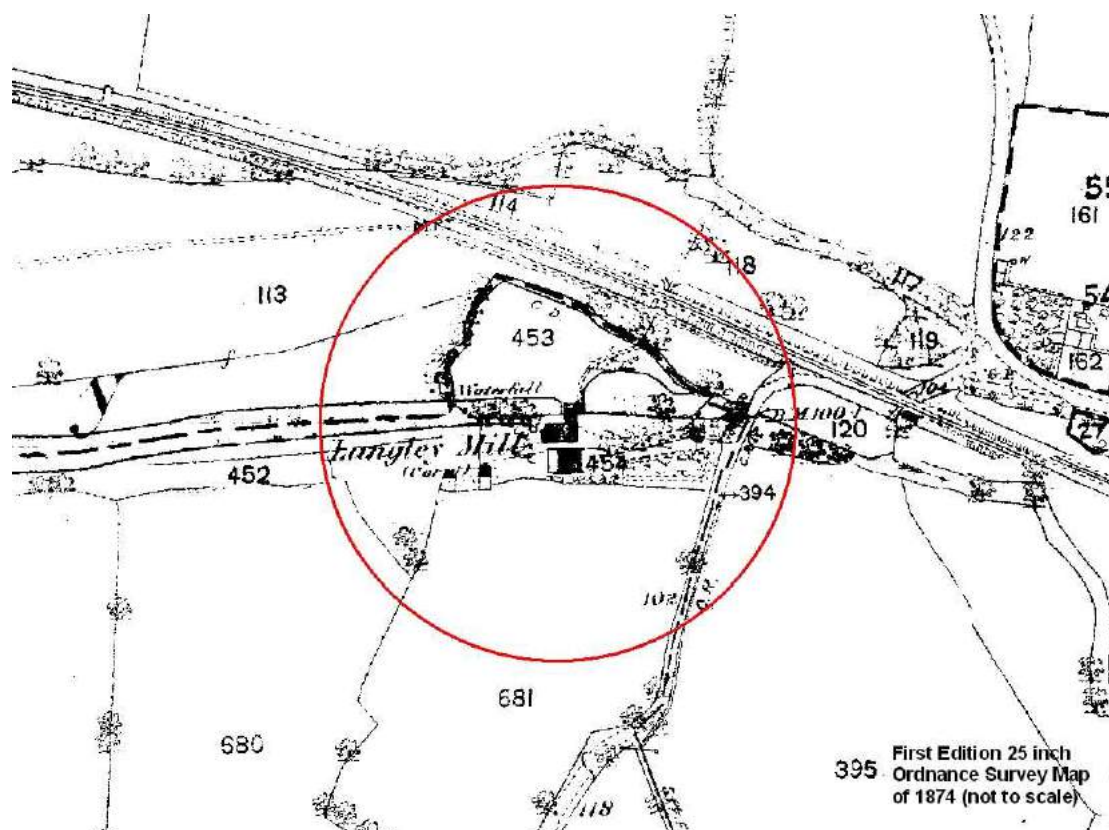
Langley Mill is presently in use as a private residence and accordingly well maintained. A historic building survey at RCHME level 2 is recommended should the mill become threatened by significant alteration or demolition.

Langley Mill looking south-west

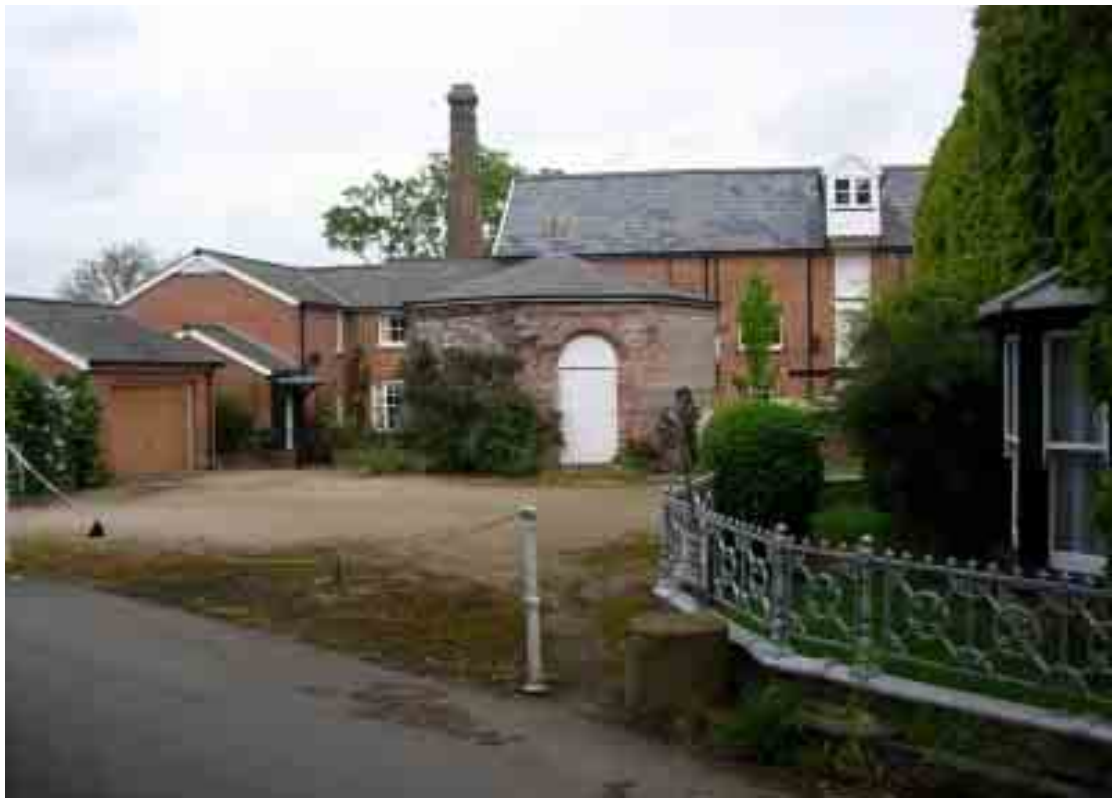
Frosts steam mill and the adjacent buildings are all presently in use as private domestic dwellings and are accordingly well maintained. An historic building survey at RCHME level 3 is recommended if the steam mill, smock mill or mill house become threatened by significant alteration or demolition.

North (Frosts) Steam Mill and base of Smock Mill, looking north-east

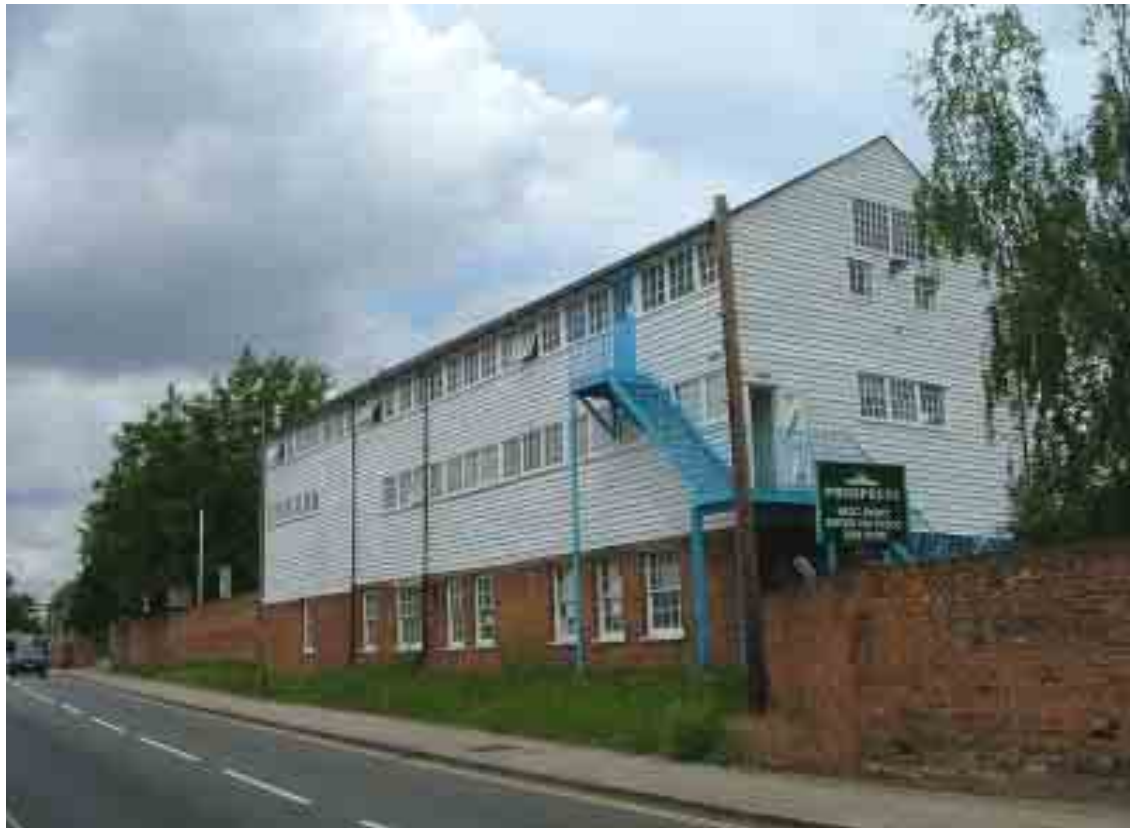
Pound End Mill is presently maintained as commercial premises and as such is well maintained. An historic building survey at RCHME level 3 is recommended if the mill becomes threatened by significant alteration or demolition.

Pound End Mill looking west-north-west

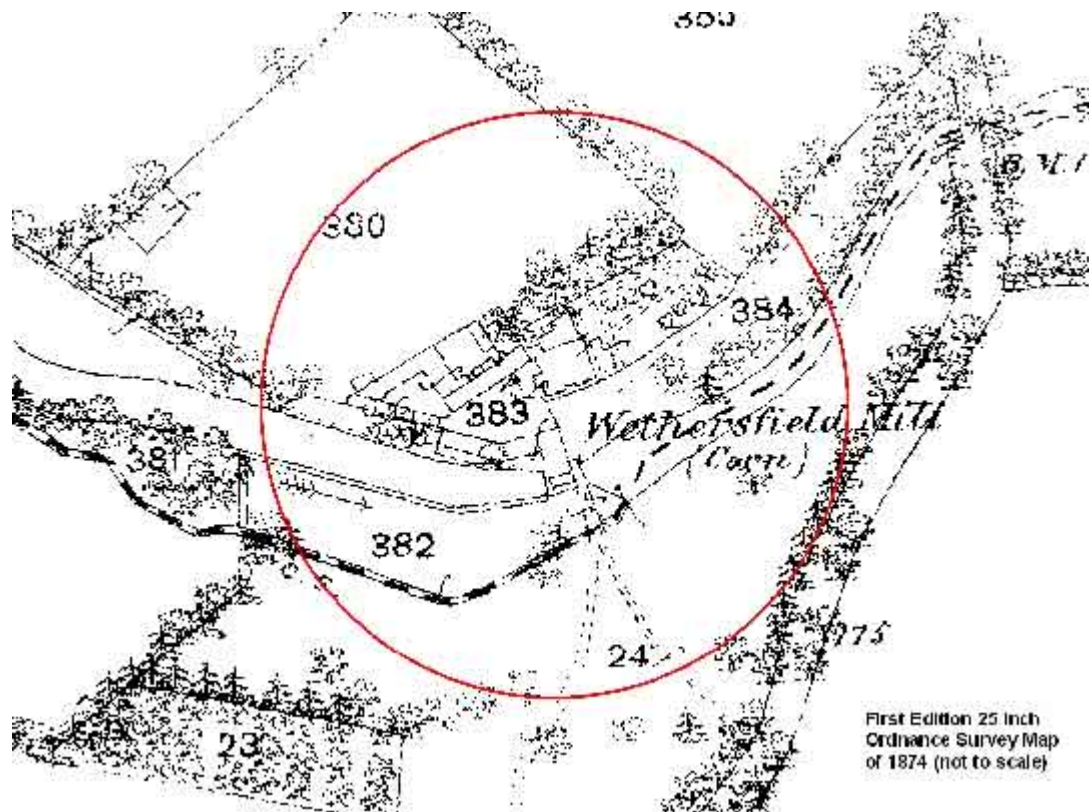
Wethersfield Mill is currently in private ownership, occupied and well maintained. Should the opportunity arise an internal inspection of the mill followed by an historic building record at RCHME level 3 is recommended to assess and record the internal spatial configurations and survival of technologies, fixtures and fittings.

Wethersfield Mill looking south

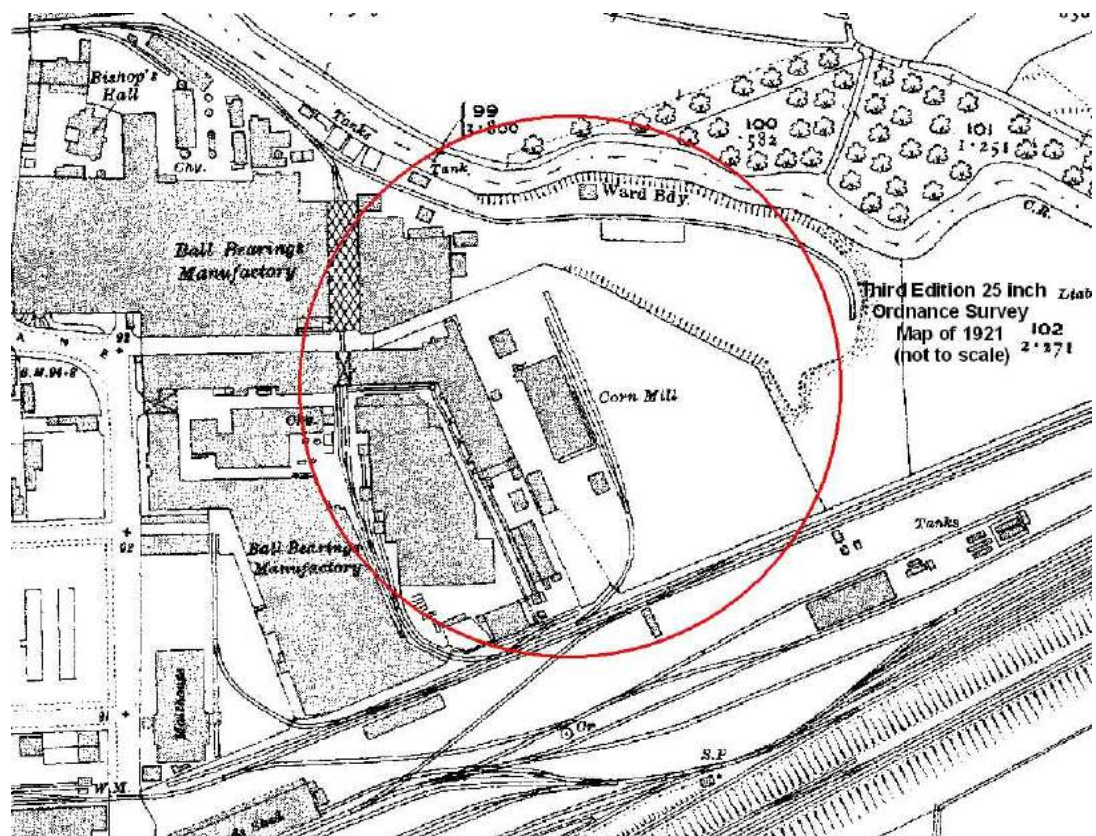
Chelmer Mill is currently in private ownership and in day to day use as part of a modern flour milling complex. It is accordingly well maintained. Should the opportunity arise or the building become threatened by significant alteration or demolition, an internal inspection followed by a historic building record is recommended to assess and record internal spatial configurations and survival of technologies, fixtures and fittings.

Chelmer Steam Mill looking north

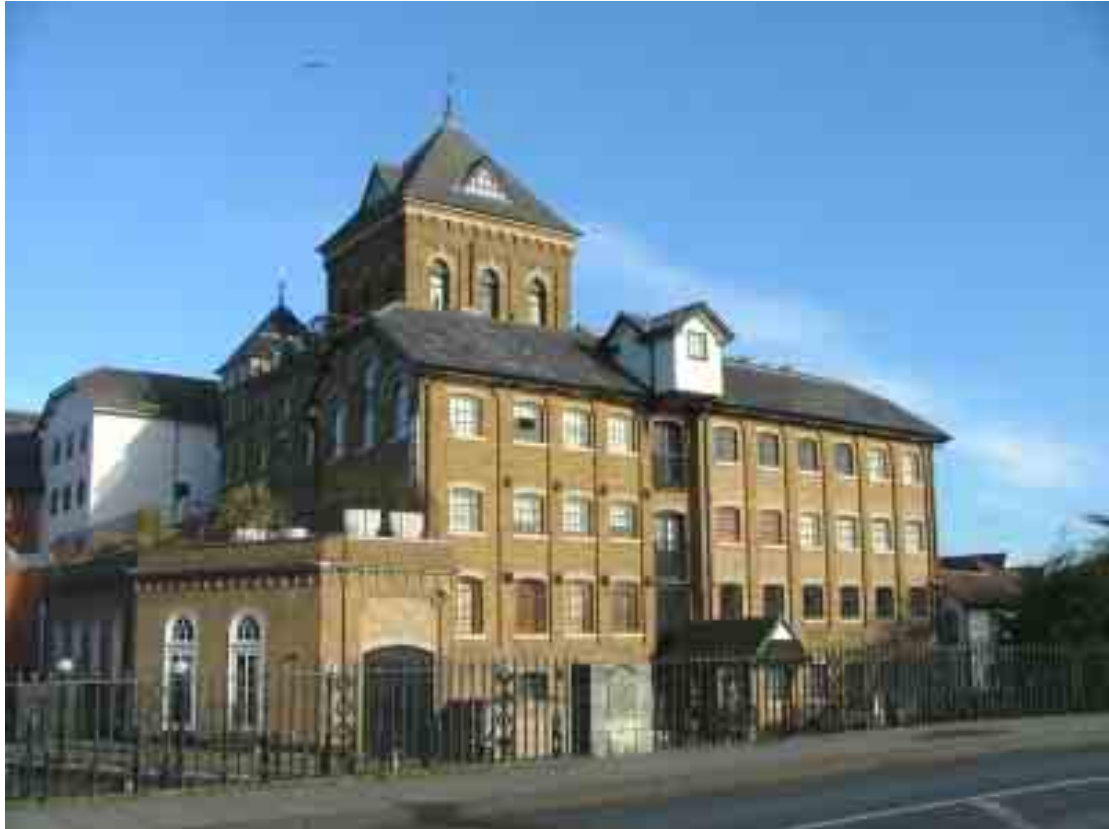
East Mill is presently in residential use and in good repair. A detailed historic building survey at RCHME level 3 should be recommended if the mill or associated buildings/structures are threatened by major works or demolition.

East Mills looking north

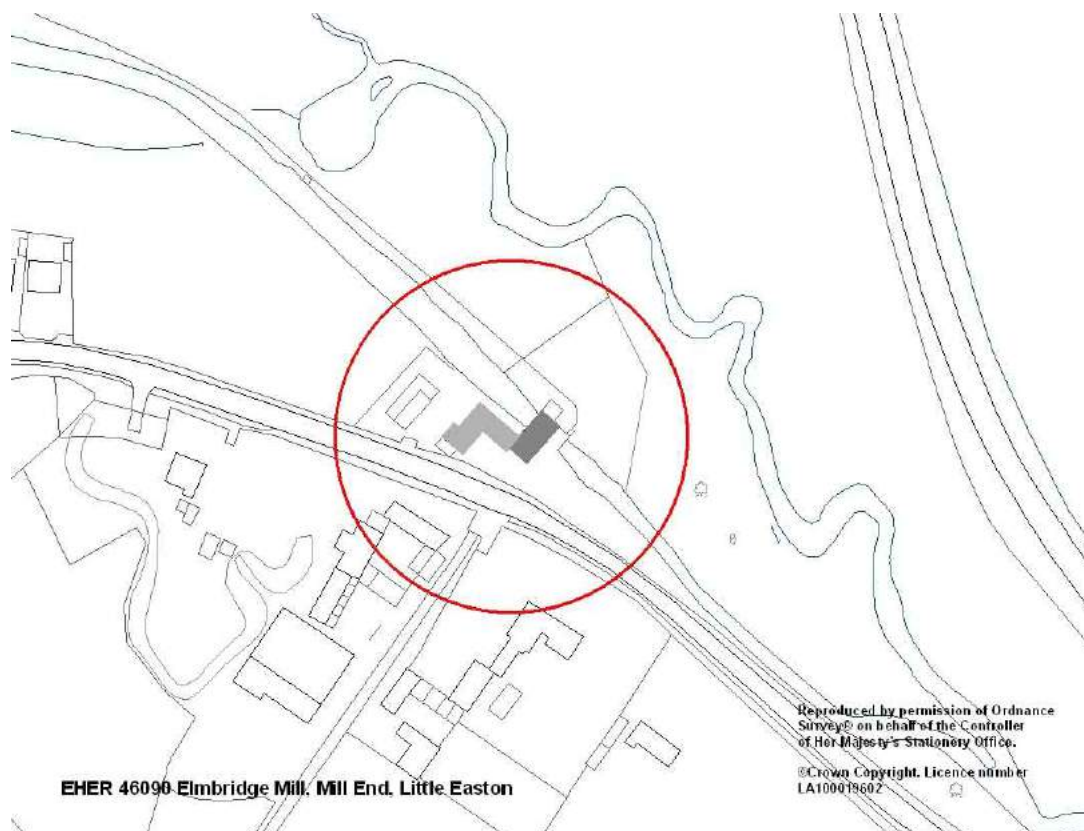
Elmbridge Mill looking north-east

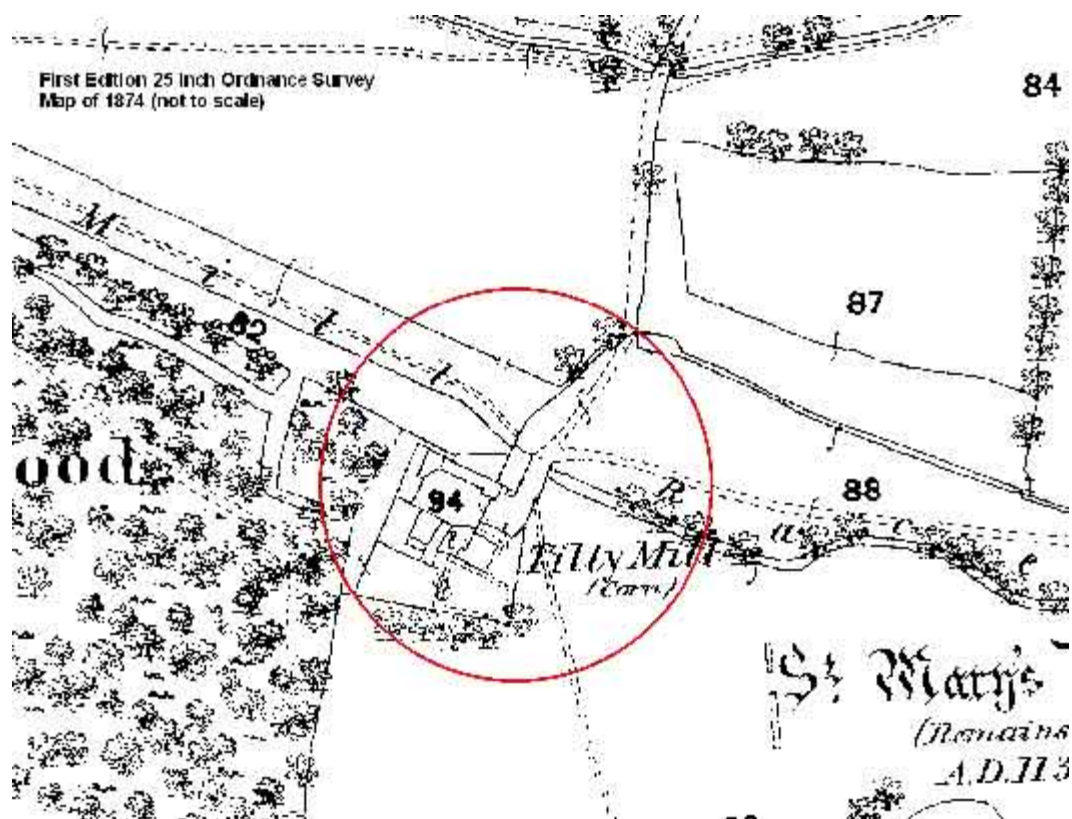
Tilty Mill looking west-north-west
