WINDMILLS IN ESSEX
Comparative Survey Of
Modern / Industrial
Sites And Monuments
No. 19

*An archaeological, architectural and historical appraisal of
medieval, post-medieval and industrial age windmills*

March 2012

Report by Laura Belton and David Morgans

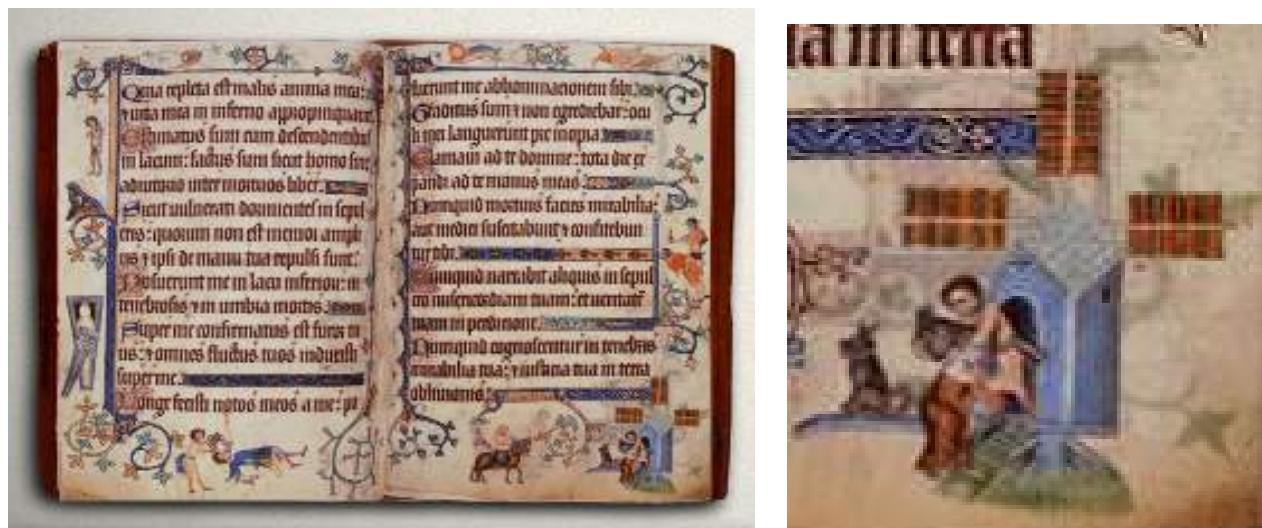
Figure 1 Illustration of the Luttrell Psalter dated 1338, showing an East Anglian windmill

Post mills were the earliest type of windmill to be constructed and appear in medieval manuscripts such as the Luttrell Psalter of 1336 (see Figure 1, above). The basic design and method of construction remained essentially unchanged for centuries, although gradually refinements were introduced to mechanisms, sails and means of operation particularly following the advent of the Industrial Revolution. Moore (2010) has considered at length the evolution of the early post mill with sails of no more than 5 metres in length into the larger post-medieval post mill. The methodology of construction remained unchanged for many centuries and was described in detail by Freese (1924). The design is believed to have progressed from an earth-fast post to a post secured in earth-mounted trestles, on which was mounted the body or buck which grew in scale as construction techniques improved.

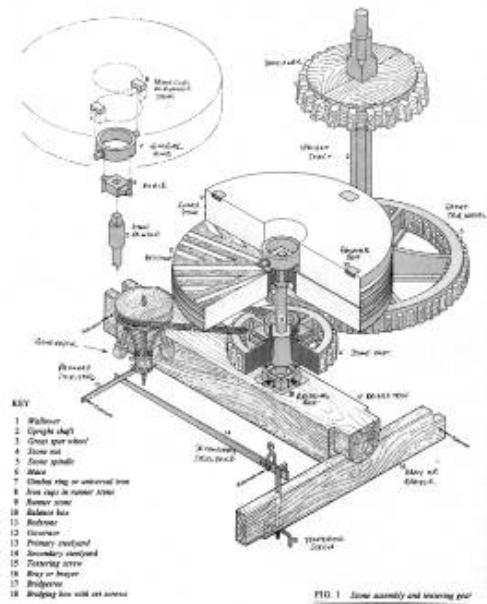
Figure 2 Illustration of the tentering gear

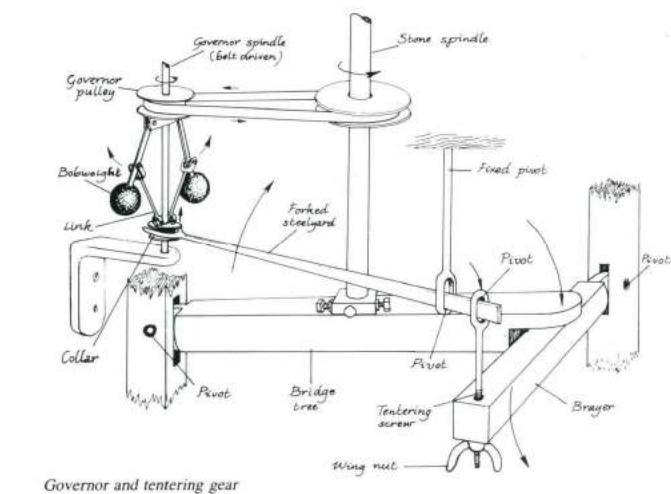
Figure 3 Illustration of a brake wheel and Wallower

The brake wheel was driven directly by the wind and increases could cause the stones to revolve too fast. As engineering science evolved this was controlled by the use of a governor to keep stones running at a constant speed. In addition, the tentering mechanism was developed to engage and disengage the stone nuts from the brake

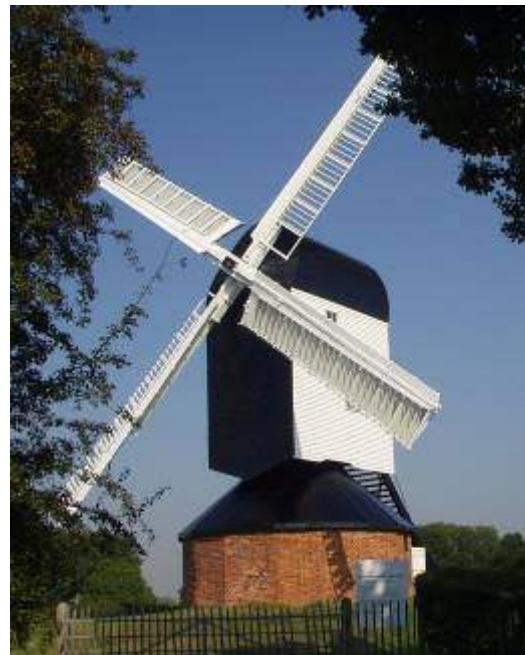
The post consisted of a shaped and smoothed tree trunk which was mounted vertically on the cross bars, but supported by quarter bars mortised into both the cross bars and the post itself and which thus transferred the weight of the mill body, or buck, onto the feet. This basic design was subjected to very small variations, such as three cross-bars rather than two found occasionally on mills such as Moreton (EHER 4098, now destroyed). The cross bars maintained the post in a vertical position.

Figure 5 Illustration of the mechanics and Internal structure of a post-mill

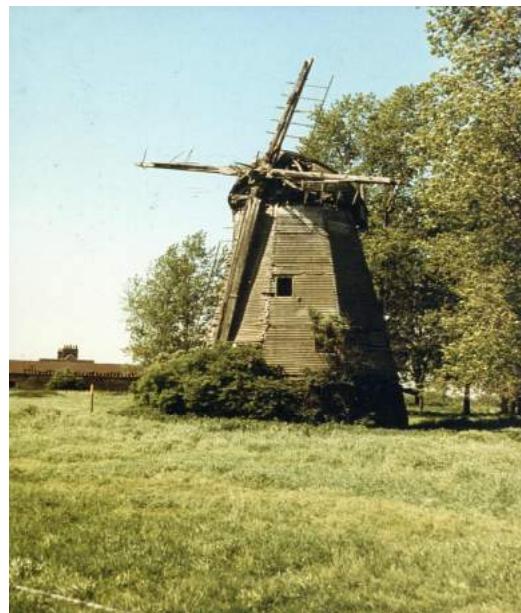
Although smock mills consist of a timber superstructure over a brick base, they are essentially tower mills, carrying the motion and the machinery within the rotating cap. Unfortunately, smock mills were subject to decay and deterioration if not maintained, and few timber superstructures survive.

Figure 9 Illustration of the interior of South Ockendon Smock Mill

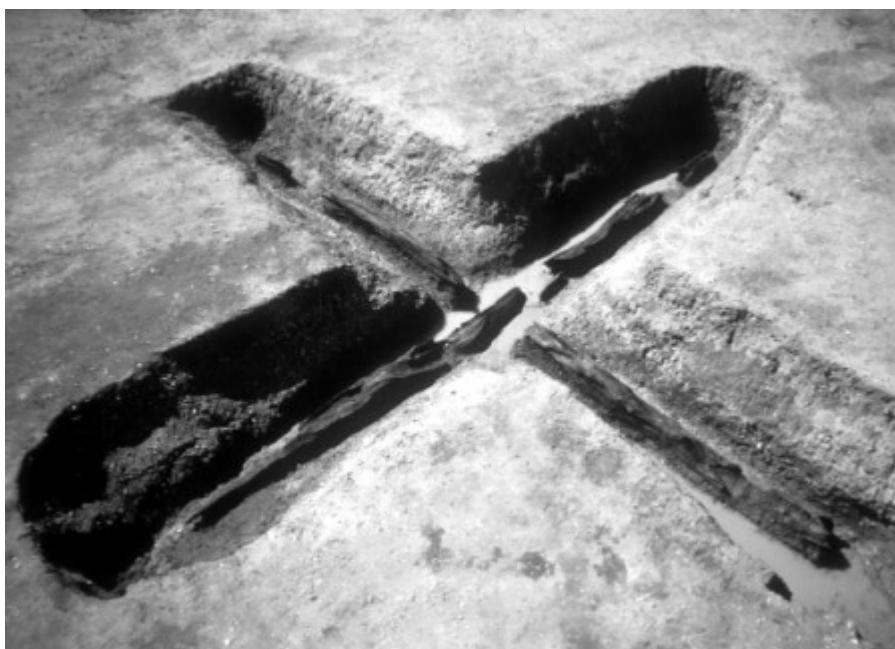
Clobbs Wood, Great Dunmow, was excavated by Oxford and Wessex Archaeology as part of the A120 road scheme (Hardy, 2007). The cropmarks at the site consisted of a circular enclosure of approximately 22m in diameter, with cross-trees in the centre. Excavation revealed deep cross tree foundations, with some timber from the cross-trees still in situ. It is thought that the mound surrounding the central post of the

windmill was a later addition, which would increase stability and promote airflow to the sails (Hardy, 167). This windmill appears to have been built for purpose, while the one at Stansted represents the reuse of an earlier, suitable site.

Figure 13 Excavated windmill at Clobbs Wood, Little Dunmow (EHER 1331) – Cross Trees were placed directly in the ground

The construction of a mound around the cross-trees and central post, such as at Clobbs Wood (EHER 1331), would have enhanced the stability of the entire structure. Windmills built on top of raised mounds seem to have been a later development. Windmills constructed on top of a mound had greater height and were therefore able to catch the wind better. The post timbers were less susceptible to rot than those with the mound built around the post, and by the post-medieval period a roundhouse was being constructed around the mound.

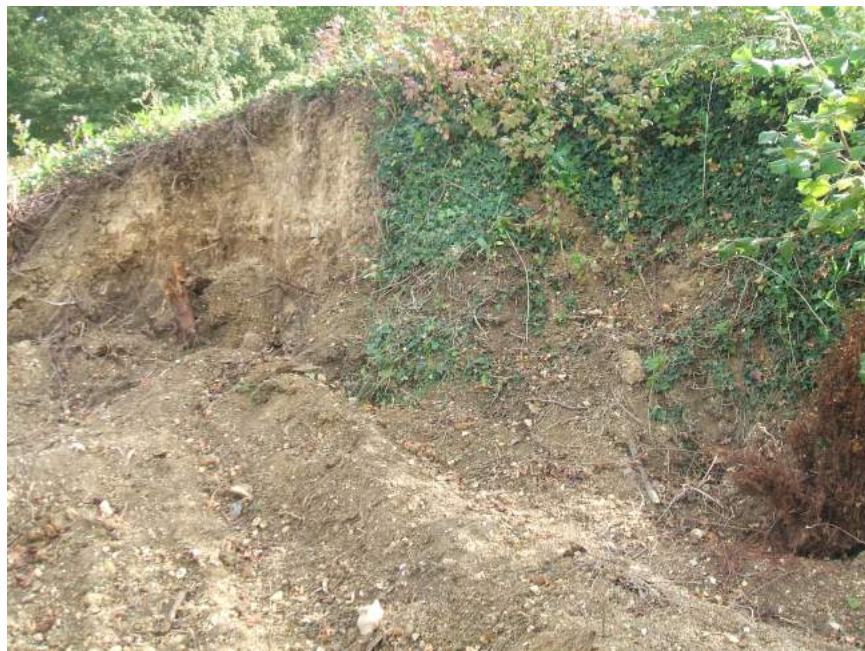
At Thaxted (EHER 1515), excavation from the top quarter of the mound produced a large selection of medieval pottery, c. C12-13. Although a post mill is known to have existed on the site in the post-medieval period, excavation of lower layers of the mound failed to reveal any indication of cross-trees (Network Archaeology, 2012). It was thought that a medieval windmill may have existed on the site, but no evidence was found during excavation, but pottery of 12th to 13th century has recently been recovered from the site during tree clearance works.

Figure 14 Exposed section of the mill mound at Thaxted.

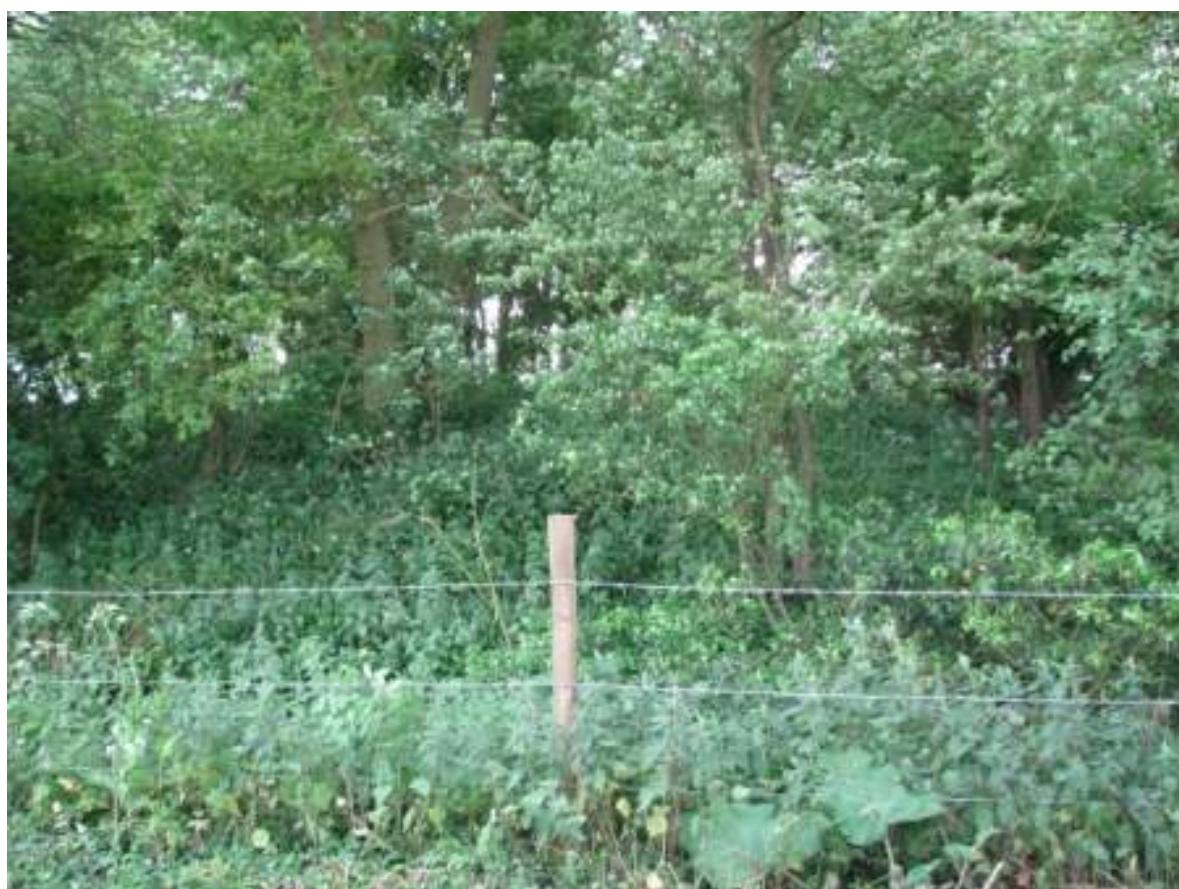
Scheduled site. The mound and ditch are roughly playing-card in shape. Ditch 3-5m wide, 1-1.5m deep. Mound is 26-27m across, 2m high. The ditch is dry and in good condition, but looks as if it might be intermittently wet. The causeway opens onto lane. The mound is covered with dense scrub with nettles, brambles and small immature trees.

Plate 13 Photograph of Mill Hill, Elmdon

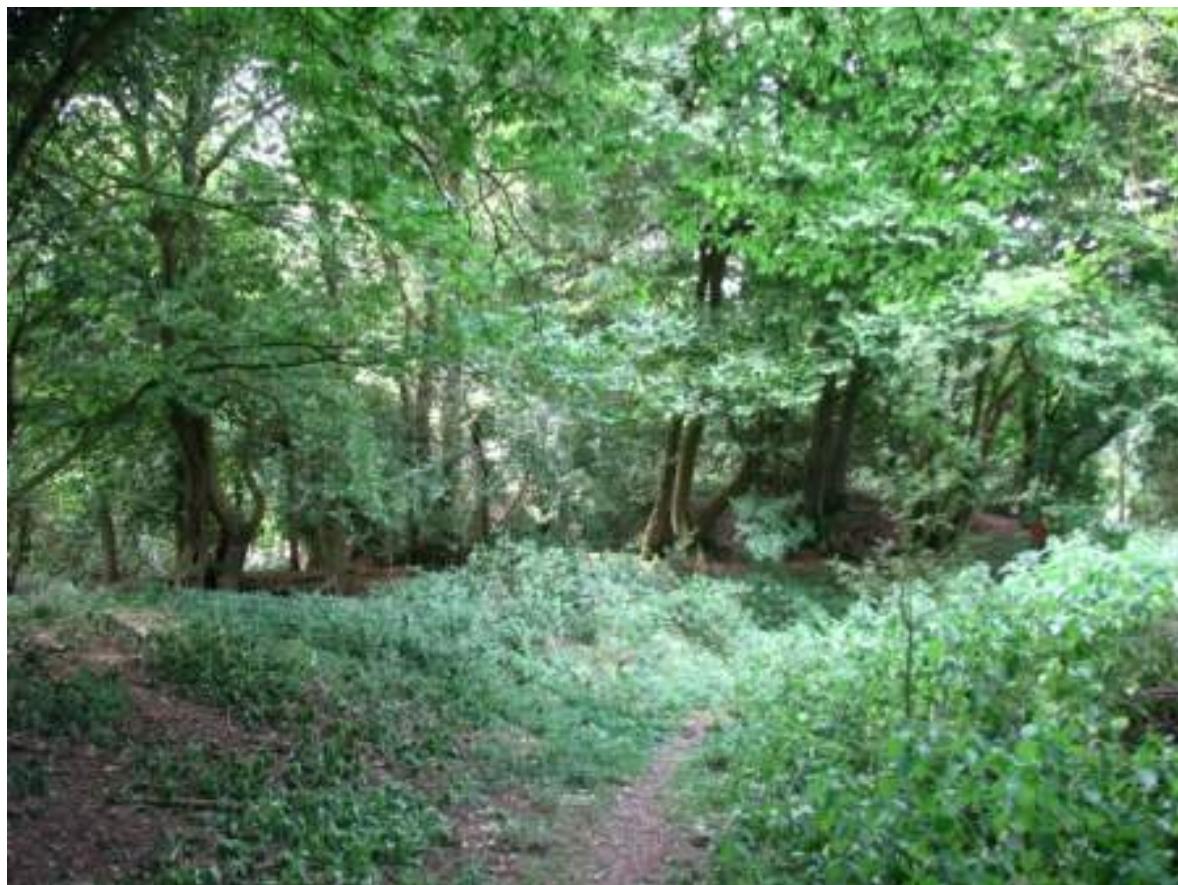
Substantial earthwork, 25m diameter at base, 15m diameter at the top, 3-4m high. Oval depression on the top. Ditch 5m wide by 2m deep, with a causeway to the green lane. Large coppice stools along the green lane which is deeply sunken in places, immature trees on the mound and some rabbit holes, otherwise vegetation scarce and preservation good. No trace of Little Horham farm.

Plate 15 Photograph of Little Hornhan Mill Mound

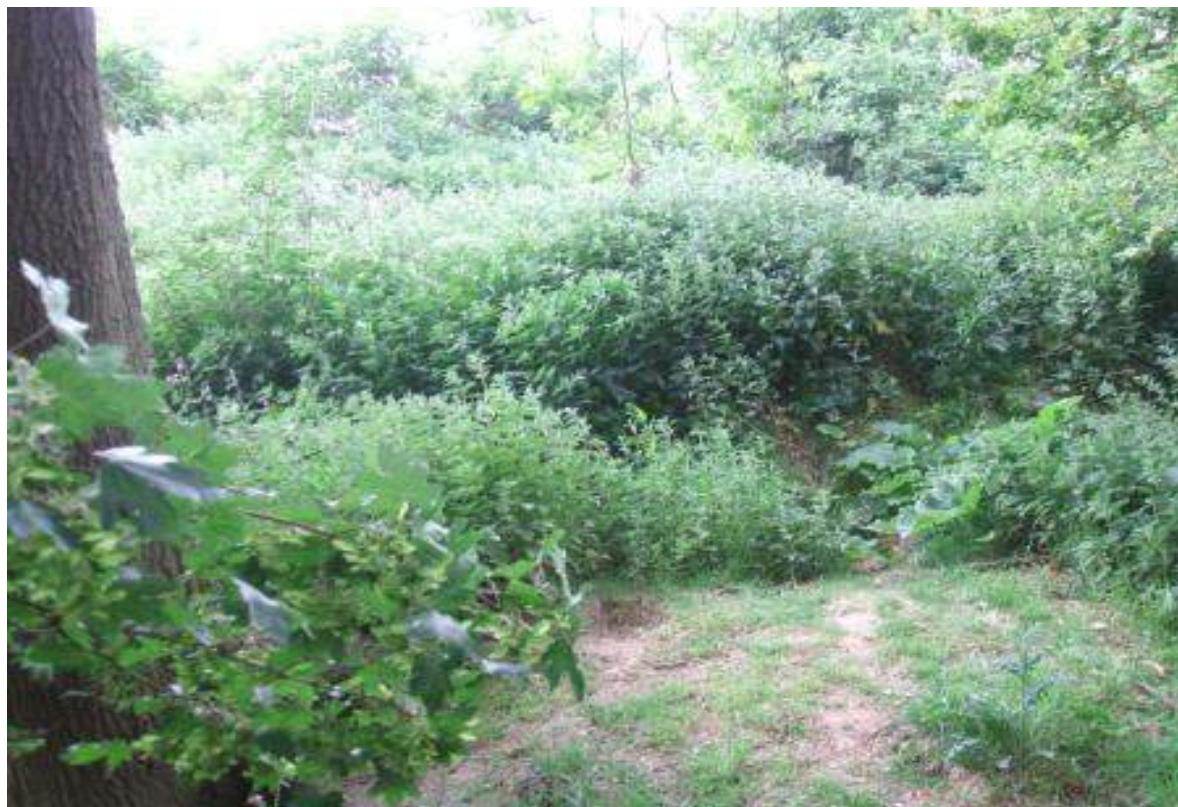
Condition: Good

Plate 17 Photograph of mill mound at Great Codham Hall

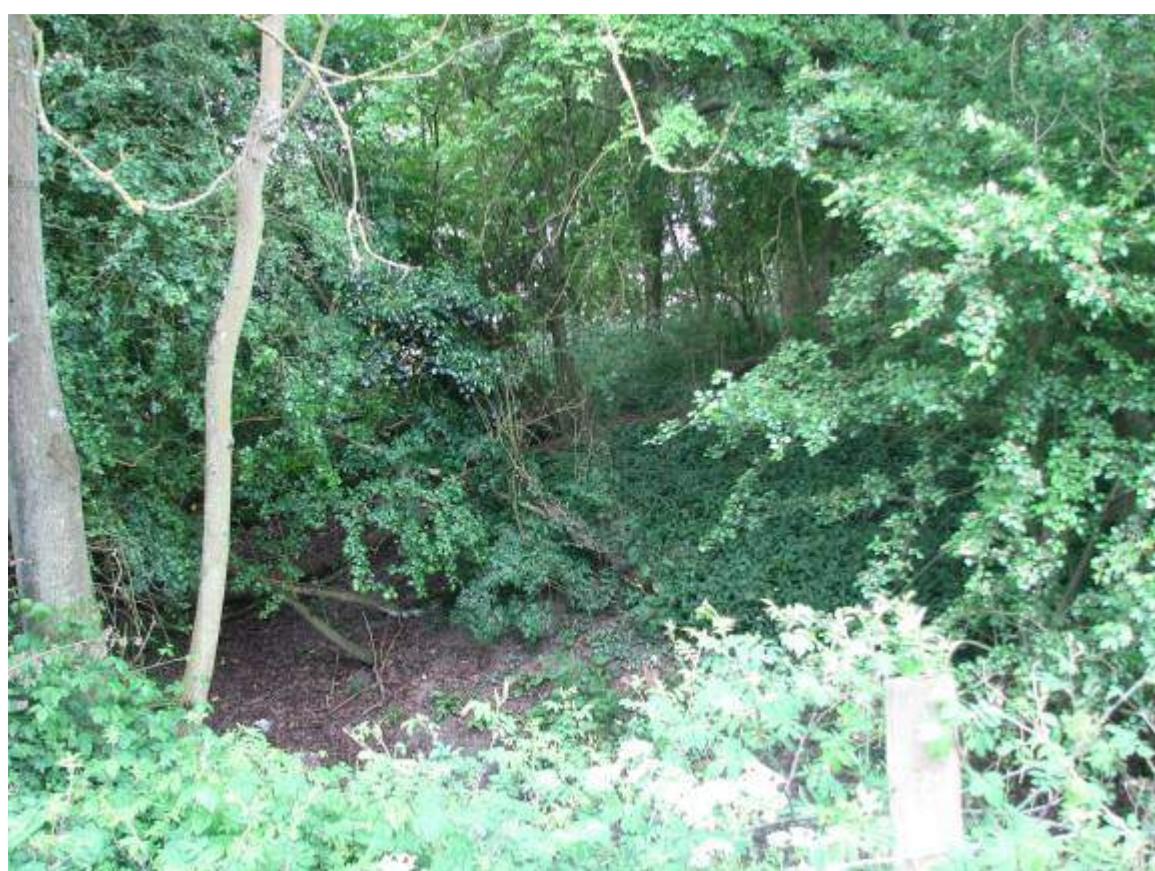
Condition: Very Good

Plate 19 Photograph of mill mound at Charwell Farm

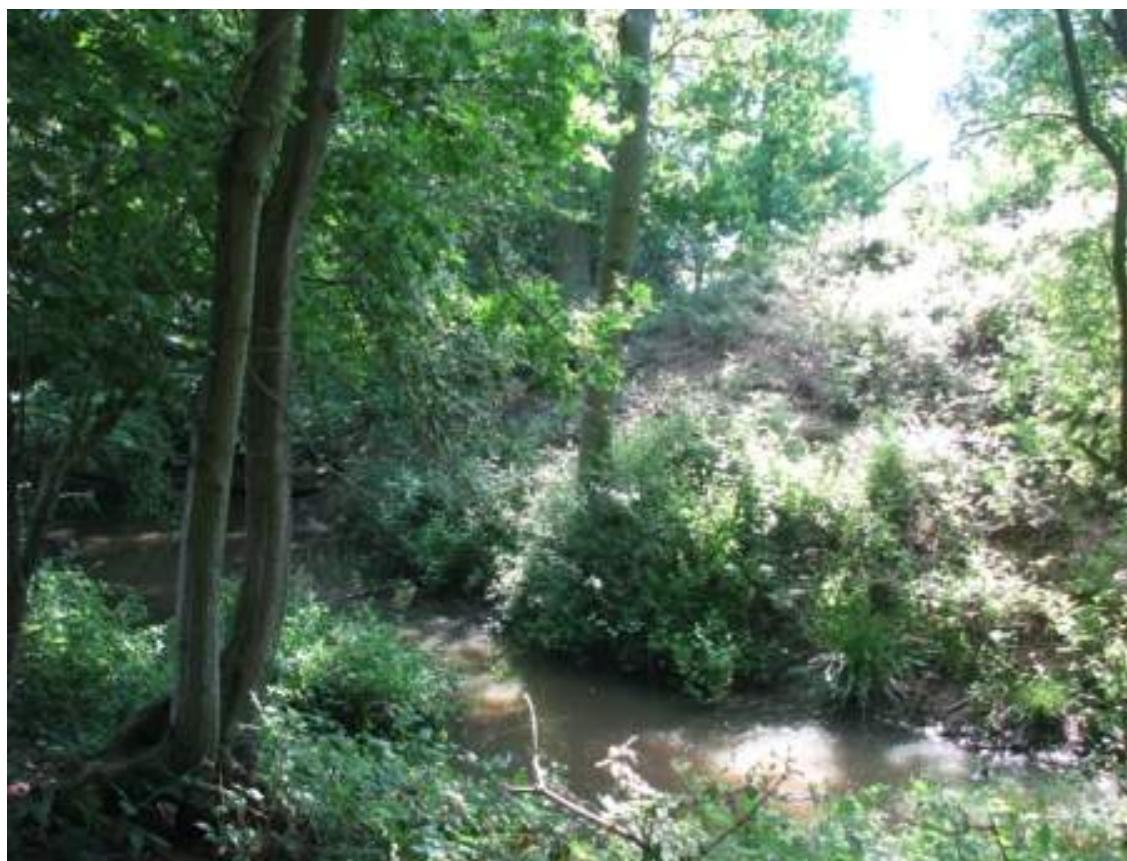
Condition: Very Good

Plate 21 Photograph of mill mound at Fenners Farm

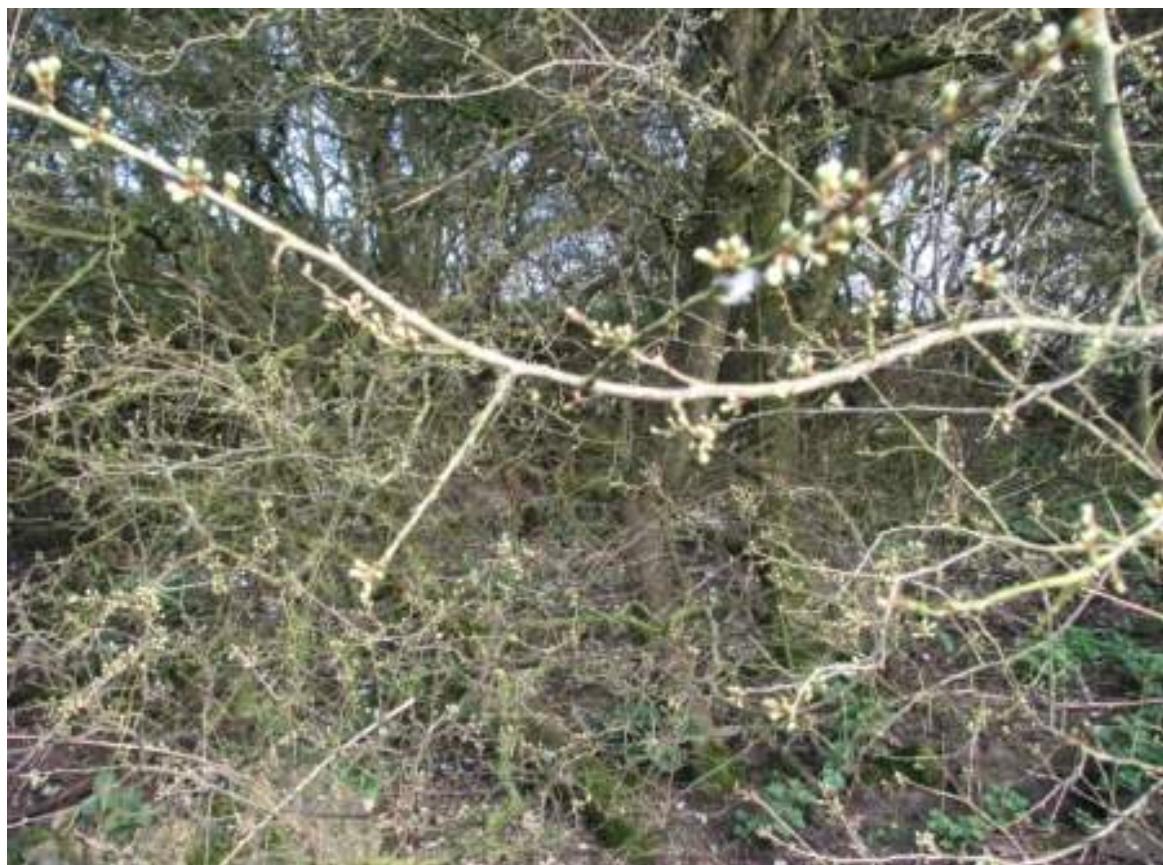
Plate 35 Photograph of mill mound at Mill End, Radwinter

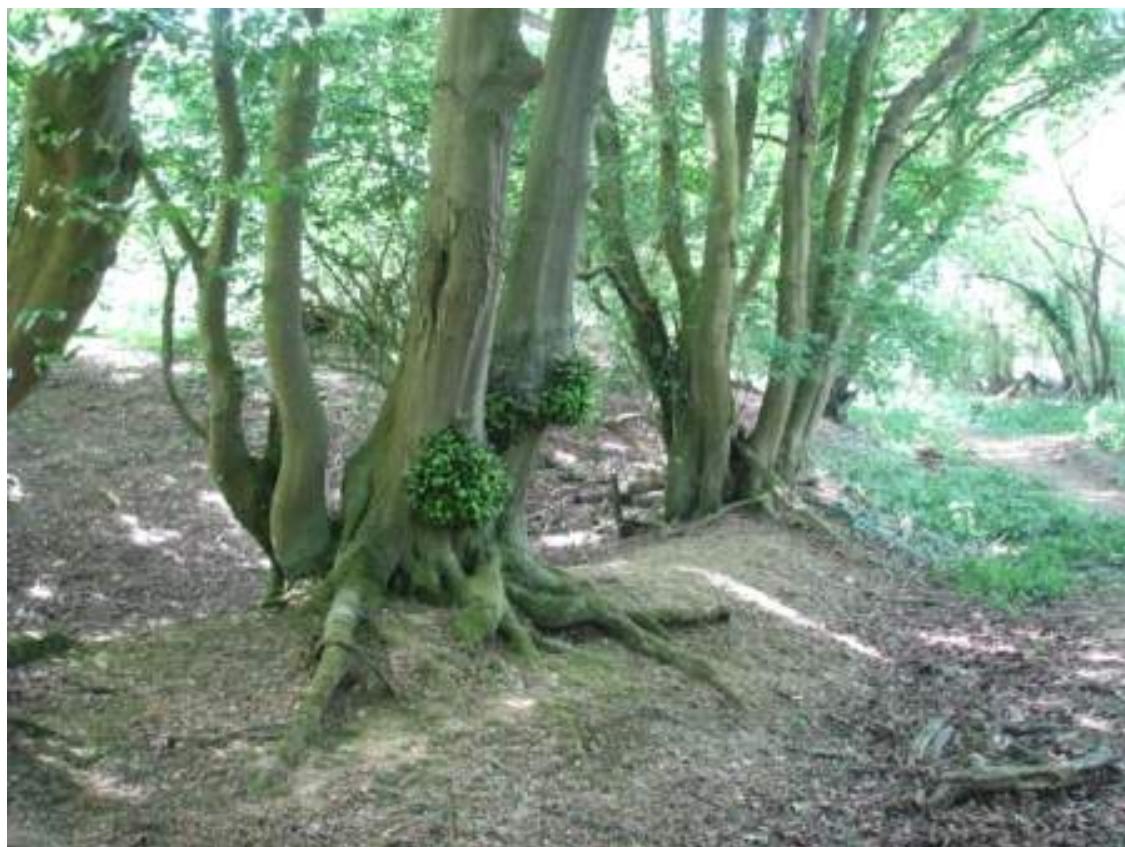
Plate 39 Photograph of mill mound at Little Hornham, Thaxted

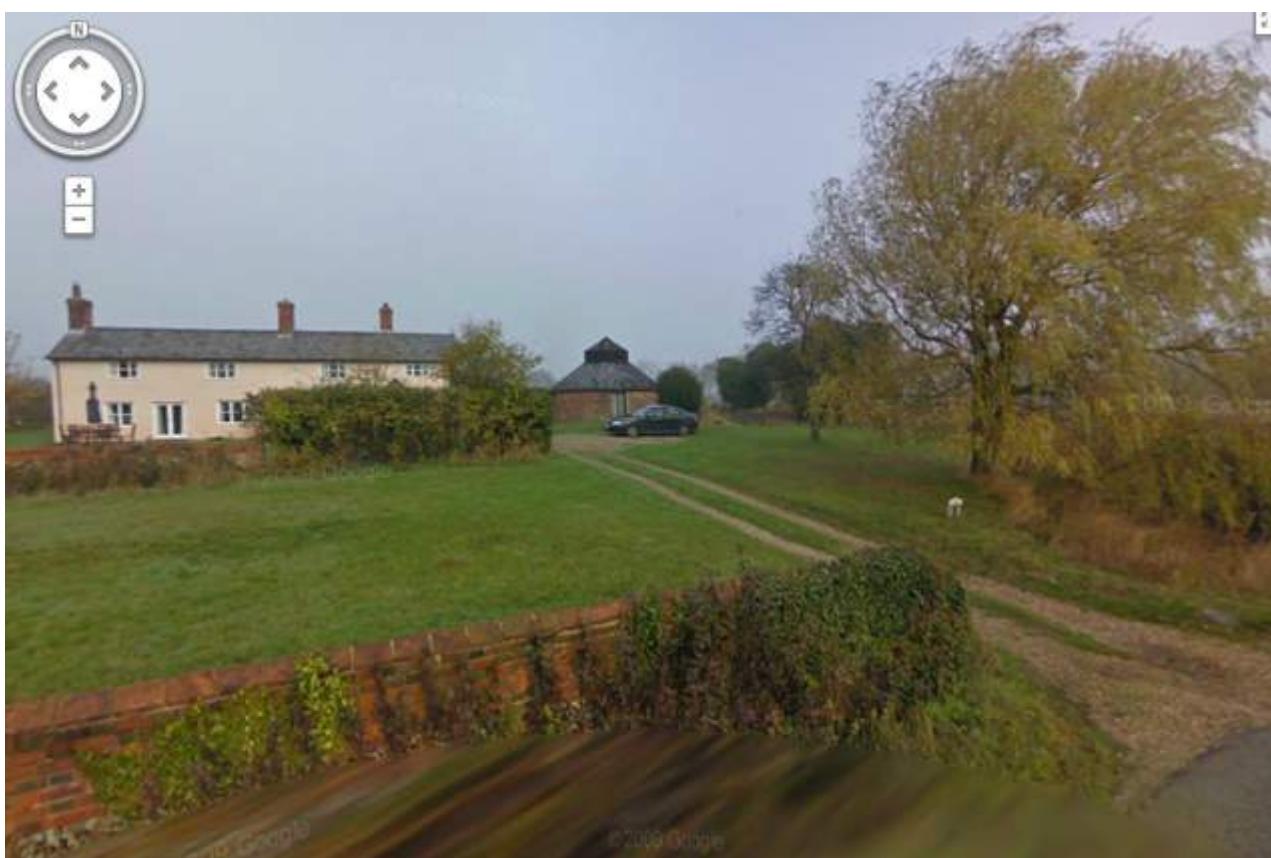
Photograph of Belchamp Walter Post Mill Roundhouse (Google Maps Street view, retrieved on August 2011)

The mill is in private ownership and the present owner is conscious of the historical importance and is maintaining the structure in good condition. If the mill becomes the subject of a planning application for residential and/or other re-use all efforts should be made to preserve its current levels of historic integrity.

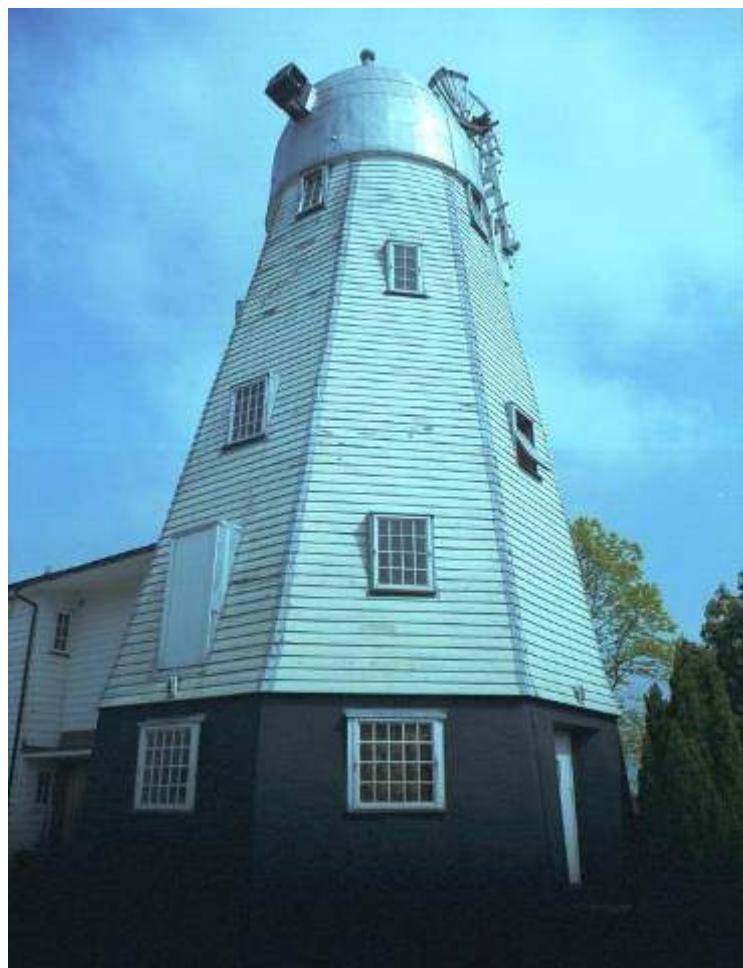
Photograph of Terling Smock Mill (Google Maps Street view, retrieved on August 2011)

In use as a private residence and as such are well maintained. Should the opportunity present itself an internal inspection is recommended and/or an historic building survey at RCHME level 3 should be recommended if the mill becomes threatened by significant alteration or demolition.

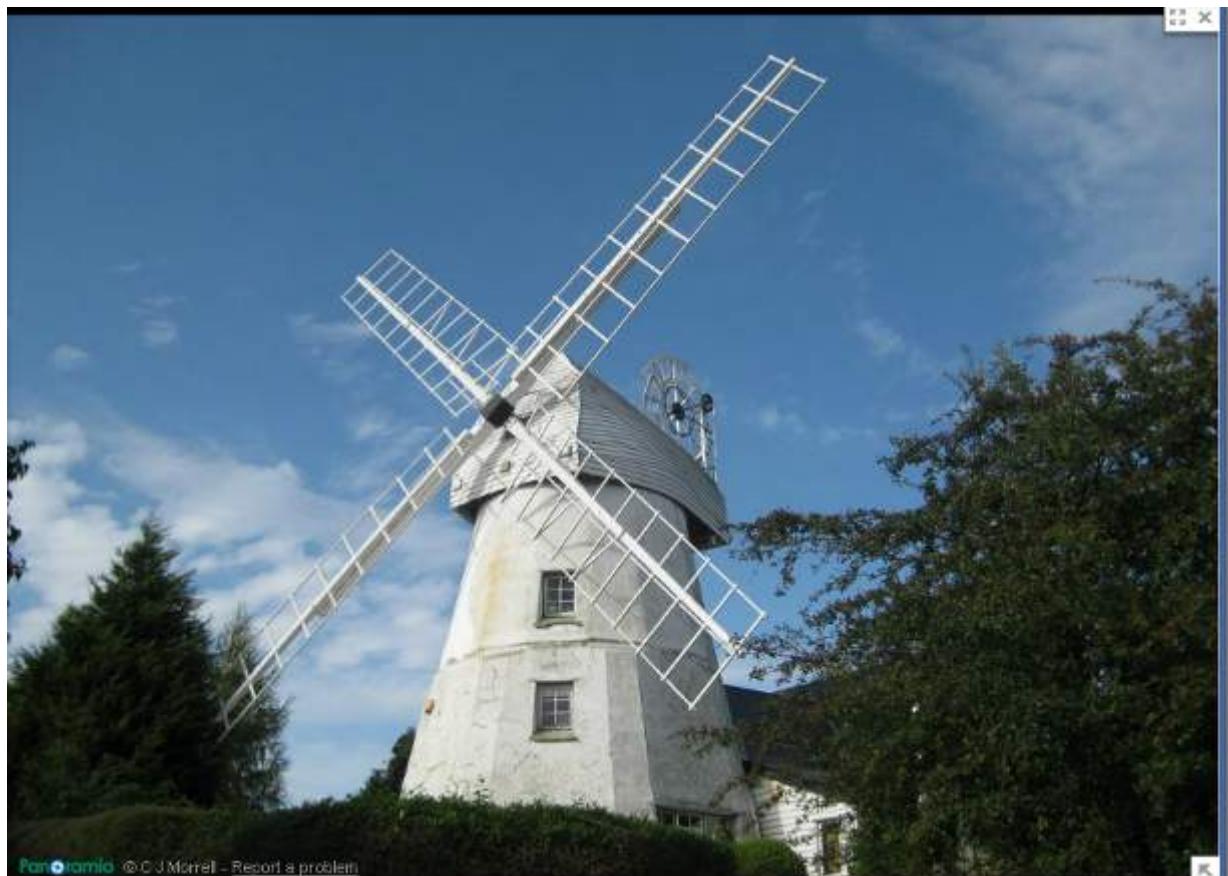
Photograph of Gibraltar Tower Mill (Google Maps Street view, retrieved on August 2011)

MANAGEMENT The tower mill is in very good repair. A detailed historic building survey at RCHME level 3 should be recommended if the mill is threatened by major works or demolition.

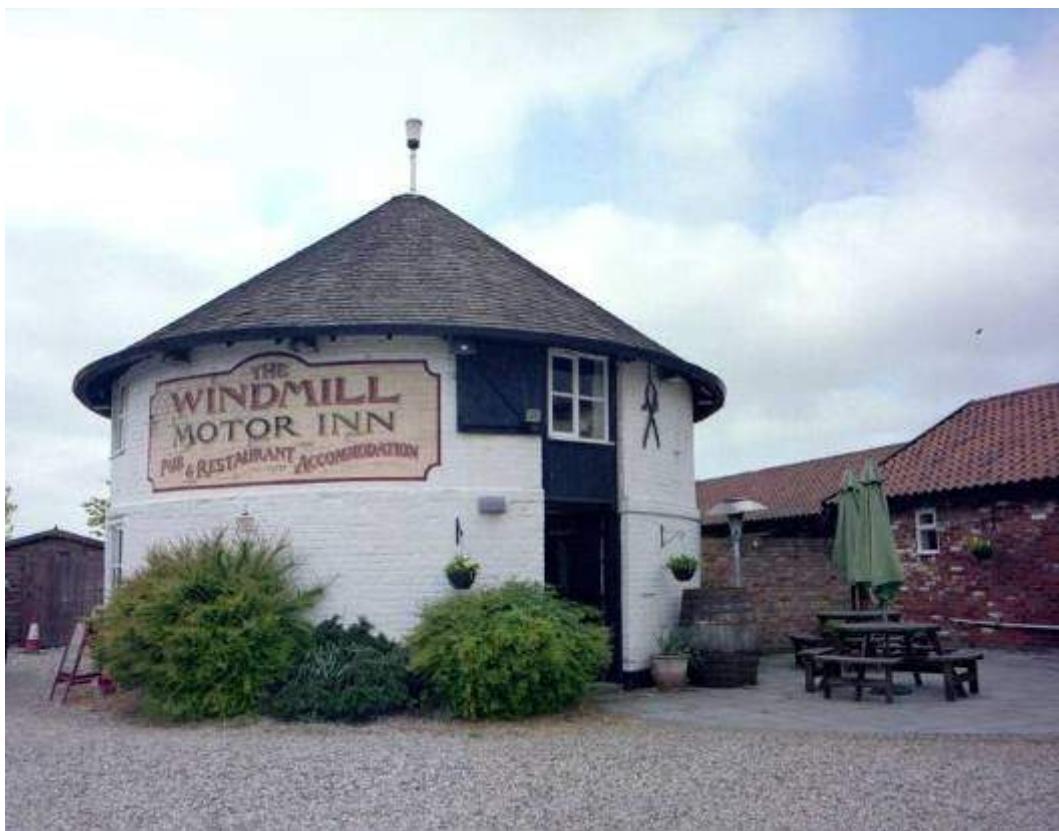
Photograph of Chatham Green Post Windmill Roundhouse (Google Maps Street view, retrieved on August 2011)

MANAGEMENT The roundhouse is presently in use as a private residence and as such is well maintained. Should the opportunity present itself an internal inspection and/or historic building survey is recommended in order to assess and record levels of archaeological/historic and survival within the building. A good photographic record should be made.

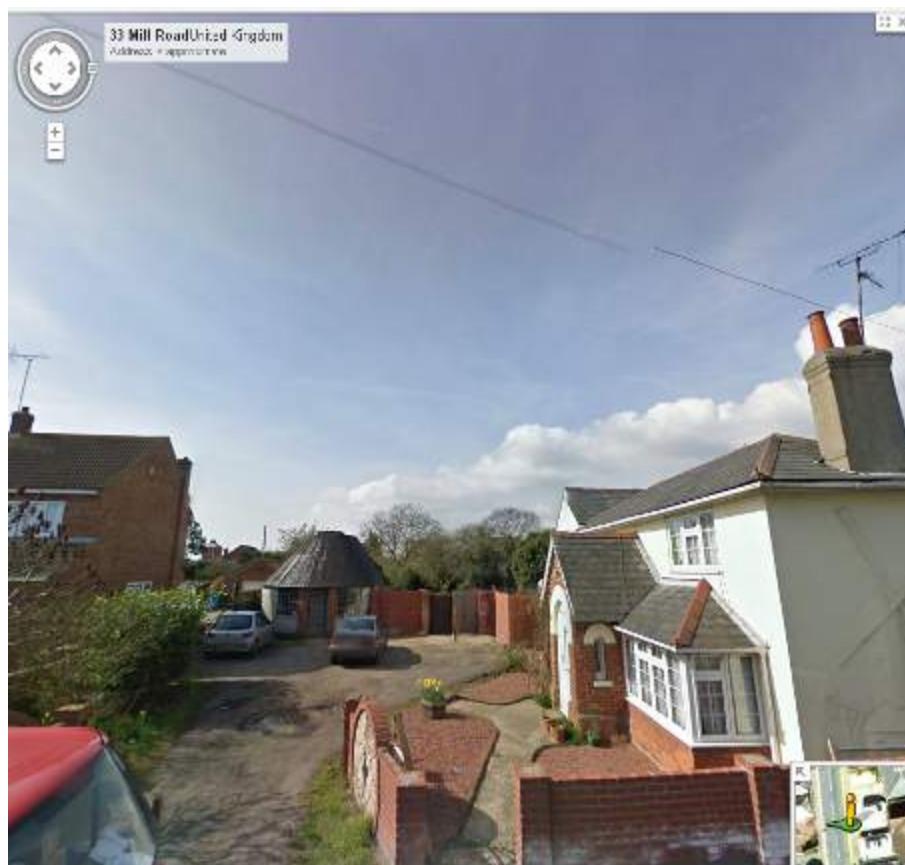
Photograph of Mayland, Nr Cardinals Mill Roundhouse (Google Maps Street view, retrieved on August 2011)

MANAGEMENT Presently in use as private residence and as such is well maintained. Should the opportunity arise, an internal inspection should be made to assess any survival of original fixtures.

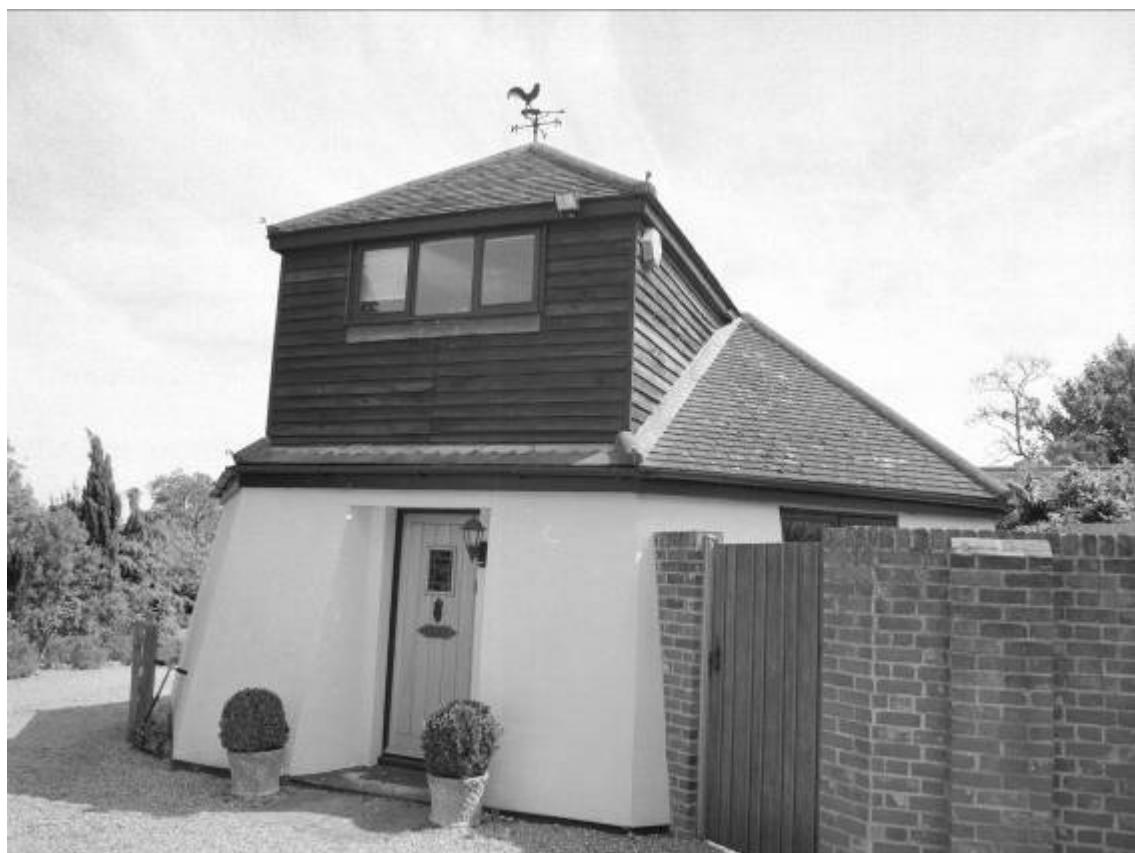
Photograph of High Ongar Smock Mill Base (Google Maps Street view, retrieved on August 2011)

MANAGEMENT Given that the smock mill base has been incorporated into a new property, no management suggestions would be necessary.

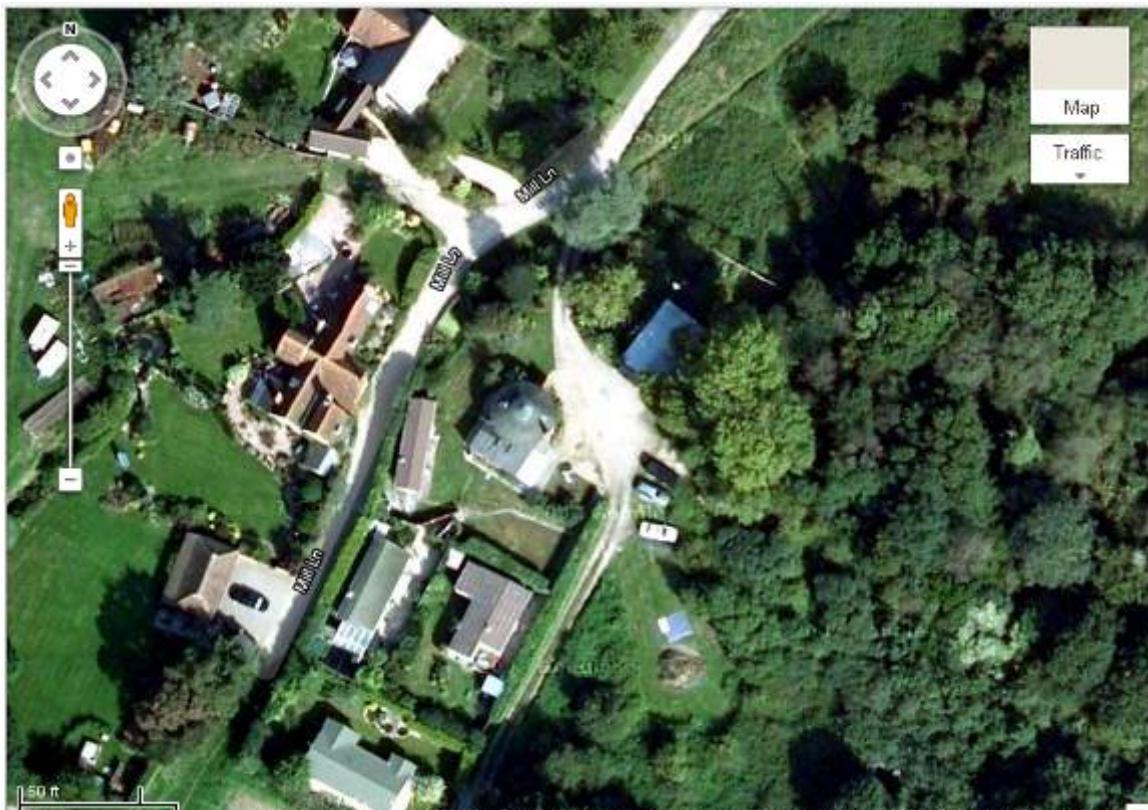
Photograph of Thorpe-le-Soken Post Mill Roundhouse (Google Maps Street view, retrieved on August 2011)

MANAGEMENT Presently in use as a private residence and are accordingly maintained. Should the opportunity present itself an internal inspection should be made.

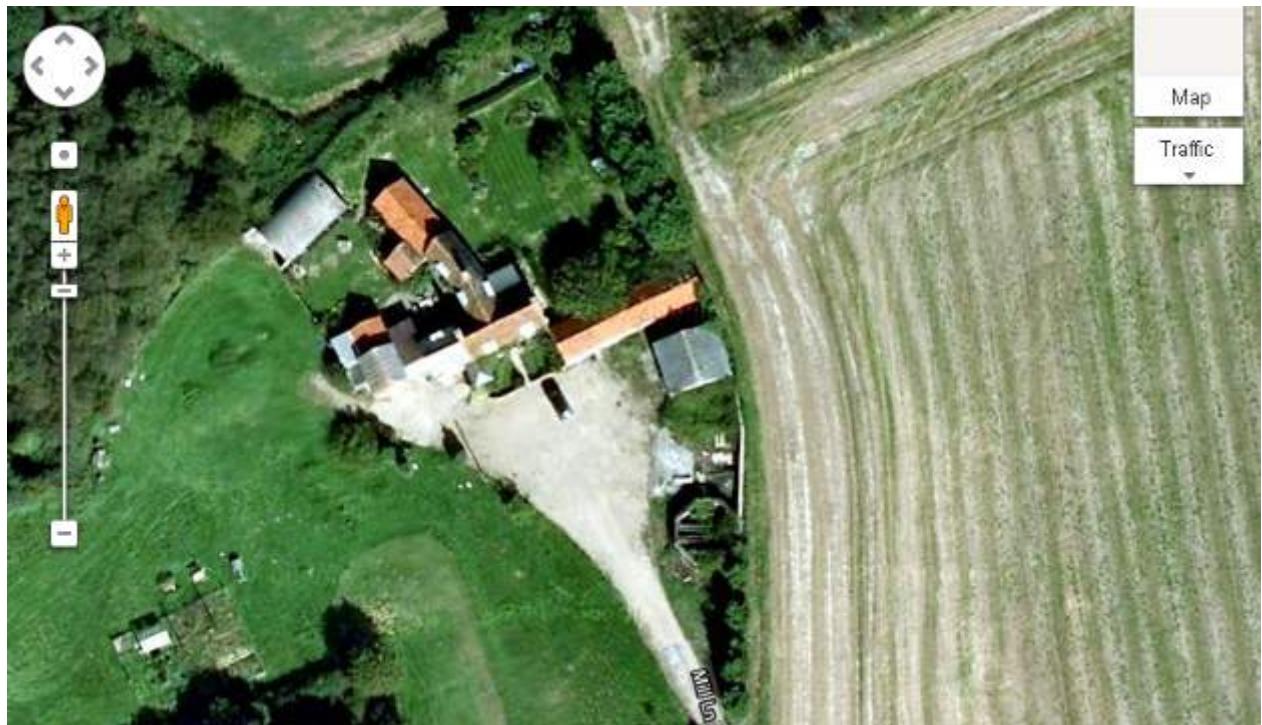
Photograph of Great Holland Smock Mill Base (Google Maps Street view, retrieved on August 2011)

MANAGEMENT Presently in fair condition. A detailed historic building survey at RCHME level 3 should be recommended if the mill and/or associated buildings are threatened by major works or demolition.

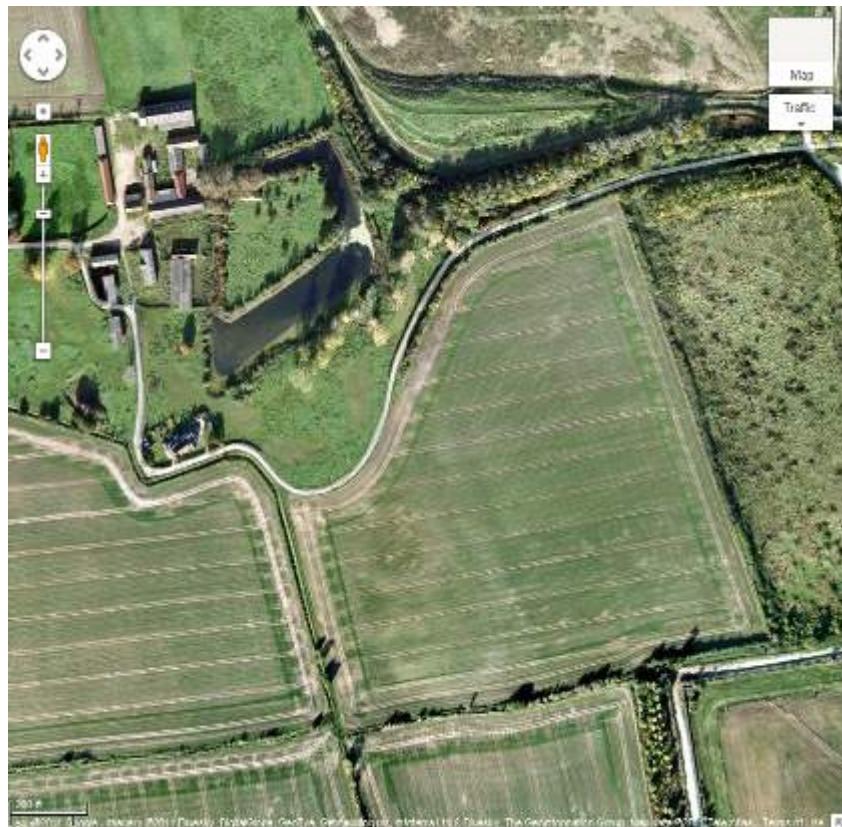
Photograph of South Ockendon Smock Windmill (demolished) (Google Maps Street view, retrieved on August 2011)

MANAGEMENT If the site is subject to planning, of the site to check for the mill leat or mill foundations as referred to above.

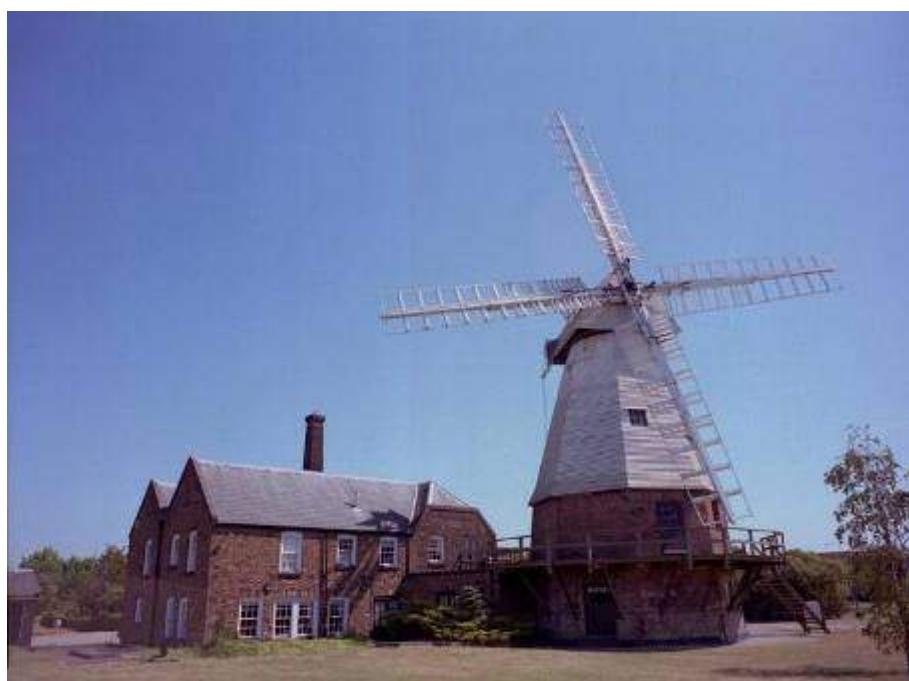
Set on a secured site, both the smock mill and the adjoining steam mill are retained in immaculate condition. Both now fully restored, the smock mill and steam mill have been converted to residential accommodation but without compromising the integrity of the historic machinery. This survey is a departure from the normal entries in that it should also be considered an update to the report on Baker Street Mills given in the Industrial Survey of Water and Steam Mills produced by the County Council in 2009.

Photograph of Baker Street Smock and Steam Mills

MANAGEMENT The smock mill is in very good repair. A detailed historic building survey at RCHME level 3 should be recommended if the mill is threatened by major works or demolition.

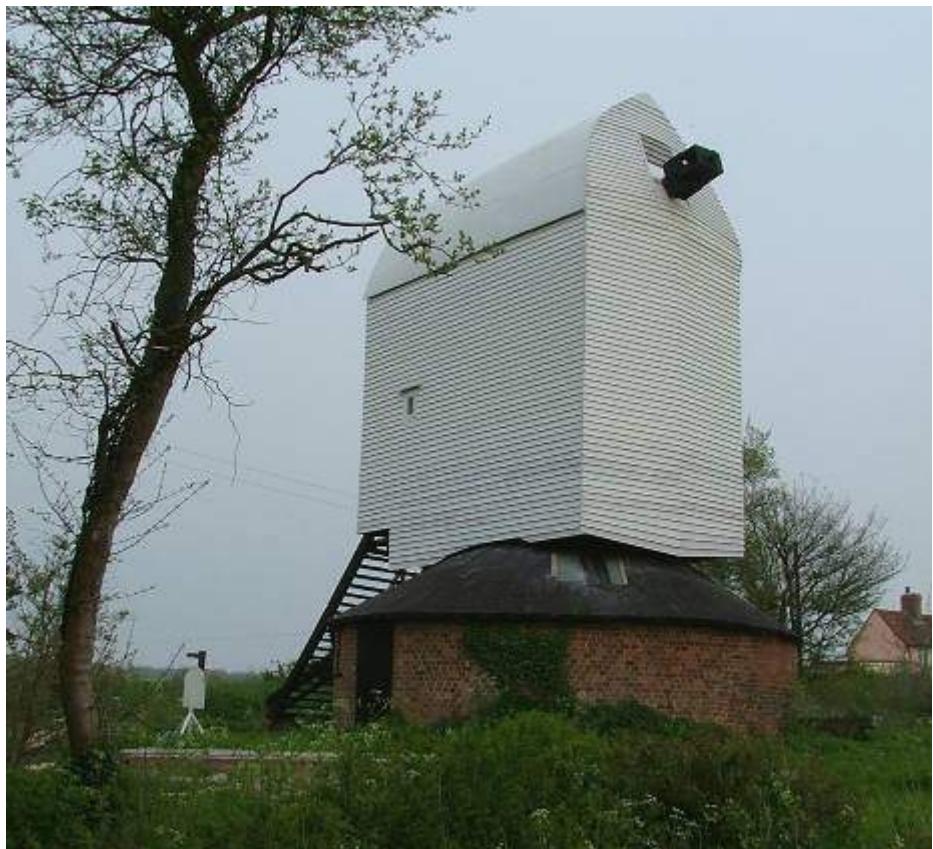
Post mill with roundhouse and tailpole. Noted in 1932 that there were two pairs of stones the larger (4ft 9 in diameter) driven from the brake wheel, the smaller (4 ft diameter) driven from the tail wheel. It was believed that the mill had not been worked for about 20 years. Noted in 1958 by Wailes that this was one of three wooden windshafts surviving in the county and the only one with an iron poll end. Described then as a 'head-and-tail' mill with two pairs of stones; the tail bridgetree was cast iron and forked.

Condition: Deteriorating, but repairs have been made

Photograph of Ashdon Post Mill (Google Maps Street view, retrieved on August 2011)

MANAGEMENT in private ownership, occupied and well maintained. If the mill becomes the subject of a planning application for residential and/or other re-use all efforts should be made to preserve its current levels of historic integrity. Prior to any agreement an impact assessment should be carried out to inform conservation bodies of the significance of the building, sensitivity of areas within the building, importance of its technology and the likely impacts of any proposed development on the fabric. These issues can then be addressed through mitigation
