WINDMILLS IN ESSEX
Comparative Survey Of
Modern / Industrial
Sites And Monuments
No. 19

*An archaeological, architectural and historical appraisal of
medieval, post-medieval and industrial age windmills*

March 2012

Report by Laura Belton and David Morgans

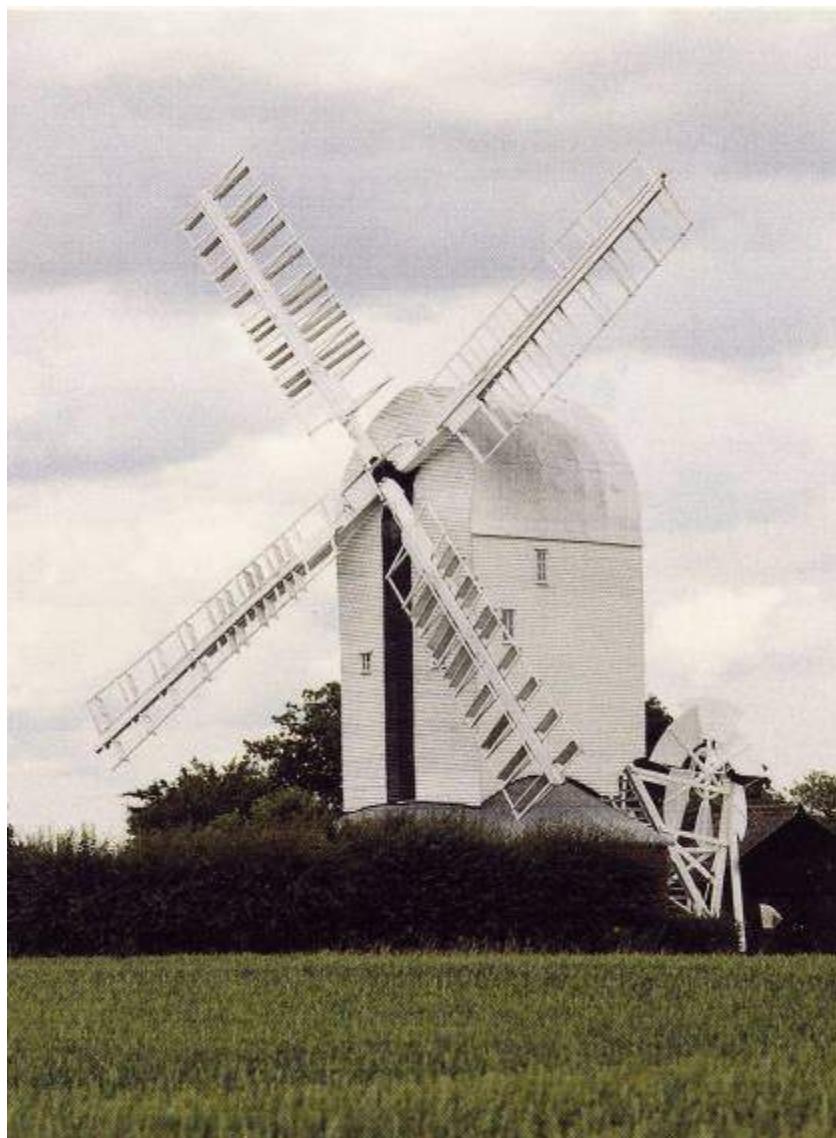
The mill is regularly visited and inspected by the Essex County Council mills team and maintained in good order. The sails are not fixed but the brake is kept on and webbing prevents movement should the brake wheel give way. The millstone sets, great spurwheel, tentering gear and bridgetrees are all intact and the mill is in operating condition. The winding mechanism works automatically keeping the mill turned into the wind. Inside the roundhouse a separate cast iron hurst houses a single set of stones. This had been installed for use with a portable steam engine located on the north side of the roundhouse and outside the building. The patent sails are operated from the spout floor by an internal striking chain. An unusual feature also seen at Bocking Church Street is the mezzanine floor within the roundhouse. The fantail gear traverses a track consisting of stone sets.

Photograph of Aythorpe Roding Post Mill (Google Maps Street view, retrieved on August 2011)

RECOMMENDED ACTION Maintain Grade II status, listing building description needs updated.

MANAGEMENT Prior to any significant future construction work to the mill an historic building impact assessment, guided by the principle of identifying and preserving as much as possible of the mill's original features, should be carried out. A detailed study of the building and its apparatus (at RCHME level 3 or 4) may also form part of any future consent

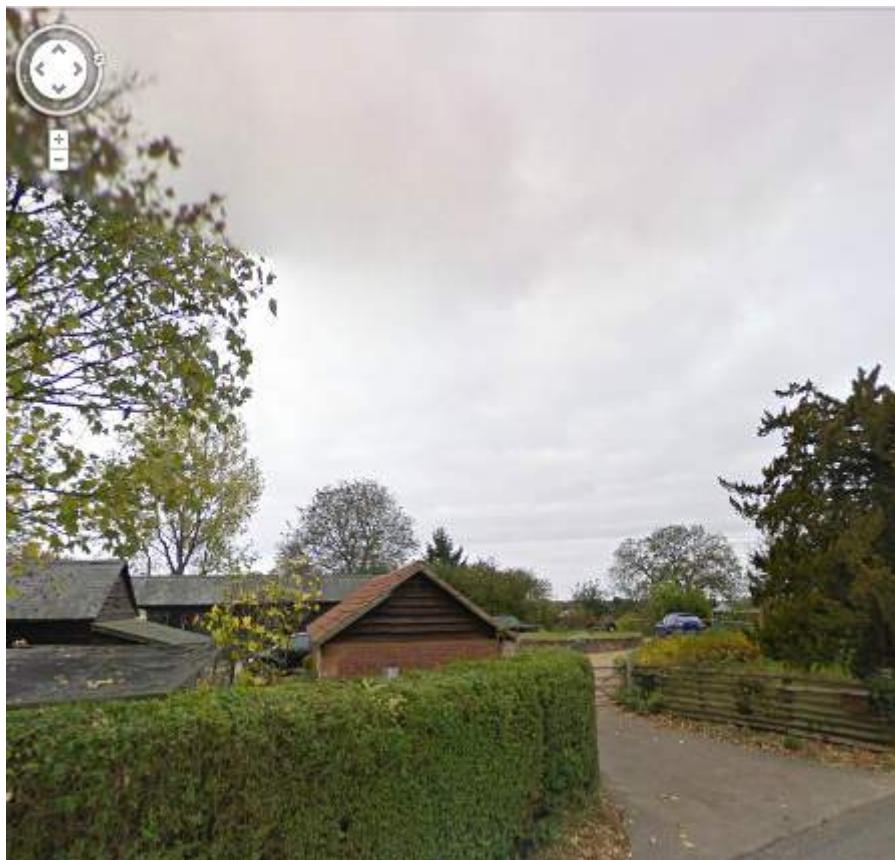
Photograph of Henham Post Mill Roundhouse (Google Maps Street view, retrieved on August 2011)

MANAGEMENT Should the opportunity arise through proposed planning applications, it would be interesting to investigate the below ground features associated with the site.

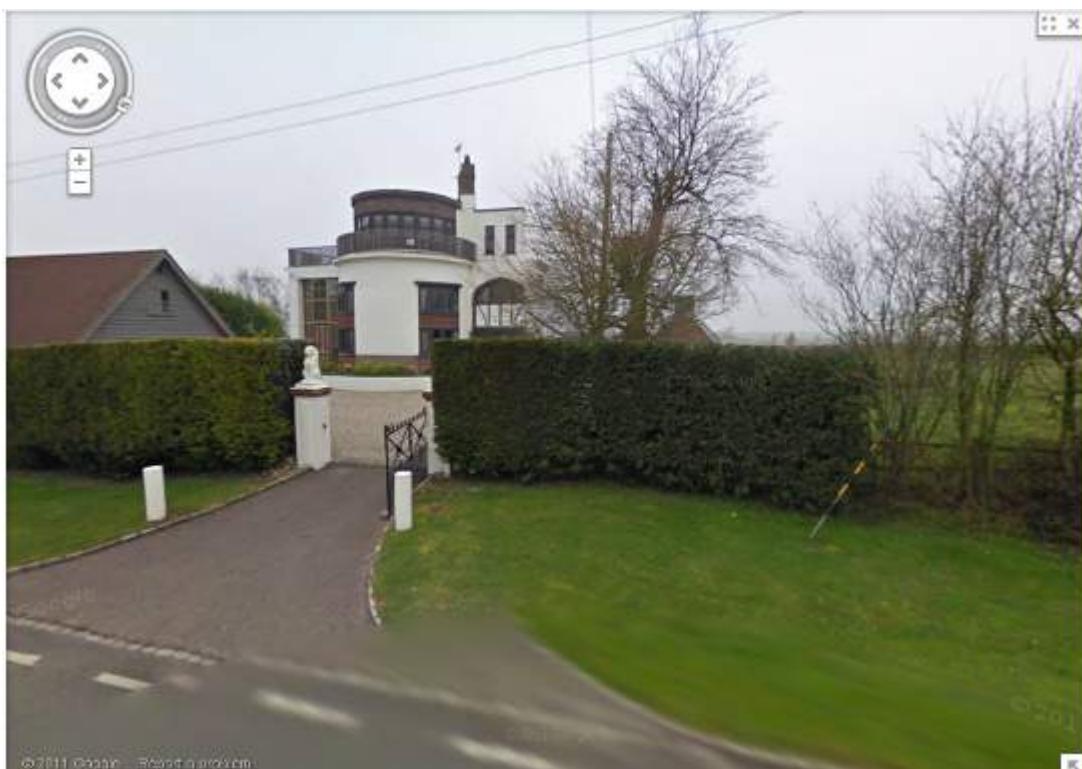
Photograph of Site of Welford's Windmill (Google Maps Street view, retrieved on August 2011)

RECOMMENDED ACTION Given the level of construction work required to make the conversion to residential accommodation, it can be assumed that no internal fixtures survive. While inclusion on a local list may be warranted, it would not meet the specification for listing.

MANAGEMENT Should the opportunity arise an internal inspection of the mill is recommended to assess internal spatial configurations and survival of technologies fixtures and fittings, and to see if any evidence of the trestle survives.

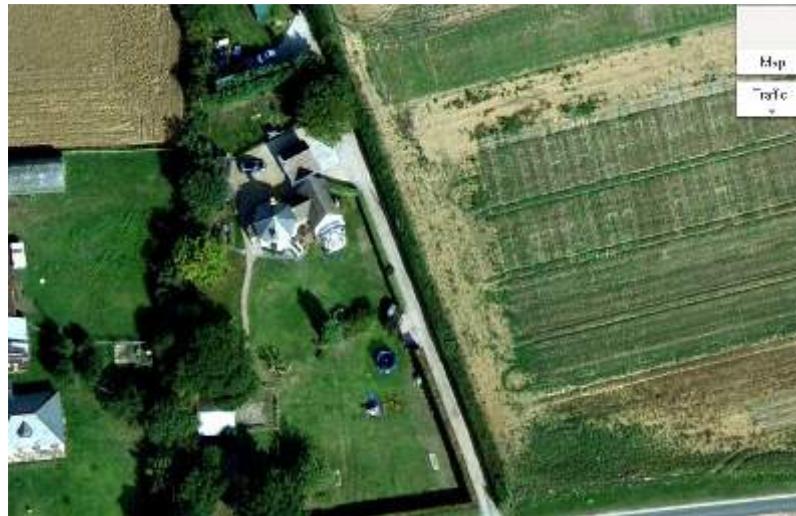
Photograph of Throw's Mill Roundhouse (Google Maps Street view, retrieved on August 2011)

RECOMMENDED ACTION The site may warrant inclusion on a local list depending on local criteria. Listed building description should be updated.

MANAGEMENT Throw's Mill Roundhouse is currently in private ownership, occupied and well maintained. Should the opportunity arise an internal inspection of the mill is recommended to assess internal spatial configurations and survival of technologies fixtures and fittings.

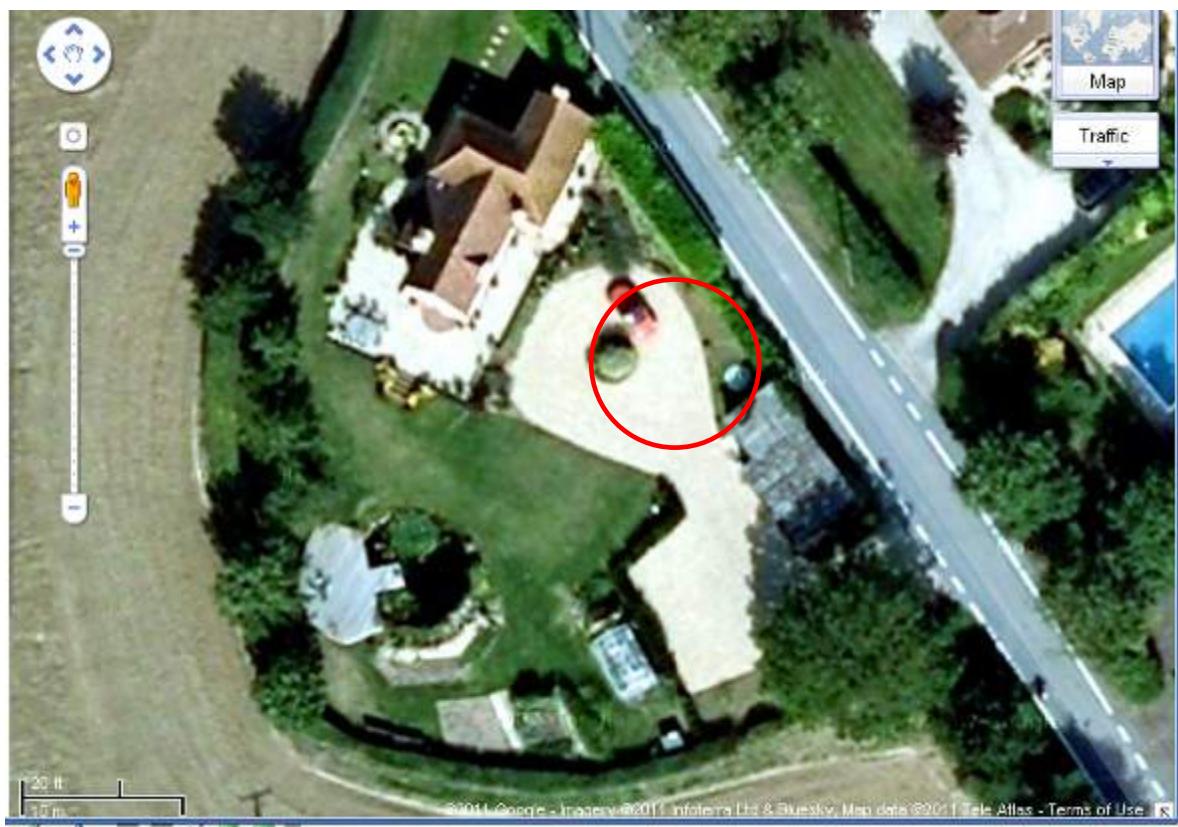
Photograph of Linsell Smock Mill (Google Maps Street view, retrieved on August 2011)

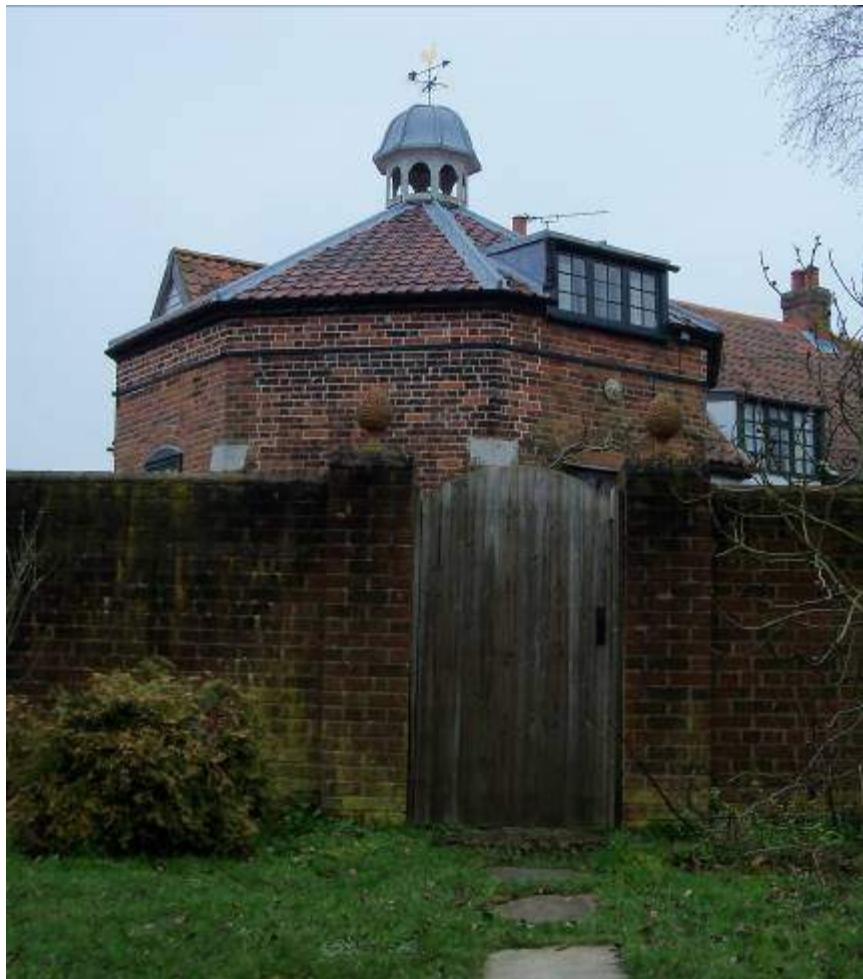
Photograph of Wimbish Tye Green Smock Mill Base

RECOMMENDED ACTION The building may warrant inclusion on a local list, depending on local criteria.

MANAGEMENT If under threat of demolition, the building should be inspected internally and a photographic record should be made of any surviving features.

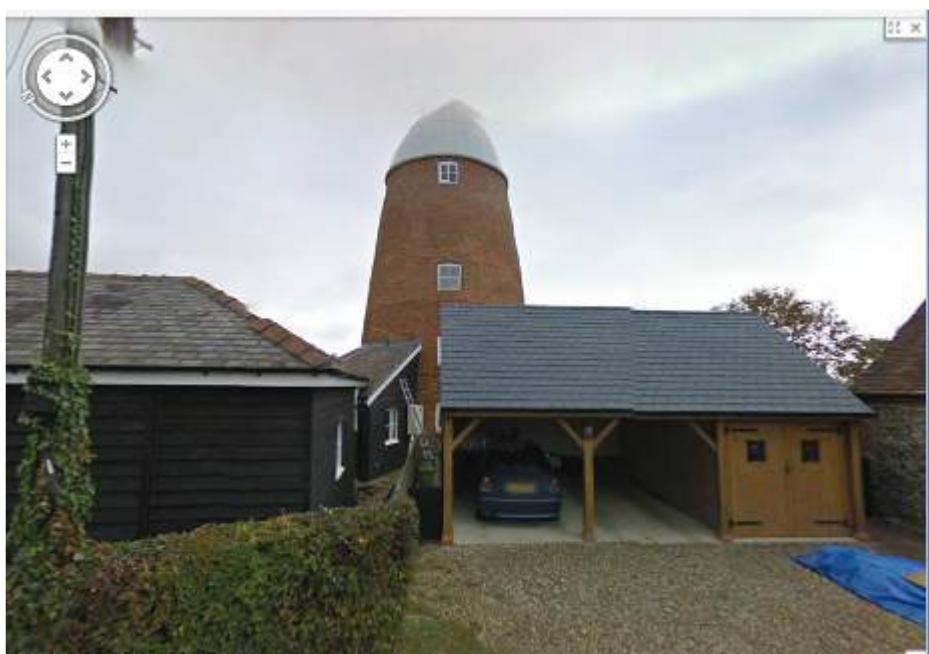
Photograph of Clavering (North) Tower Mill (Google Maps Street view, retrieved on August 2011)

Prior to any significant future construction work to the windmill an historic building impact assessment, guided by the principle of identifying and preserving as much as possible of the mill's original features, should be carried out. A detailed study of the building may also form part of any future consent.

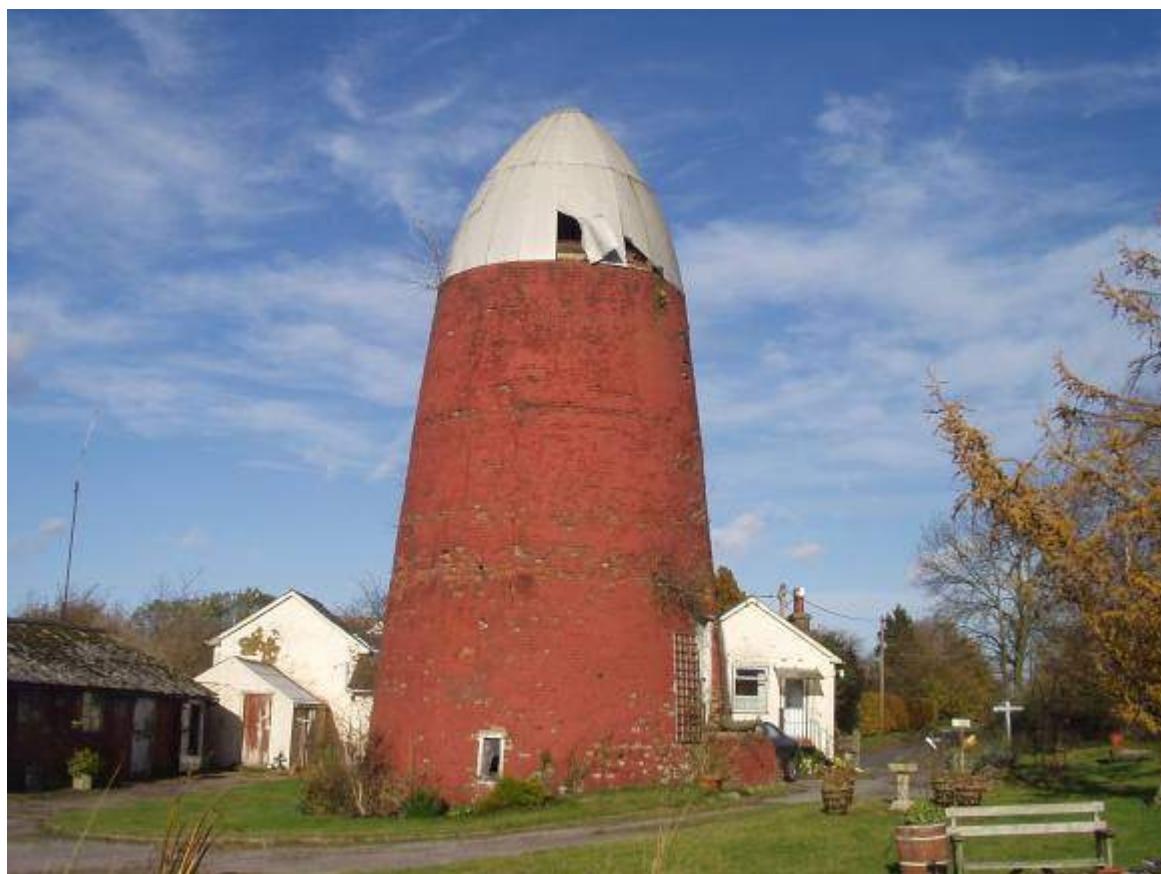
Photograph of Clavering (South) Tower Mill (Google Maps Street view, retrieved on August 2011)

MANAGEMENT Should the windmill become threatened, an internal buildings recording should be made as part of any condition to develop or demolish.

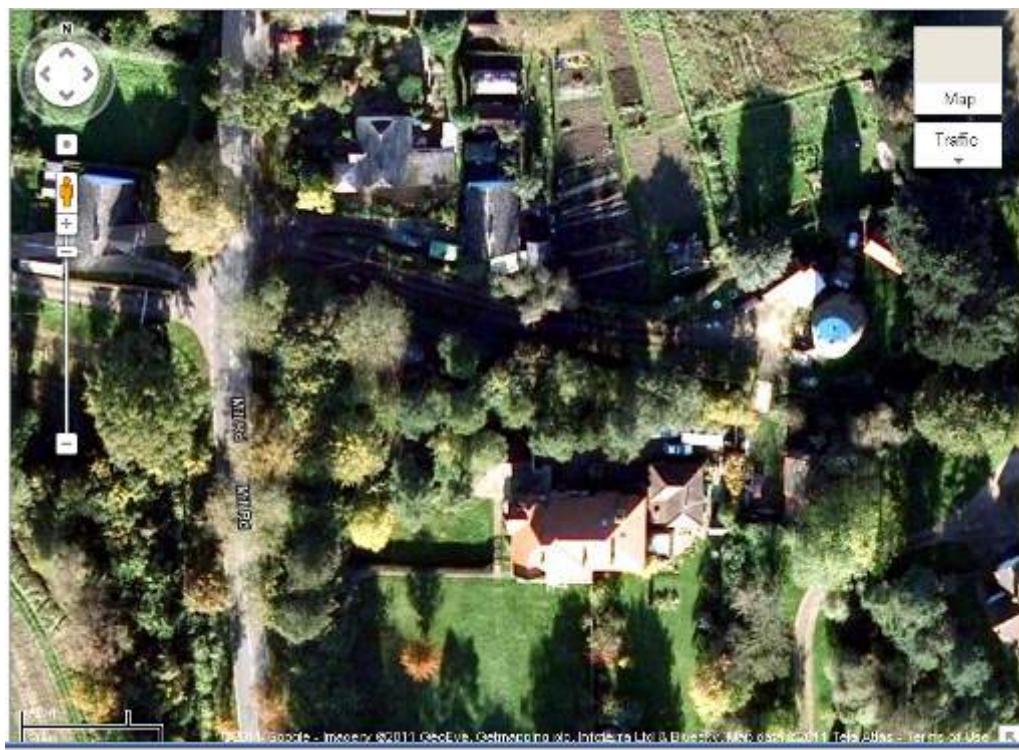
Photograph of Debden Tower Mill (Google Maps Street view, retrieved on August 2011)

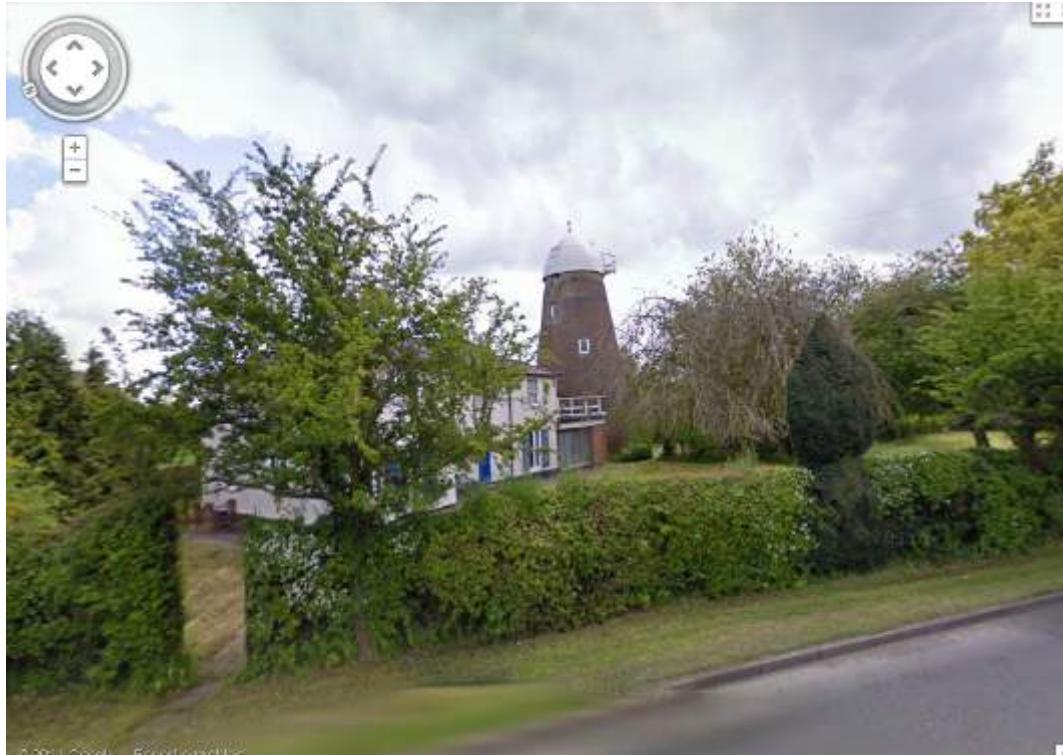
Photograph of Great Dunmow Tower Mill (Google Maps Street view, retrieved on August 2011)

MANAGEMENT Undertake an internal survey if possible, and the buildings should be recorded in advance of any demolition or conversion works.

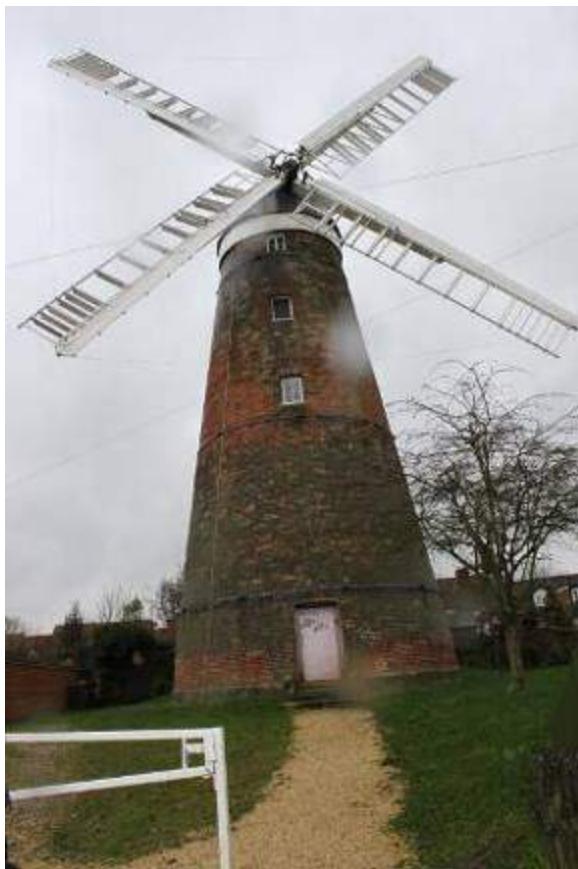
Photograph of Stansted Tower Mill (Google Maps Street view, retrieved on August 2011)

MANAGEMENT The windmill is currently well maintained and cared for. Prior to any significant future construction work to the mill an historic building impact assessment, guided by the principle of identifying and preserving as much as possible of the mills original features, should be carried out. A detailed study of the building and its apparatus (at RCHME level 3 or 4) may also form part of any future consent.

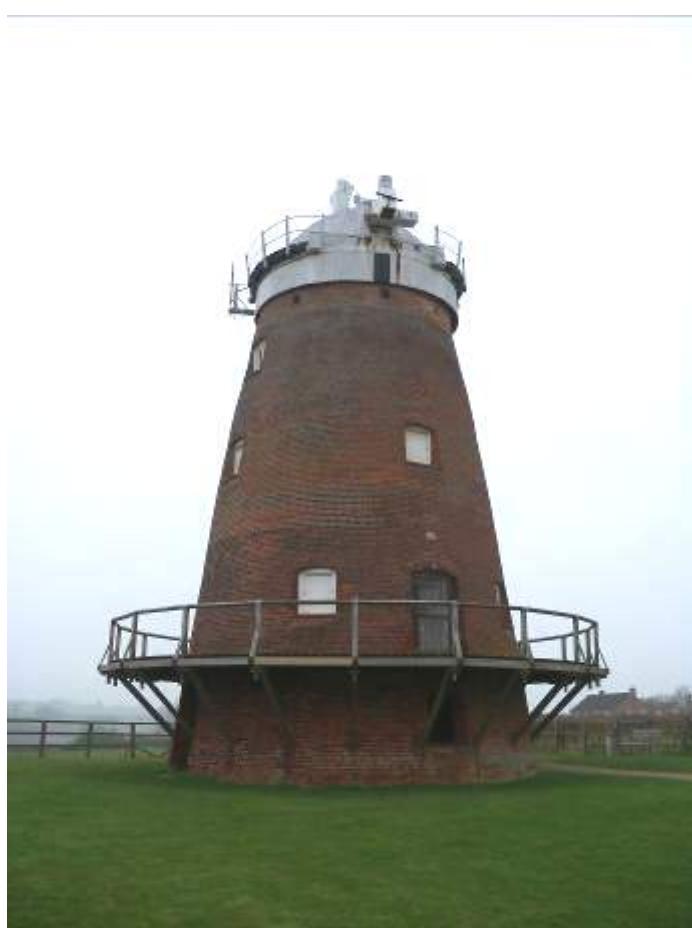
Photograph of Thaxted Tower Mill (Google Maps Street view, retrieved on August 2011)

MANAGEMENT Prior to any significant future construction work to the mill an historic building impact assessment, guided by the principle of identifying and preserving as much as possible of the mill's original features, should be carried out. A detailed study of the building and its apparatus (at RCHME level 3 or 4) may also form part of any future consent.

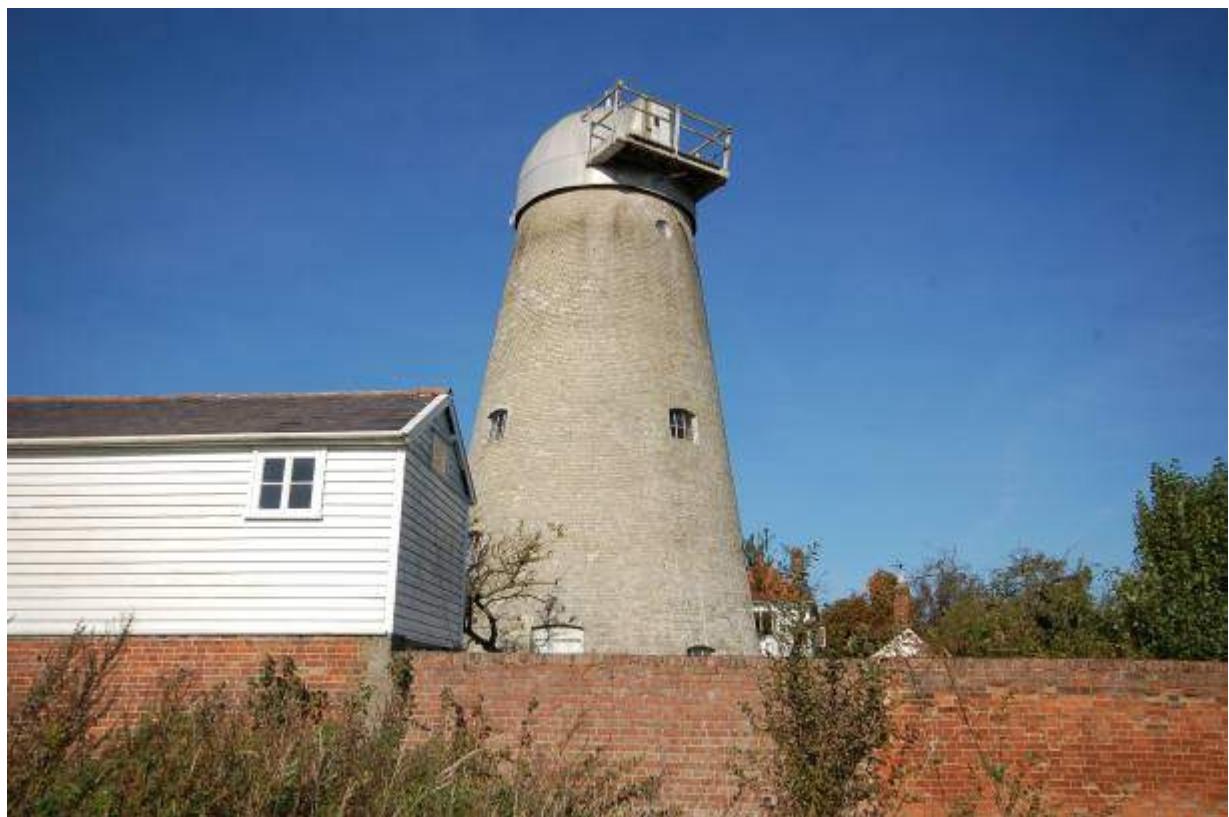
Photograph of White Roding Tower Mill (Google Maps Street view, retrieved on August 2011)

MANAGEMENT Should the opportunity present itself an internal inspection and/or historic building survey is recommended in order to assess and record levels of archaeological/historic and technological survival within the building.
