THE SAFFRON WALDEN BRANCH RAILWAY LINE

An Archaeological Assessment of the Former Audley End-Saffron Walden-Bartlow Branch Railway Line

**An Archaeological Assessment of the Former Audley End-
Saffron Walden-Bartlow Junction Branch Railway**

**Survey and report by
Adam Garwood**

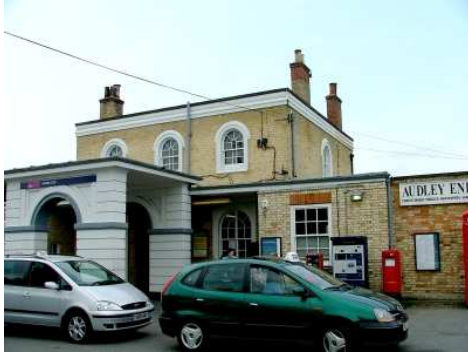
NGR TL 5160 3630

Although Audley End Station was not included in the branch line survey as it belongs to the first phase of railway construction initiated during the 1840s, it is included in the gazetteer because of its obvious associations with the branch line. The Grade II listed station at Audley End (EHER 36774) was built circa 1845 by Francis Thompson, railway architect of the early C19 whose work (mainly in the north Midlands) notably includes, Chester Station. In 1845 "The Builder" attributed both Great Chesterford and Audley End stations to Francis Thompson. It is a rectangular two storey yellow gault brick building with a parapet and ornamental stucco band. Three window range on the west and east fronts and one window range on the north and south ends, double-hung sashes with semi-circular heads, in stucco architraves. The east front has a covered carriage approach with corresponding stucco arches and coursed pillars. The west front has a C20 platform canopy, without a fascia, on original cast iron ornamental brackets (DoE 1984). The North bound platform is a simple three bay waiting area built in corresponding yellow gault brick with a moulded pendant fascia and canopy supported on original decorative cast-iron columns.

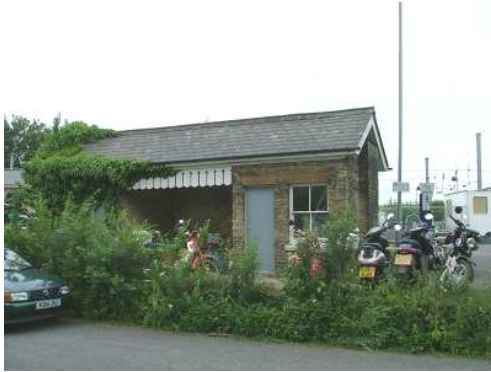
NGR TL 5163 3628

The original branch line halt and a length of platform still survive to the south-east of the main station building and at the western extreme of the former branch line. The waiting room/station office (EHER 40454) is a small unimposing building lacking the grandeur of the main station. It is built using a similar yellow stock brick in Flemish bond and uses blue bull-

nosed bricks to dress and protect the lower courses on each wall angle. Covered in Welsh slate and with gable ends, north and south, the halt is a symmetrical building having a central open canopied seating area with bench seating flanked by either an office or waiting room. Truncated stacks show that both rooms were once heated, although whether the fireplaces are still intact is unclear (no access). All the windows retain their original vertical sash windows and have coade (fake) stone heads with deep skewbacks and stone sills. The platform extends for c.60m to the east of the halt and is brick built with stone oversailing edge copings. Ramped at both ends, the platform also tapers gradually to compensate for the disparity in ground levels as the branch line rises out of the Cam valley up to the level of the main line.

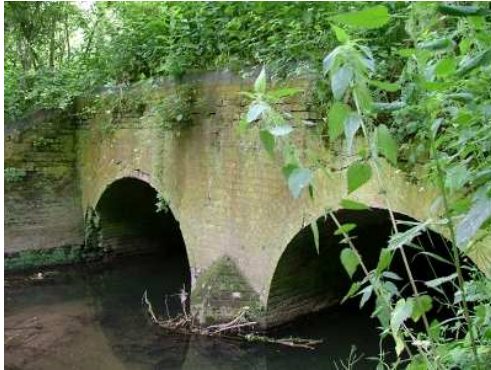
NGR TL5222 3665

A brick-built C19 culvert channelling the River Cam below the railway embankment to the north-east of Wendens Mill. The bridge abutments and revetments are built in red stock brick laid in English Bond while the parapets are capped with blue brick copings. The double-arch of the culvert is built using four on-edge courses, and is supported on a central cutwater. The culvert shows little sign of alteration and survives intact and in a sound structural condition. It is however, no longer in use, very overgrown, and would benefit

from maintenance to control invasive vegetation.

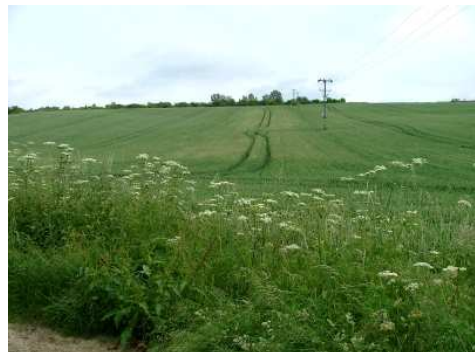
The embankment/cutting to east of the culvert (EHER 40455) has now been removed and the railway line as it continues east is now only recognisable as a linear plantation of coniferous trees. From TL 576 368 to the western outskirts of Saffron Walden, the cutting has been backfilled and the land reverted to arable. No evidence

remains of the culvert or railway embankment that passed over the River Fulfen (TL 530 372). On the outskirts of the town, the railway cutting partially remains to the north and west of Beeches Close, but the Newport Road and the Borough Lane overbridges have both been removed.

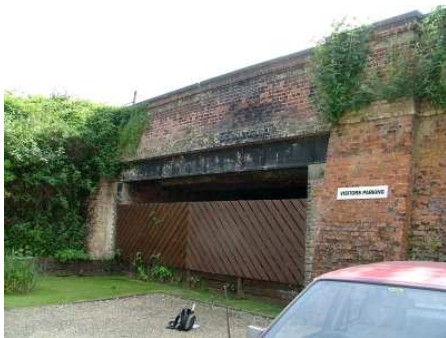
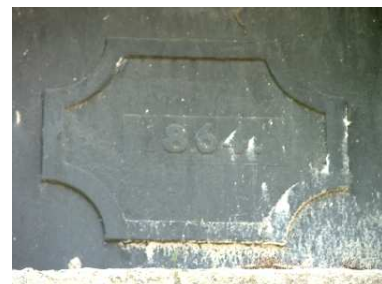
EHER 40456 **Debden Road Overbridge**

Iron beam and brick jack arched bridge supported on piers of red stock brick with yellow brick dressings and a parapet with decorative bands and over-sailing brick copings. Four jack arches support the bridge bed axially and spring from five large wrought iron bridging beams, manufactured in 1864 by founders J.I. Headley of Cambridge. The outer

beams are embossed with decorative panels (one bearing the date plaque, see picture) and are set onto highly compressive stone corbels. Additional lateral support was provided to the piers, on both flanks, by lean-to buttressing. There is evidence of localised reworking and a large section of the northern approach wall has been rebuilt.

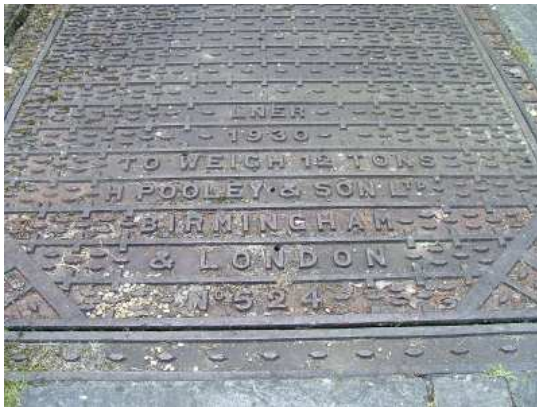
NGR TL 5783 3794

Adjacent to Debden Road Overbridge at the junction of Station and Debden Roads is weighbridge court, a complex of modern apartments named after the weighbridge, retained within the development. The site lies within the former goods siding/coal yard, to the north of the line. The weighbridge, added in c.1930 and replacing an earlier example depicted on a map of

1900, lay near to yards main entrance onto Station Rd. Capable of weighing up to 12 tons, it was manufactured by H. Pooley and Sons Ltd, of Birmingham and London and was commissioned in 1930 by the LNER (London and North Eastern Railway) Acc No. 524.

The survey also discovered a number of features which do not fit into any of the above categories. The recommendation for these sites, such as the weighbridge (EHER 40457) in Saffron Walden, as with the rest of the railway, is that they should be retained wherever possible.

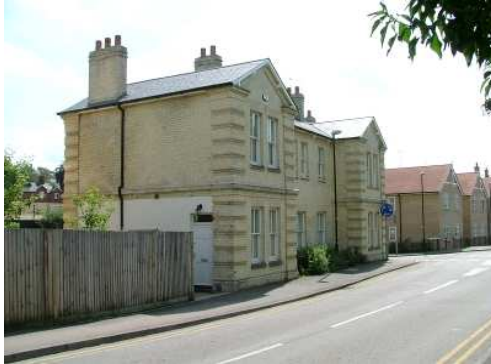
NGR TL 5402 3801

Built in c.1865 the station is a symmetrical 2 storey 5 bay building in yellow gault brick, with forward set gabled cross-wings at each end. The shallow pitched roofs are slate covered and the angles are dressed with nail-head banded brick quoining (a characteristic of the SWRC) rising to a simple moulded eaves cornice and an open pediment at gable. The walls have a

brick plinth with a bead moulding and a moulded first-floor band which wraps around both cross wings. The principal windows are either four or eight pane sash windows set into apertures with gauged brick voussoirs. A small single-storey toilet and porters annex formerly attached to the east end was demolished during the buildings conversion to a dwelling, while the former main entrance from Station Road, also built with brick voussoirs, has been converted into a window. The present canopy on the rear trackside elevation is a modern replica, possibly reusing original brackets.

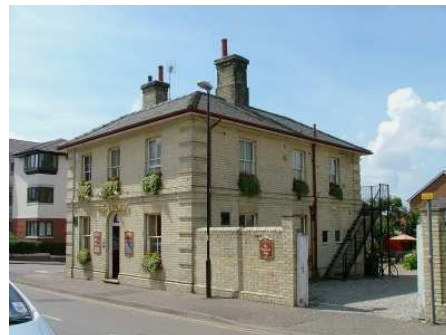
NGR TL 5396 3801

Contemporary with and sharing many of the same architectural traits/corporate styling as the main station the Railway Tavern was purpose-built to serve the station and its customers. Built to a slightly over square plan the two-storey basemented gault brick building, has brick quoins with nail head decoration, horned sash windows and a shallow hipped slate covered

roof with wide overhanging eaves. Moulded cavetto floor and eaves bands decorate the main elevations. Original courtyard boundary walls and contemporary stabling, trap house and outbuildings remain around courtyard to the east. A recent refurbishment removed the original public bar/lounge bar divisions, horse shoe bar and a small off-sales hatch adjacent to the main entrance.

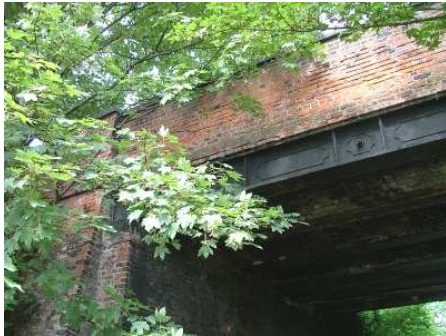
**EHER 40459
South Road Overbridge**

The South Road overbridge adopted the same design and was built to the same

specifications as its contemporary to the west at Debden Road. It is an Iron beam and axial jack arched bridge supported on brick-built piers of red stocks in English bond, with yellow brick dressings and a brick parapet. Four jack arches strengthen the deck axially and spring from five large original wrought iron I section bridging beams. The outer

beams are embossed with decorative panels and inscribed with the founders, J.I. Headley of Cambridge and dated 1864. Additional lateral support is provided to the piers on both flanks by lean-to buttressing and to the deck by tie-rods. The bridge was widened to the east in 1887, but has since also been re-engineered, using modern reinforced concrete beams. The bridge lies just within the Mount Pleasant Road Conservation Area and as such enjoys some protection

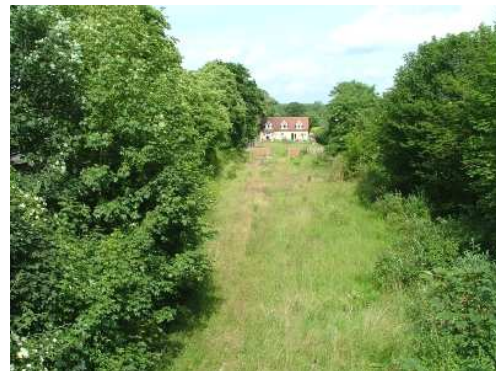
South Road to Thaxted Road, Saffron Walden

The eastern half of the railway cutting between the South Road overbridge and Thaxted Road remains unbuilt as does parts of the rail embankment immediately west of Thaxted Road. New build which is starting to encroach from developments along the south of the cutting increases pressure for future development to infill the cutting. Such

schemes would have a negative impact upon the remains of a railway turntable, engine house and carriage shed formerly situated near to south road bridge and within the unbuilt cutting. Future planning proposals should accommodate the need for an archaeological evaluation to fully assess and record buried evidence of the sites Industrial past.

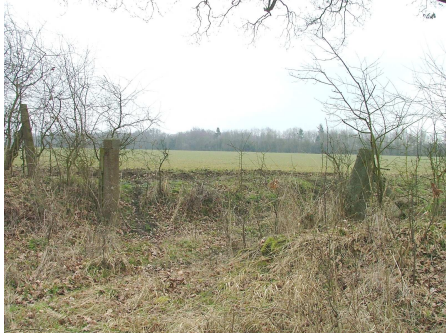
EHER 40496
Brights Wood Crossing Point

Crossing point of former track/droeway between Brights Wood and the Ashdon Road. Only the chamfered concrete gate posts and a number of concrete fence posts remain along the south-eastern side of the rail cutting. The corresponding posts to the north have been removed.

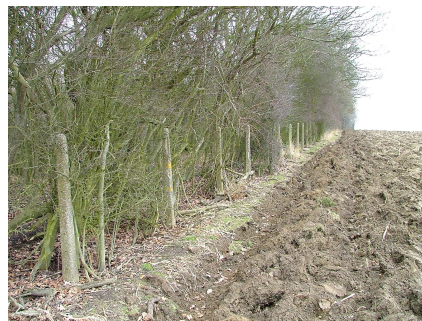
NGR TL 5642 3997- 5692 4100

The decayed bases of telegraph poles, presumably carrying electrical cabling for power or telecommunications are present intermittently along the southern side of this stretch of the rail cutting

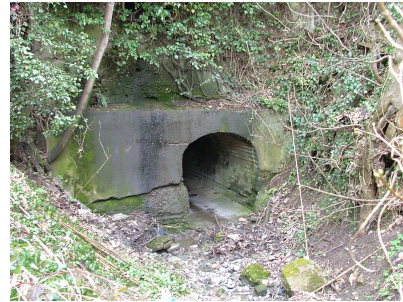
Brick built culvert channelling the Slade under the rail embankment as it approaches the Thaxted Road. Although it has a large structural crack in the face of the arch, the culvert remains in use, unblocked and maintained.

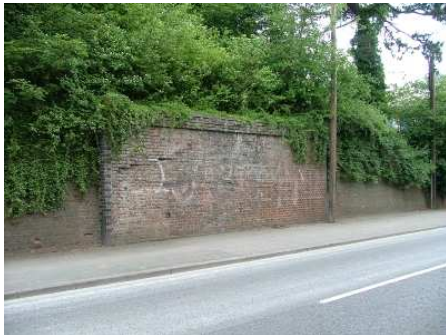
EHER 40460
Thaxted Road Underbridge

Former iron beam underbridge spanning Thaxted Road. The bridge deck was probably removed due to the height restrictions it imposed upon one of the main arteries serving the industrial area of the town. All that remains is the red brick piers, earth embankment and the brick abutments. The brickwork is much plainer than that used in the

Debden and South Road bridges and may demonstrate, in its stylistic change, the second phase of the line in 1866.

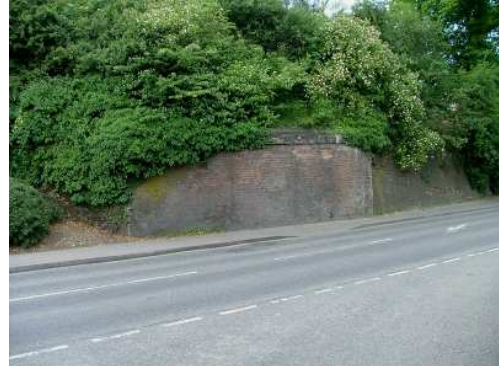
Only the red brick piers and abutments of the former iron beam underbridge remain on the south side of Radwinter Road. The iron beam deck probably met the same fate and for the same reasons, as its Thaxted Road contemporary

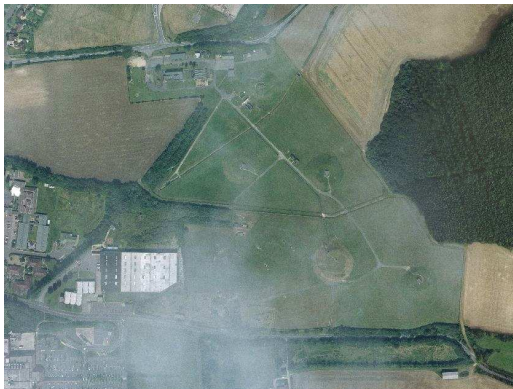
Ashdon Road Air Ministry Site

Restrictions on access into the grounds of two large commercial operations between Radwinter and Ashdon Roads prevented inspection of the railway cutting in this area. Map evidence shows that the branch line forked to the east at TL 553 386 to an Air Ministry Sidings (EHER 40475), which was built in 1939, to serve massive underground fuel tanks (EHER 40476) stockpiling aviation fuel during World War II for the surrounding airfields at Debden, Little Walden etc. The sidings/cutting (seen to the north-east of the large white building), a network of internal roadways and six large circular subterranean tanks capped by earthen banks, still appear on contemporary aerial photographs (see above). At present completeness and levels of integrity remains unclear, although as the site is operated by Serco petro-chemicals it is very likely that the original WWII fuel tanks still remain in use.

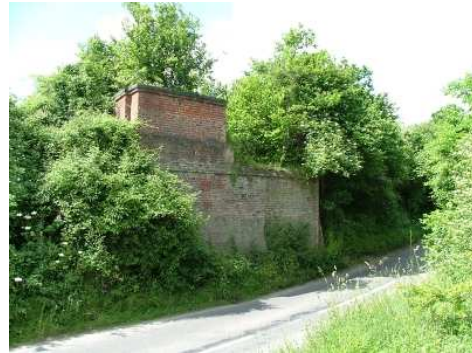
EHER 40462
Ashdon Road Underbridge

Only the brick piers and revetments on the south side of Ashdon Road survive. The deck and the northern bridge structure were removed during the construction of a goods siding for Acrow Engineering during 1955 and later in 1957 for Acrow Halt (EHER 40463). The goods sidings serving the works no longer survive as it has been redeveloped as part of the Ashdon Road Industrial Estate.

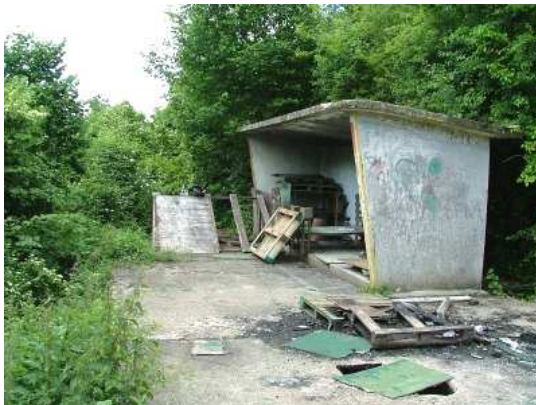
EHER 40463
Acrow Halt

Built in 1957 for the benefit of the Acrow Works and particularly its staff, Acrow Halt still lies within a stretch of overgrown cutting to the east of the works and north of Ashdon Road. The Halt comprises a c. 80m stretch of reinforced concrete platform ramped at both ends and oversailing the former line to the east. A simple lean-to shelter of concrete construction is situated along the western side of the platform, as is a concrete ramp leading up into the adjacent works. Tubular iron hand rail posts are intermittently spaced along the edge of the platform and access ramp. Although the halt lies redundant, its robust construction and isolation away from the former works and outside the envelope of the modern industrial estate are key factors in its survival.

Built in 1957 by Acrow for the benefit of the works and particularly its staff, Acrow Halt survives intact and in a sound structural condition within a stretch of overgrown cutting to the east of the works and north of Ashdon Road. Its robust concrete construction and isolation away from the former works (now an industrial estate) after the lines closure are key factors in its survival. Although of a very simple utilitarian design, functional modern structures like Acrow halt, rarely survive their redundancy. Unlike the majority of the ancillary railway structures which were rapidly swept away, the halt remains as an important example of the towns post war industrial development. At present the halt is under no foreseeable threat although any expansion of the Ashdon Road Industrial Estate or development to the north of Ashdon Road would compromise its future.

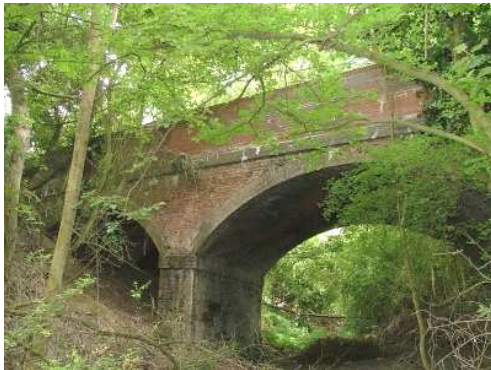
NGR TL 5640 3997

A triple arch accommodation bridge built with a large central (rail) arch flanked by smaller outer arches springing from the railway banks. Built with red brick piers and abutments (English bond), the bridge has white brick dressings facing each of the three course on-edge arches and a plain blue brick band at deck level. The parapets, also in red brick, are modern and have a blue brick on-edge coping. Generally in a fair condition, although there are areas of brick spalling within the arches, particularly on the west side and more seriously a large structural crack passing through the parapet and abutment in the southern springing arch. Limitations on maximum road weights may be necessary due to structural weakness. Movement in the bridge (AEB2122) is presently being monitored.

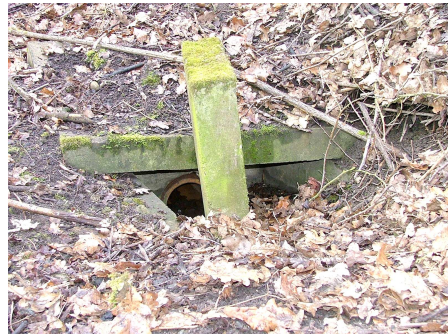
NGR TL 5650 4008

Pre-cast concrete conduit with ceramic pipe located on the northern side of the track bed. The conduit was probably used for the underground channelling of railway signals/cablings alongside the track.

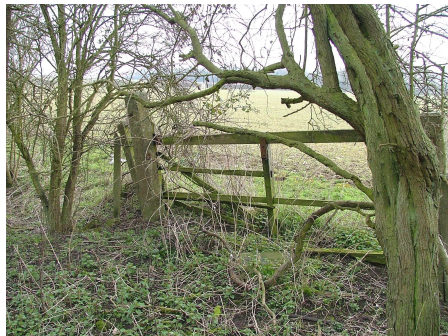
EHER 40494
Crossing Point

Crossing point comprising four concrete gate posts, two either side of the cutting and a pair of timber gates. The crossing is banked slightly along its flanks suggesting its was used as a cattle drove way. The gates have deteriorated but the concrete posts remain upright and intact.

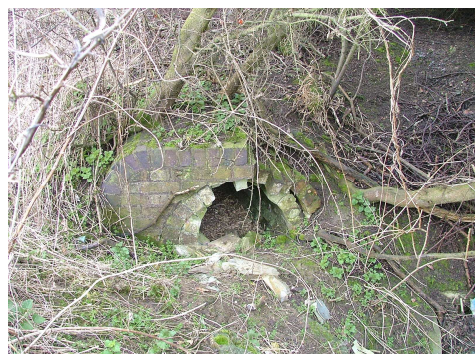
Redundant brick built culvert channelling a small east to west flowing spring beneath the rail embankment. The small diameter culvert is built using red brick but has a blue brick coping course around the opening. It is no longer in use, (replaced by a modern drain) and is starting to deteriorate badly.

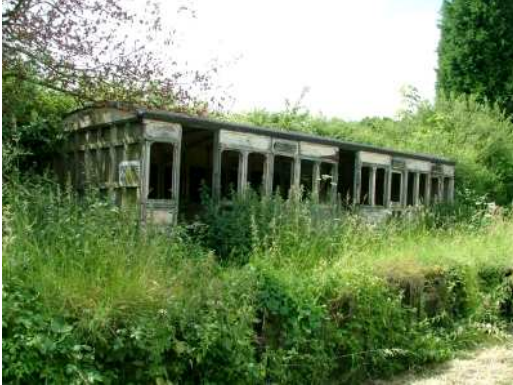
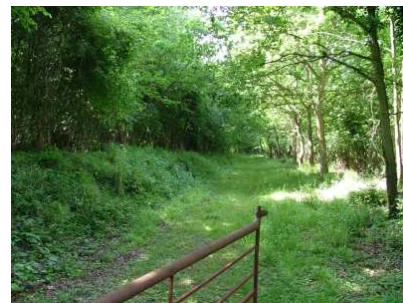
**EHER 40467
Ashdon Halt**

Ashdon Halt was the only (public) scheduled stop between Saffron Walden station and Bartlow junction. Reached from Fallowden Lane, the halt originally comprised a length of raised platform built along the south-eastern side of the rail cutting. Later in 1915, a disused GER coach body was provided to act as a waiting room (Paye, 1981). Both the platform and the former waiting room/carriage remain in situ. Measuring c.50m in length, the platform is ramped at both ends and built using a railway sleeper revetment holding back an earth and clinker bank. The sleepers are laid on-edge four courses high (c.1.2m) and held by sleeper posts at c.1m intervals. Set onto the platform bank and toward its northern (village) end is the body minus under carriage, of a former GER passenger carriage. It is mainly constructed of timber, with close boarded timber-framed walls supporting a shallow camber arched timber boarded roof (latterly felted). The original front-facing seating have been removed and the carriage refitted with continuous bench seating, built along three of its walls. No glazing remains. The site lies redundant and the coach body, exacerbated by the loss of external wall cladding, is deteriorating badly.

Ashdon Halt was the only (public) scheduled stop between Saffron Walden Station and the Bartlow Junction. It simply comprises a ramped and battered earthen bank, improved in 1915 with the addition of a waiting room in the form of a disused GER coach body. The site lies redundant and although some protection to the carriage has been attempted through its re-roofing with felt, the loss of cladding from the carriage body has exposed its structural timber frame, which is visibly deteriorating. The timber battering to the bank has also deteriorated, resulting in localised collapse. Both bank and carriage require conservation and ideally a full survey prior to further deterioration.

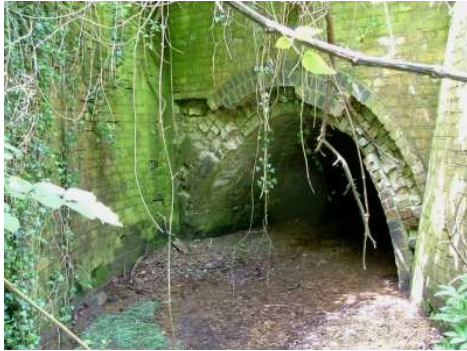
NGR TL5794 4229

No evidence of the rail bridge at Rectory lane or the rail embankment to the south of the road, remain. The southern embankment appears to have been completely quarried away while to the north of the road survival is intermittent. Presently only the causeway which provides access to Reckitts Farm remains. A culvert channelling a tributary of the River Bourne, east-west below the

causeway, still remains in use. Built to a typical railway architectural style the culvert comprises a squat 4 course on-edge blue brick faced arch with red brick abutments in English bond. Splayed brick revetment walls channel the river bed and retain the bank around the area of the opening. The culvert is in use and is presently clear of any obstructions. Only the eastern culvert arch was inspected. It showed considerable amounts of brick spalling and loss of mortar, particularly around the arch face, and a number of large and significant structural cracks within the brickwork of the revetments and abutments. There are no signs of collapse within culvert itself, but to ensure its future stability the culvert requires remedial repairs.

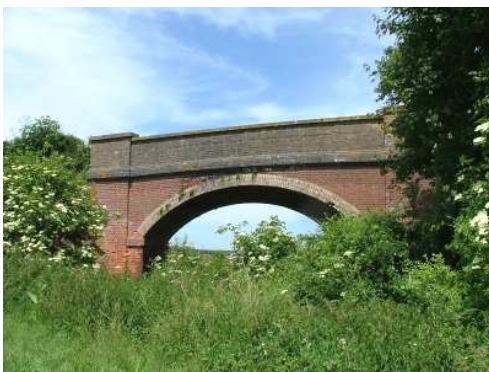
A single arch accommodation bridge built with red stock brick abutments in English

Bond, a three course on-edge brick arch with white brick dressings and red brick piers and splay revetments holding back banks to the north and south. The brick parapet, tops of the piers and saddle-back copings are later replacements. The bridge remains in use, now providing access to farm buildings to the west of the line and is well maintained, showing areas of recent repair, particularly to the revetment walls.

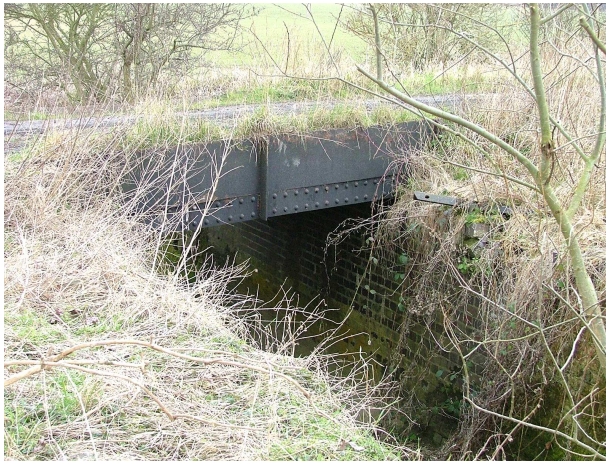
NGR TL 5822 4395

A culvert channelling the River Bourne, below the railway embankment still remains in use presently carrying an access road to farm buildings to the north. This culvert is not typical of the arch/tunnel type brick culverts but is more akin to the iron beam bridges with a wrought iron beam bed resting on brick built abutments. Brick revetment walls

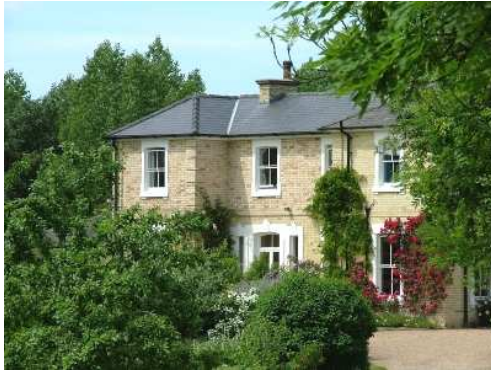
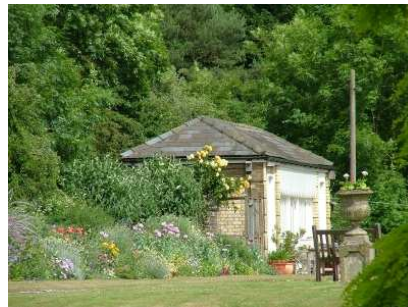
NGR TL 5841 4496

Bartlow Station was initially built (between 1862-1866) by the Great Eastern Railway (GER) to serve the Shelford to Sudbury line and subsequently the Saffron Walden branch line reached via a pedestrian causeway between the station and adjacent halt. The Shelford, Haverhill, Sudbury line is now redundant and the station building has since been converted

for residential use and lies in private hands. The station adopts a similar architectural style to Saffron Walden Station, and is built using similar brickwork and standardised ground plan. The roofs however, are hipped and not gabled and the brickwork lacks the nail head detail within the quoining typical of the SWR corporate style. The stone window surrounds at Bartlow are more elaborate and the sash windows taller and more elegant. The slight variations in architectural treatment between the two stations reflect the corporate styles of the two companies who built them. The railway canopy and all other external features including the platform and cutting appear to have been removed when the station (now renamed Booking Hall) was converted to residential use. A small single storey eastbound waiting room (reused as an outbuilding) is present to the rear of Booking Hall at TL 5841 4498. It is built in the same style as the station and has kept its original canopy with pendant fascia. The subsequent re-landscaping of the grounds to the south of the station and the creation of a small lake has removed the pedestrian causeway which once linked the station to the branch line. Both station and waiting room lie just within Cambridgeshire

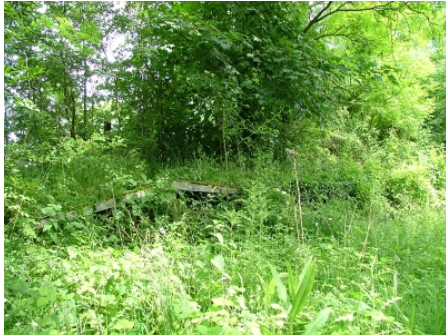
**EHER 40471
Bartlow Halt**

As the branch line sweeps in a wide arc toward Bartlow junction and the Shelford-Sudbury line, it progressively rises onto a railway embankment (TL 58374487-5817 4503) and out of the low lying flood plain of River Bourne. The branch halt line platform

mainly survives intact and extends for c.120m along the north-eastern side of the embankment between (TL 5832 4495-5838 4487). The platform is built in a similar style to that at Ashdon Halt, comprising an earth and clinker bank, c.1.2m in height, but in this instance with a tarmac top dressing. The platform bank is battered back using

a timber sleeper revetment (4 courses deep) with upright sleeper posts braced laterally using iron tie-bolts. An over-sailing timber kerb runs along the rail side of the platform and both the north-western and south-eastern platform ends are ramped. The railway embankment is presently used as a footpath and the platform, although overgrown, survives in a reasonable condition but starting to suffer from areas of localised collapse and subsidence.

The halt platform mainly survives intact and extends for c.120m along the north-eastern side of the railway embankment, south west of the station. The platform is built in a similar style to that at Ashdon Halt, comprising a ramped and battered bank but in this case with a tarmac top dressing. The railway embankment is presently used as a footpath and the platform, although extensively overgrown, survives in a reasonable condition, but is suffering localised collapse and subsidence. The site at

Bartlow junction has already seen the loss of the pedestrian causeway to the station, demolition of ancillary railway structures and the conversion of the station and the Sudbury bound platform. The halt contributes significantly towards the branch lines heritage and as such should be conserved to arrest its deterioration and insure its immediate future.

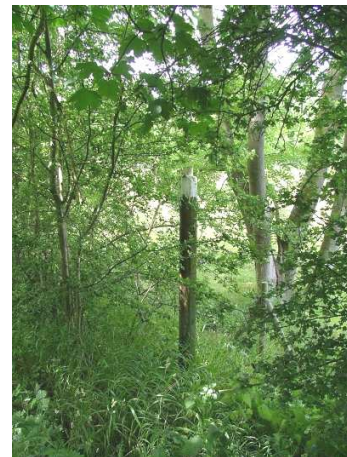
Located centrally to the rear of the halt platform (EHER 40471) and at the junction of the former pedestrian causeway to the station (TL 5835 4491) is the cast-iron base of a railway sign/finger post (EHER 40472).

Although the head is missing, its fingers were probably directed to the north-east and toward the main station building.

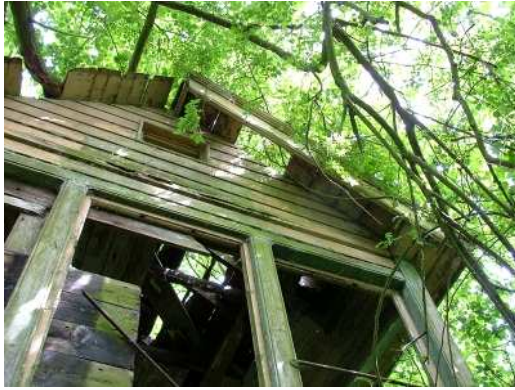
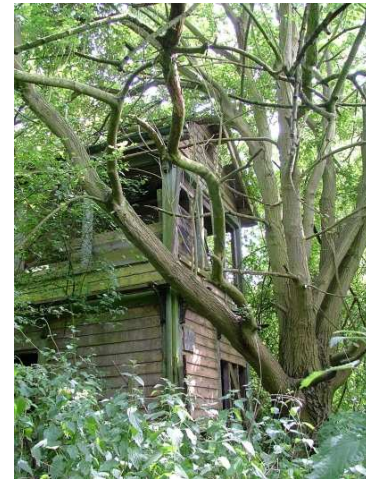
Signal Box at Bartlow Junction

To the north-west of the platform and toward the junction of the branch line and the Shelford-Sudbury line lies a derelict late C19 (1890s) Saxby and Farmer signal box (TL

5827 4499). The signal box is a two-storey, rectangular plan building with gable ends east and west and an external straight flight to the first floor. The walls are clad with weatherboard (shiplap) nailed onto a heavy primary braced 3 bay softwood (pine) timber-frame mounted onto a 5 brick course 1B wall plinth capped with chamfered blue brick copings. Heavy iron brackets with quatrefoil

sprandrels supported an external walkway with handrail which formerly ran around the first floor. Some lengths of boarding and handrail remain. The first-floor was extensively glazed with 6 large window openings in each long wall and 3 window openings in both gable ends. The shallow roof trusses are still partially covered in elm boards but the roofing slates are no longer intact. Both gables retain their moulded barge boards and square gable ventilators. An aperture cut through the roof boards for a flue betray the use of a small boiler/heater on the first floor. The first floor structure comprises lateral timber joists at 12" centres resting upon timber rails nailed to the long wall frames. Internally all of the mechanics controlling the points and signals have been removed. A large axial beam support for the lever mechanisms still extends the length of the ground floor, while braced to the northern wall were heavy upright timber mounting posts with rounded heads, formerly providing anchorage for the main control levers on the floor above. Floor mountings and conduits passing beneath the signal box to trackside were also in evidence. No other internal fixtures, fittings or finishes were recognised. Access up onto first floor was not possible.

The signal box currently lies derelict and within dense undergrowth. The roof coverings are missing and the building is far from watertight. There is considerable decay to the first floor boards and roof structure. However, remarkably the wall frames survive in a reasonable state. The survival of signal boxes from this period are unusual and the survey has shown that no other examples survive along the branch line. To ensure its future the signal box needs to be made weathertight, but in the longer term, it needs to be adopted/used by an interested party. The signal box is not beyond restoration and could be a rewarding project if taken up by a local historical society or group of railway enthusiasts.

The remains of a late C19 (1890s) Saxby and Farmer signal box is situated within dense undergrowth toward the junction of the Saffron Walden Branch Line and the Shelford-Sudbury line at TL 5827 4499. The derelict two-storey timber-framed signal box is no longer weathertight missing all of its roof covering and a significant amount of its shiplap weatherboarding. Internally all of the mechanisms/levers controlling the points and signals have been removed and the floor boards to the upper floor are decayed and no longer safe. However, the wall frames survive in a reasonable state with few significant areas of rot. The survival of functional railway buildings such as signal boxes from the later C19 are unusual and the survey has shown that no other examples remain along the branch line, with those at Saffron Walden and Audley End removed not long after the lines redundancy. To ensure its future the signal box initially requires remedial repair works to halt its deterioration, but in the longer term requires fuller conservation and ideally needs to be adopted/used by an interested party. The signal box is not beyond restoration and could be a rewarding project if taken up by a local historical society, a group of railway enthusiasts or the Railway Heritage Trust.

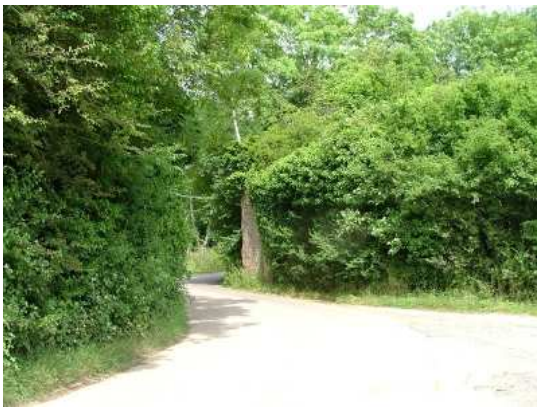
EHER 40474
Underbridge at Hadstock Road

The embankment, brick revetment and piers belonging to the bridge remain either side of the Hadstock Road, but the deck of the underbridge (probably iron beam) has been removed. The remains are currently overgrown but show little obvious signs of distress.
